History of Transformer Failures in the Nuclear Industry

YOUNGSTOWN STATE UNIVERSITY

December 2023

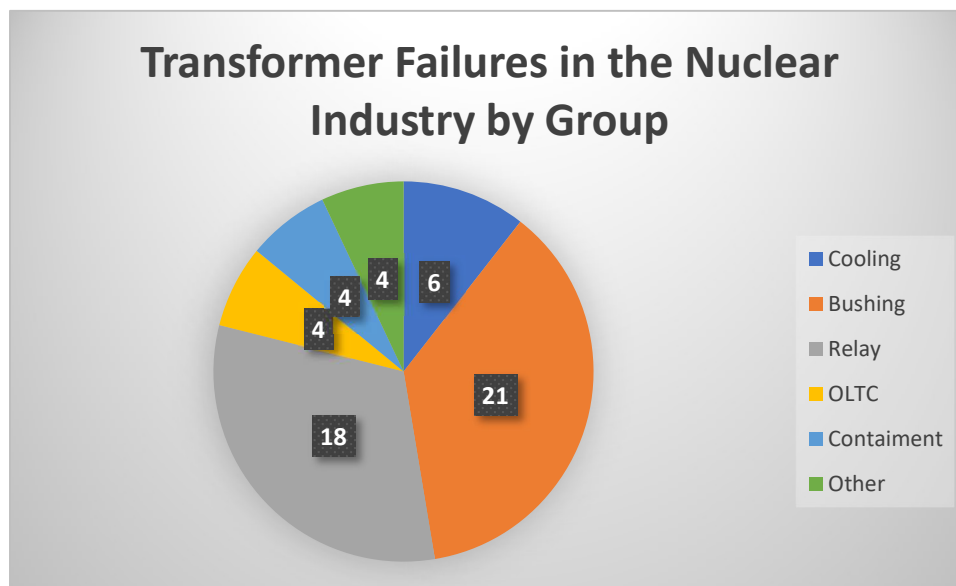
Figure 1 Transformer Failures by Group

From the table, it can be stated the two largest failure categories are Bushing Failures (21), and Relay related failures (18). In addition, out of all the failure types presented bushing failures are especially notable as every bushing failure resulted in a minimum of isolating the

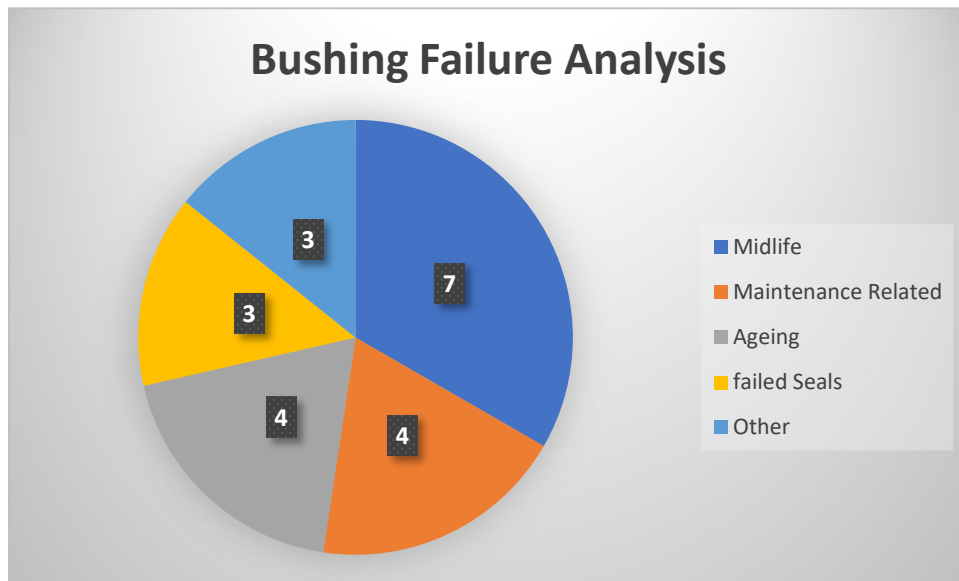
Figure 1 Bushing Failure Analysis

The consequences of bushing failures ranged depending on when the failure was identified and exactly what failed, even though all bushing failures resulted in a trip of the transformer. There were six instances resulting in transformer fires, nine that resulted in an oil leak. (Being either from the containment of the transformer or the oil in the bushings) There were instances where potential failures that were detected before the bushing showed any obvious degradation. (Three found via Doble testing)

From the events collected Midlife failures appear to be the most common. Out of the seven midlife failures four failed catastrophically causing a transformer fire, one was identified leaking, and the transformer was isolated before a catastrophic failure could occur, and two were identified during an outage via Doble testing.

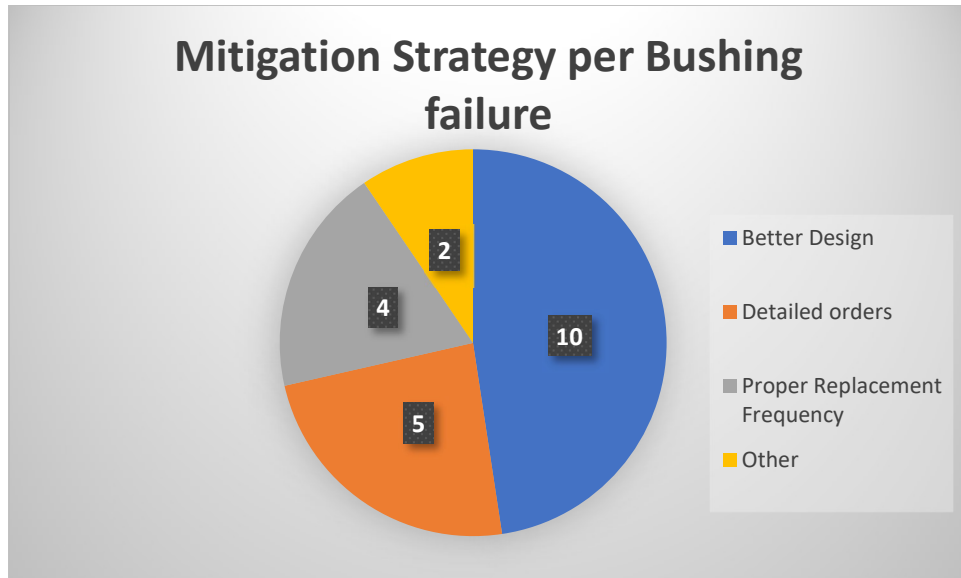
Figure 2 Mitigation Strategy per Bushing Failure by # of mitigated

The above figure represents the number of failures which could have been potentially mitigated / prevented regarding the failures identified in section 3. From the above, it can be seen utilizing a better design would have likely mitigated against roughly half of the potential failures identified. While this would help mitigate against a substantial number of failures, it can be expensive as swapping bushing types may necessitate draining the transformer, hence this should be performed when replacing the bushings to help minimize cost and downtime. Replacing the bushings should be performed on a fixed basis, and it should be noted that this category is most likely misrepresented to an extent as the nuclear industry is currently performing bushing replacements and usually bushings do not reach an old enough age.

Detailed Orders: This would mitigate against maintenance leaving bushings with inappropriate connections, as well as leaving test cap connections to lose. (Caused an oil leak from the bushing)

Other: This category is for failures which couldn't have been mitigated as easily as they were caused by some external force such as animals or falling debris. Walkdowns could have potentially helped however would have been unlikely to have identified the issues.

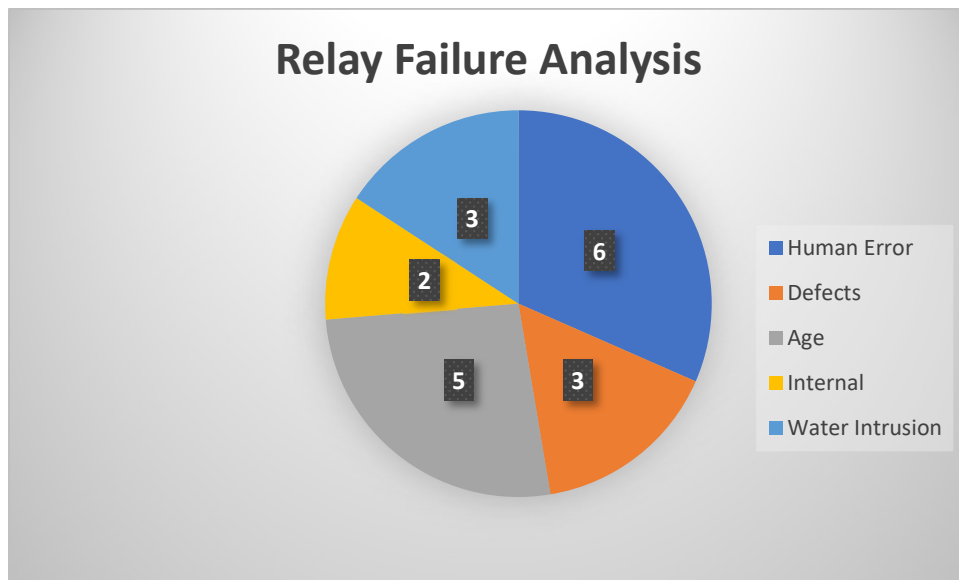
Figure 3 Relay Failure Analysis

A failure of an 87T, 63, or 50/51 relay will typically be more consequential than a failure of an Open Phase Protection System, as the previous relays are directly related to transformer protection so a false operation would more commonly result in a trip or at least an alarm. Additionally, two of these failures resulted in relays not operating and were found during testing.

Out of the eighteen relay failures that were included in the study, six were due to some form of human error. This is notable as failures which are caused by human error are some of the most avoidable. In addition to this, many of the events changed the way stations performed testing, increased the amount of peer checks, and updated their procedures to better incorporate

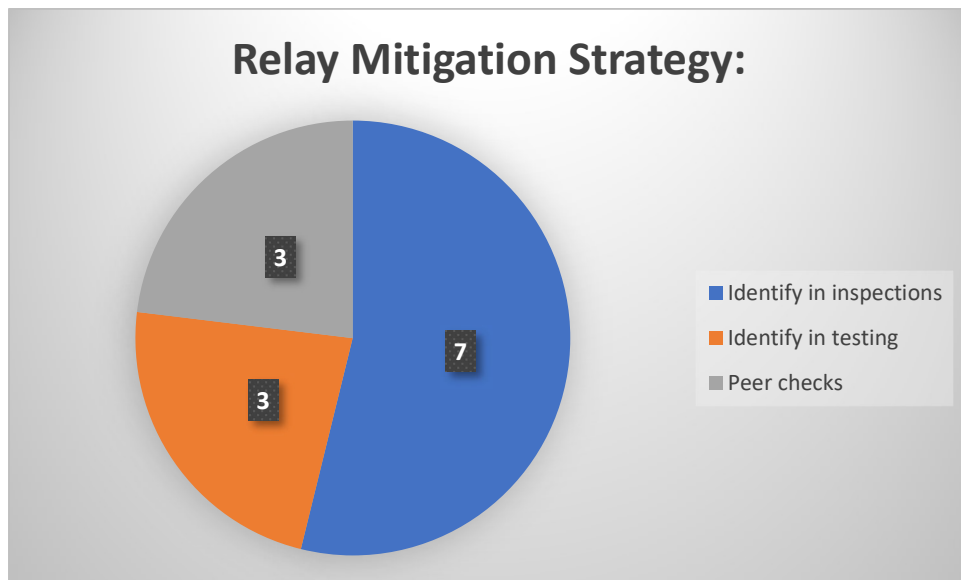
Figure 4 Relay Mitigation Strategy

Several failures identified can be seen as random events due to manufacturing issues, or random internal relay failures, however most relay failures identified could be detected via occasional inspections to difficult areas to reach on transformers, additional functional testing, or peer checks and maintaining good situational awareness with the job at hand.

All water intrusion events could have been identified via inspections, as all had sufficient time to corrode the terminations inside or were identified via an inspection. Additionally, several ageing events were due to wires fraying and contacting other components, which could have been identified via additional inspections on uncommonly accessed areas of the transformer
