THE DIELECTRIC FAILURE MECHANISM OF A  
HIGH VOLTAGE FEEDTHROUGH

Submitted in Partial Fulfillment of the Requirements  
for the Degree of  
Master of Science  
in the  
Electrical Engineering  
Program

YOUNGSTOWN STATE UNIVERSITY

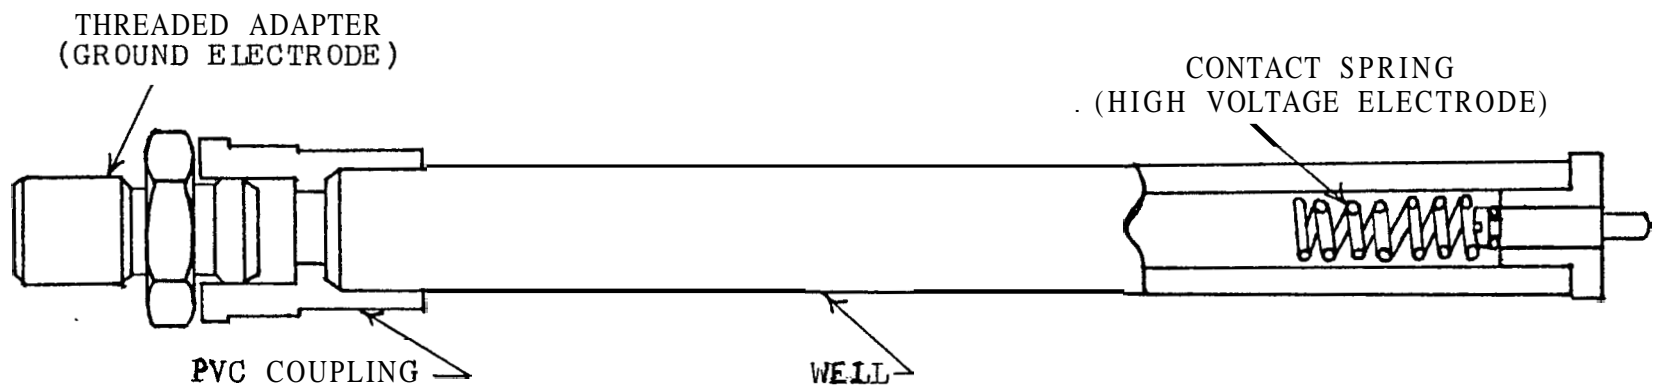
FIGURE 5. CROSS SECTION OF HIGH VOLTAGE WEDTHROUGH OR WELL

The insulation problem began showing up in field units in the fall of 1980, about nine months after the 115KV system was first introduced for sale. It was first noted as a high current condition (>160 microamps) on the power supply's microammeter and a corresponding drop in the voltage at the tip of the gun. The power supply, cable, and gun are designed to have high effective resistances. Therefore, with a current this high, the voltage at the gun tip, available to charge the paint, was essentially zero.

The cause of this high current draw turned out to be current on the inside surface of the well and the surface of the cable end inside the well. Both of these surfaces were normally excellent insulators.

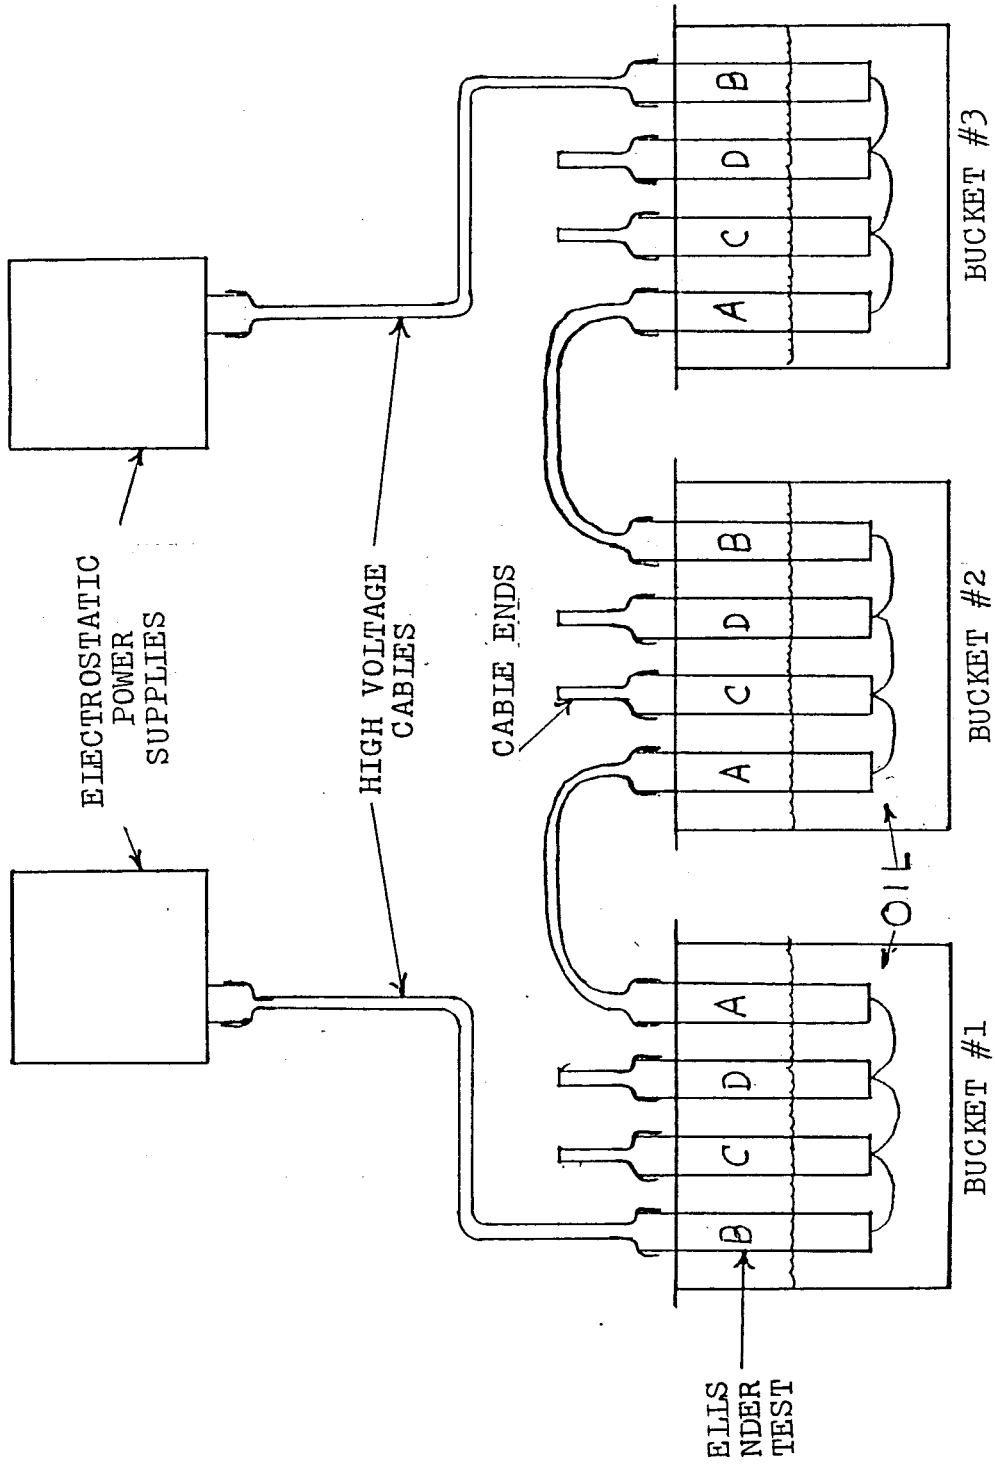
FIGURE 10. TEST SETUP FOR EXPERIMENT 2.

Within eighteen hours, two wells showed signs of being in the first stage of degradation. The cable in well 2B, which had been dipped in water, had black carbon smudges

at the tack end and had a yellow stain near the grounded cable adapter. The well itself had visible arcing inside, when it was energized without the cable. However, a bore-scope examination showed only hair line arc-tracks.

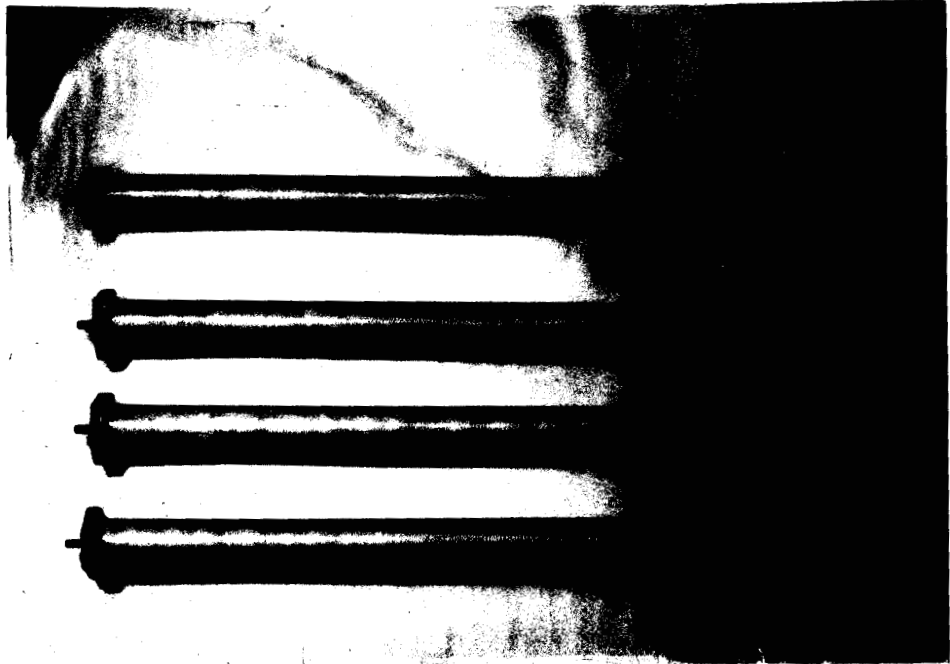
FIGURE 12. SAMPLE GLASS-MELAMINE WELLS FROM EXPERIMENT 3.

To eliminate the PVC material, a brass adapter was machined to join the glass-melamine well to the grounded, threaded cable adapter. One well was fitted with this and the test was repeated. 2.0 cc of water were added to the well and a clean cable end was inserted. In 1.5 hours, the well had audible and visible arcs, but there was not tracking. Instead the surface of the cable had become alligator-skinned. These wells are illustrated in Figure 12.

The conclusions of this experiment are as follows. First, the PVC is necessary for arc-tracking to occur. A
