**A ROSGEN LEVEL III ANALYSIS OF TWO STREAM RESTORATION
PROJECTS NEAR YOUNGSTOWN, OHIO**

Rajesh Kumar Poudel

YOUNGSTOWN STATE UNIVERSITY

December, 2010

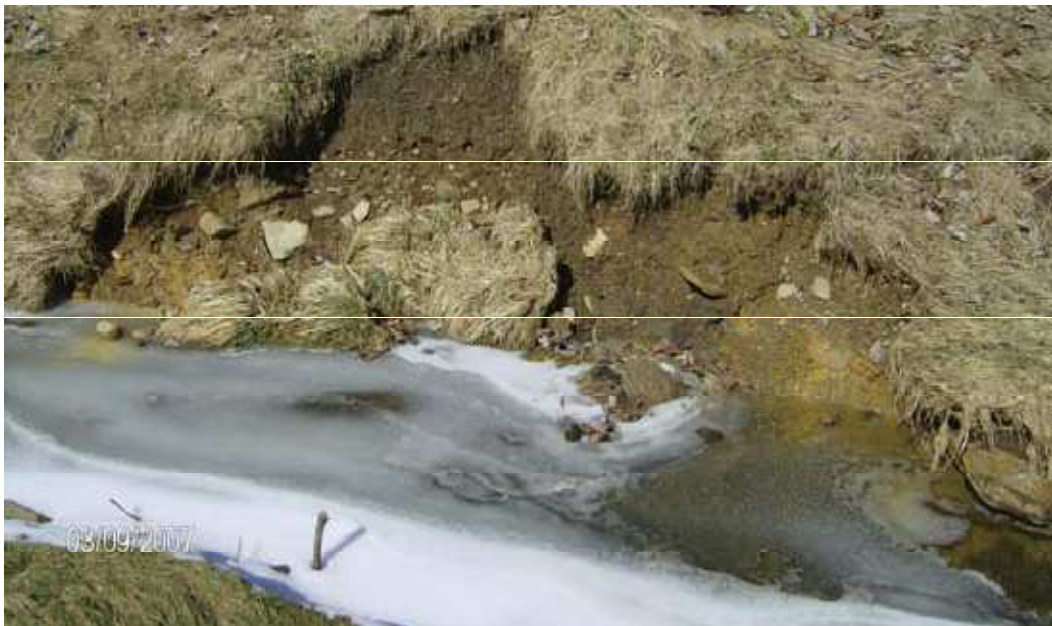
Figure 2.10 Bank erosion and collapse on the north bank of the Austintown Park stream (WPI 2007).

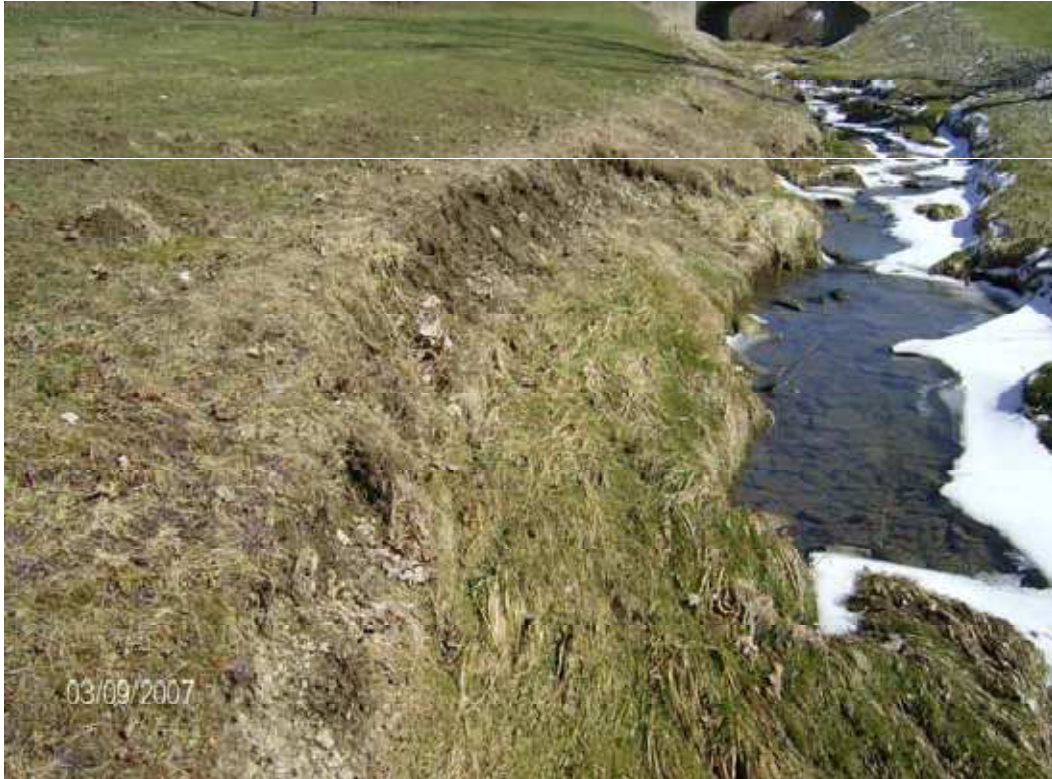
Figure 2.11 Sliding and eroding bank on the north bank of the Austintown Park stream (WPI 2007).

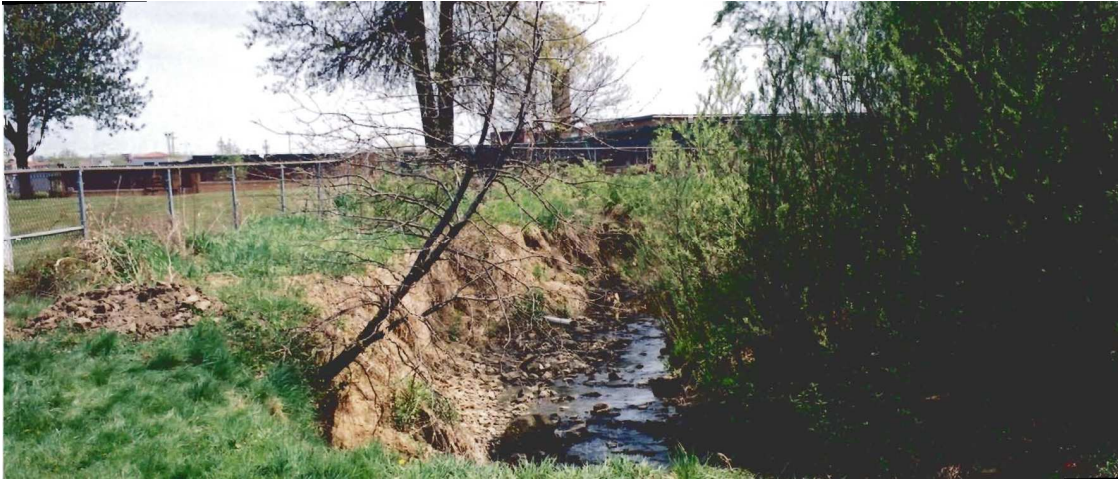
Figure 2.16 Bank erosion on the right side of Indian Run, looking upstream (WPI 2003).

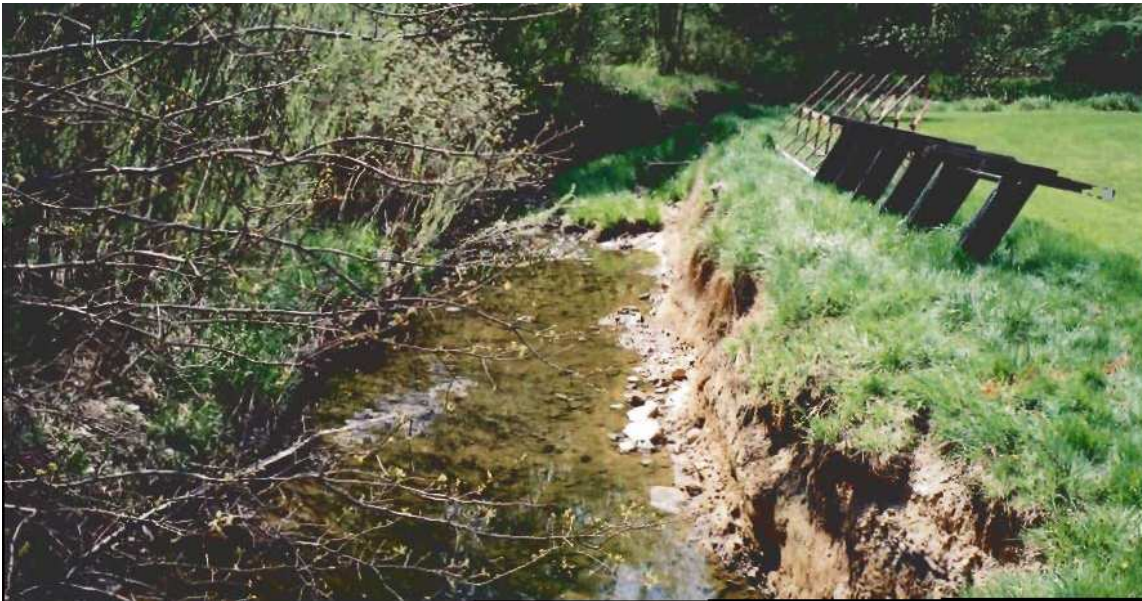
Figure 2.17 Bank erosion on the right side of Indian Run, looking downstream (WPI 2003).

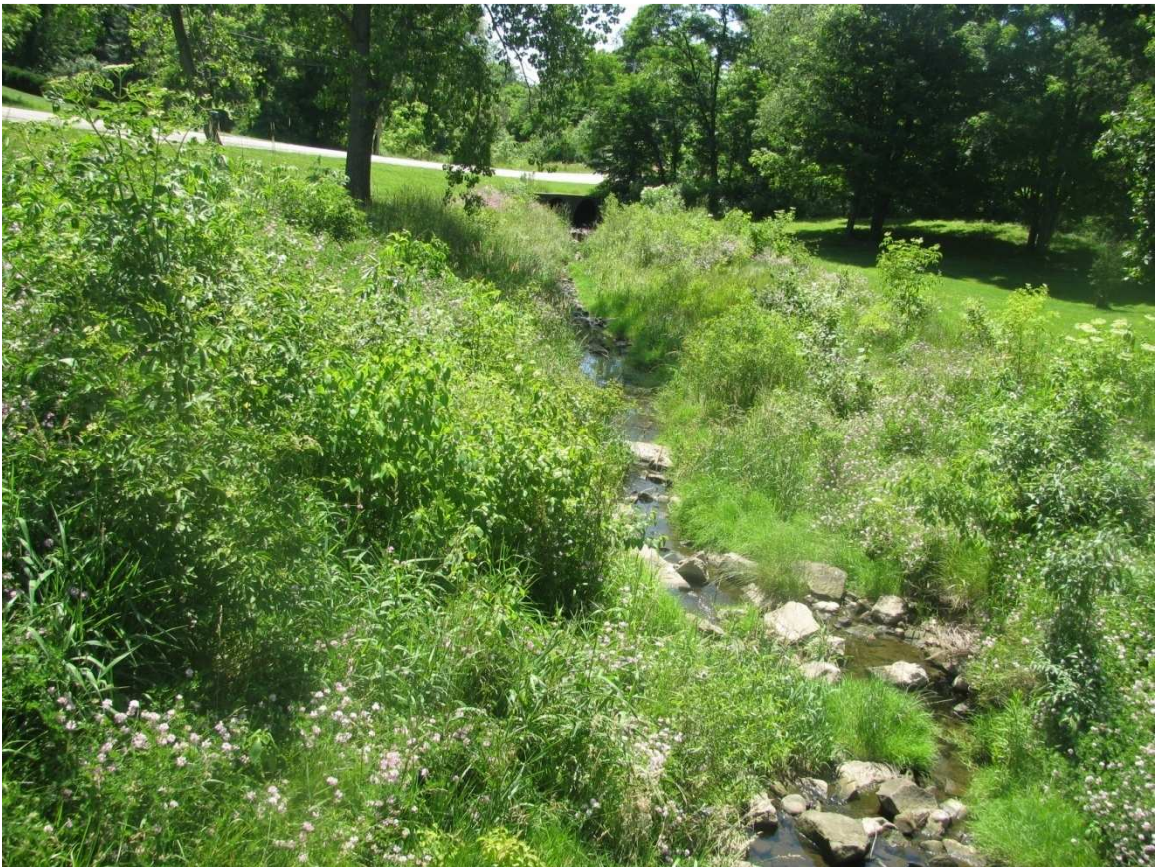
Riparian Vegetation: Past photographs (Figure 2.11) and aerial photos of the Austintown Park site indicate that there was only a narrow strip of riparian vegetation (grasses and small shrubs) along both banks of the stream before restoration. Grass on the adjacent land was mowed up to the edge of steeply sloping banks. There were no trees on the right bank (looking downstream) and only two trees on the left bank. After the restoration of the stream section, there is a 10 to 15 ft wide, moderate density combination of grass and brush on both banks. Although there are a few small trees, the combination of grass/brush is dominant (Figure 4.2). Hence, the riparian vegetation of the Austintown Park Site is rated as 8b (combination grass/brush – moderate density).

Figure 4.2 Riparian vegetation in restored reach of Austintown Park site (June 2010).

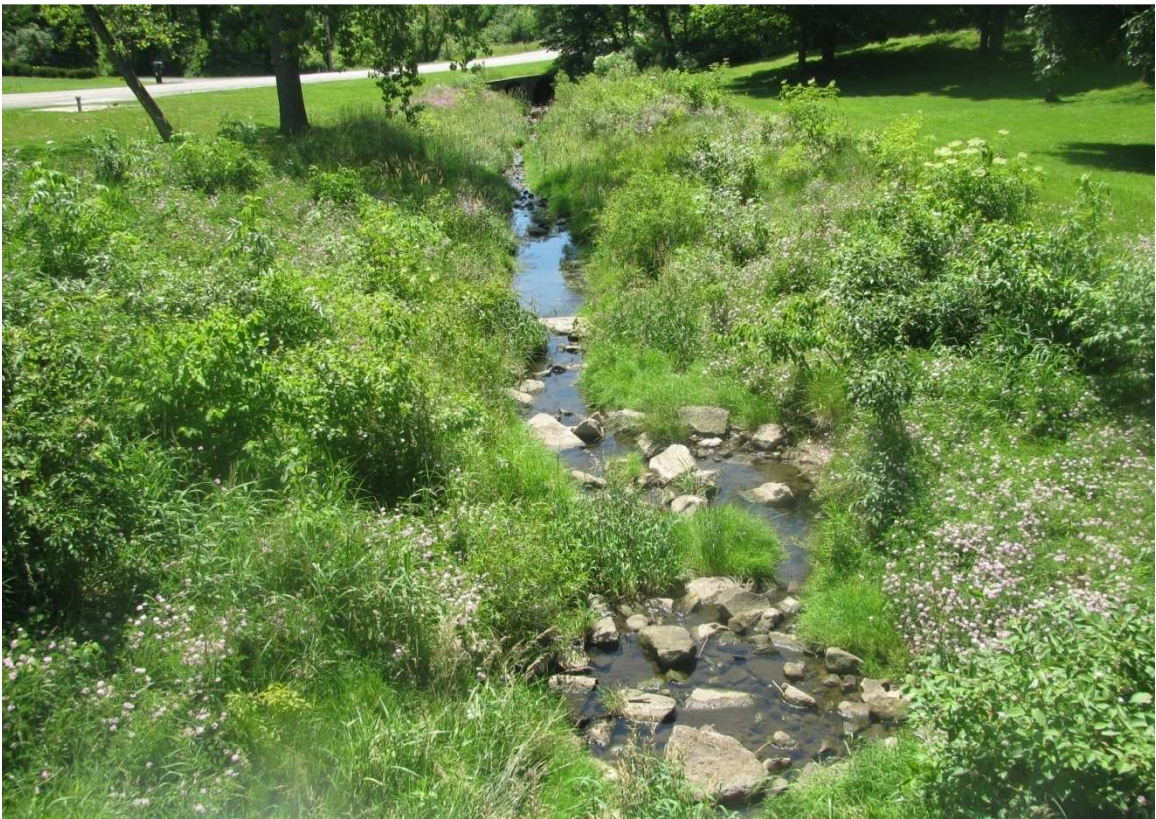
left bank of the stream (looking downstream), and because of the limitations in work space due to the presence of a bridge and culvert at the upstream and downstream project limits, respectively, the project designer could not achieve the expected sinuosity.

Figure 4.3 Depositional pattern and meander pattern in channel reach of Austintown Park site (June 2010).

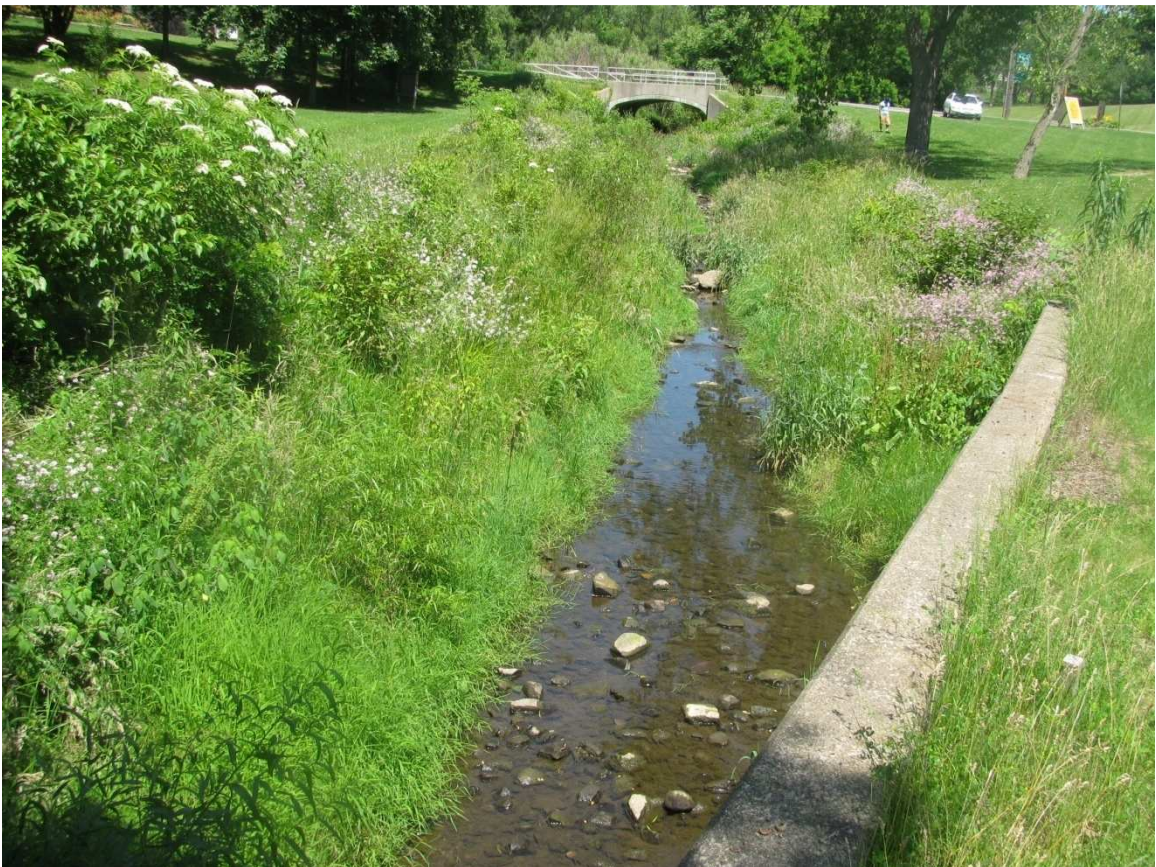
encroachments by the construction of the Kirk Road on the left bank of the river (looking downstream), a bridge and a culvert on the upstream and downstream ends of the study reach, respectively (Figure 4.4), have influenced the existing flow regime. As A result, the stream could not maintain its own natural flow path, and the meander pattern and significant channel adjustments have occurred. Hence, referring to Table 2.6, stream channel debris and channel blockages can be categorized as type D2 and D10.

Figure 4.4 Debris and channel blockages in restored channel reach looking upstream at Austintown park site (June 2010).

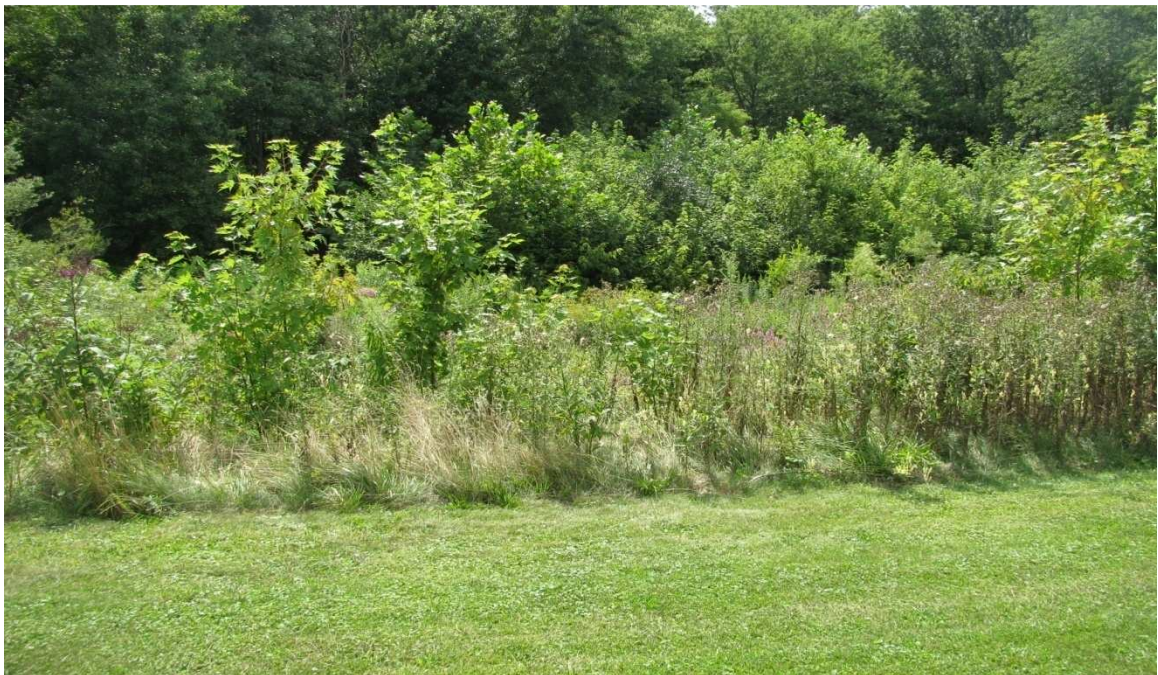
10 to 20 feet wide from top of the stream, and includes a very dense mixture of grass, shrubs, and small trees (Figure 4.6). The additional 5 feet of grass buffer has also laid in the riparian buffer development. The riparian vegetation on the right bank can be categorized as 8c (Table 2.1). Riparian vegetation on the left bank was not modified significantly by the restoration, and can be classified as category 10b (Table 2.1) – moderate density deciduous with brush/grass understory (Figure 4.7).

Figure 4.6 Riparian vegetation on the right bank of the Indian Run site (July 2010).

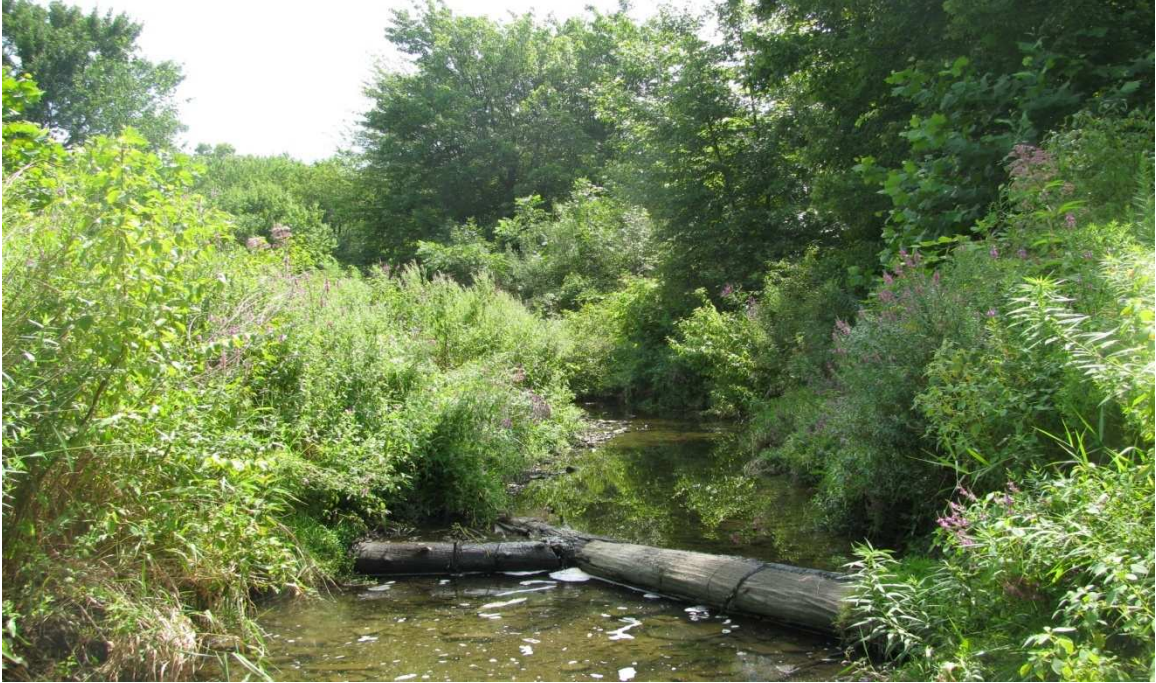
Figure 4.7 Riparian vegetation on the left bank of the stream reach looking upstream at the Indian Run site (July 2010).

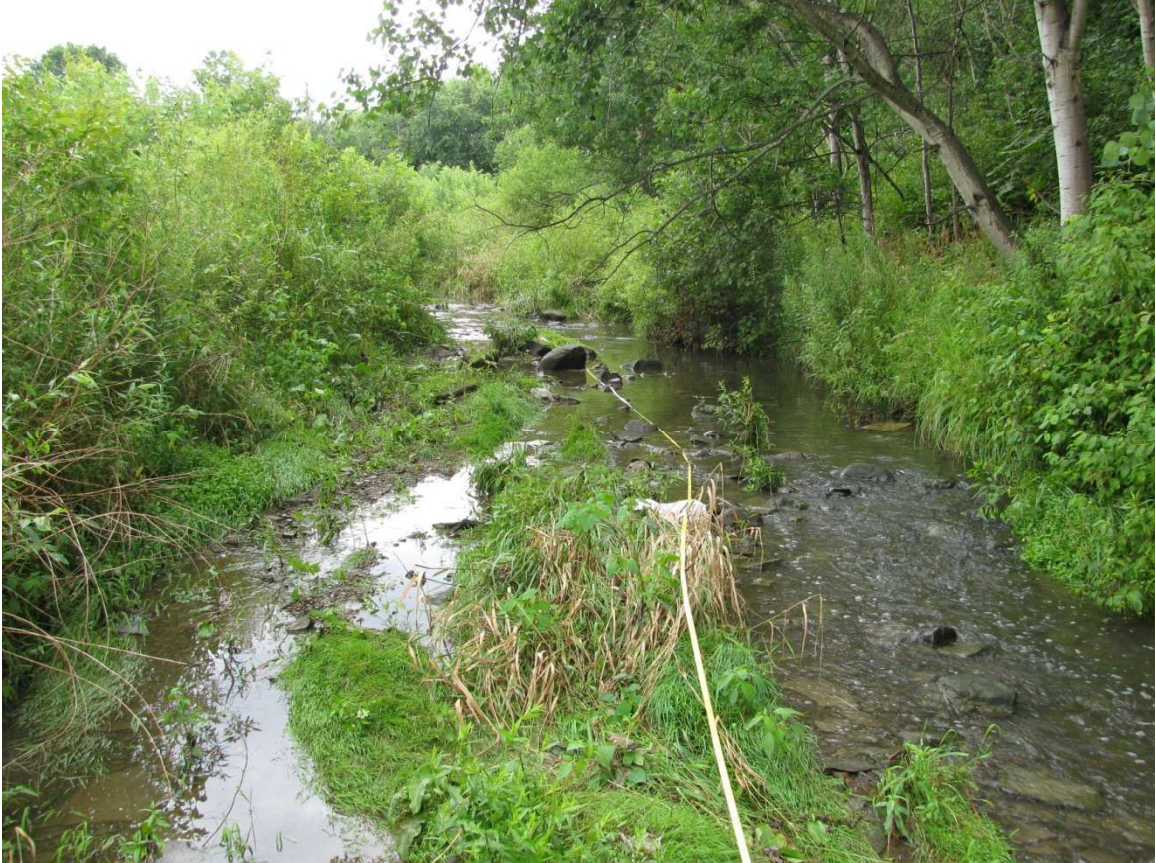
in the restored stream reach of the Indian Run Site (Figure 4.8). Hence, referring to Table 2.4, the depositional pattern in this case can be designated as type B-2.

Figure 4.8 Depositional pattern in the restored reach of Indian Run (July 2010).

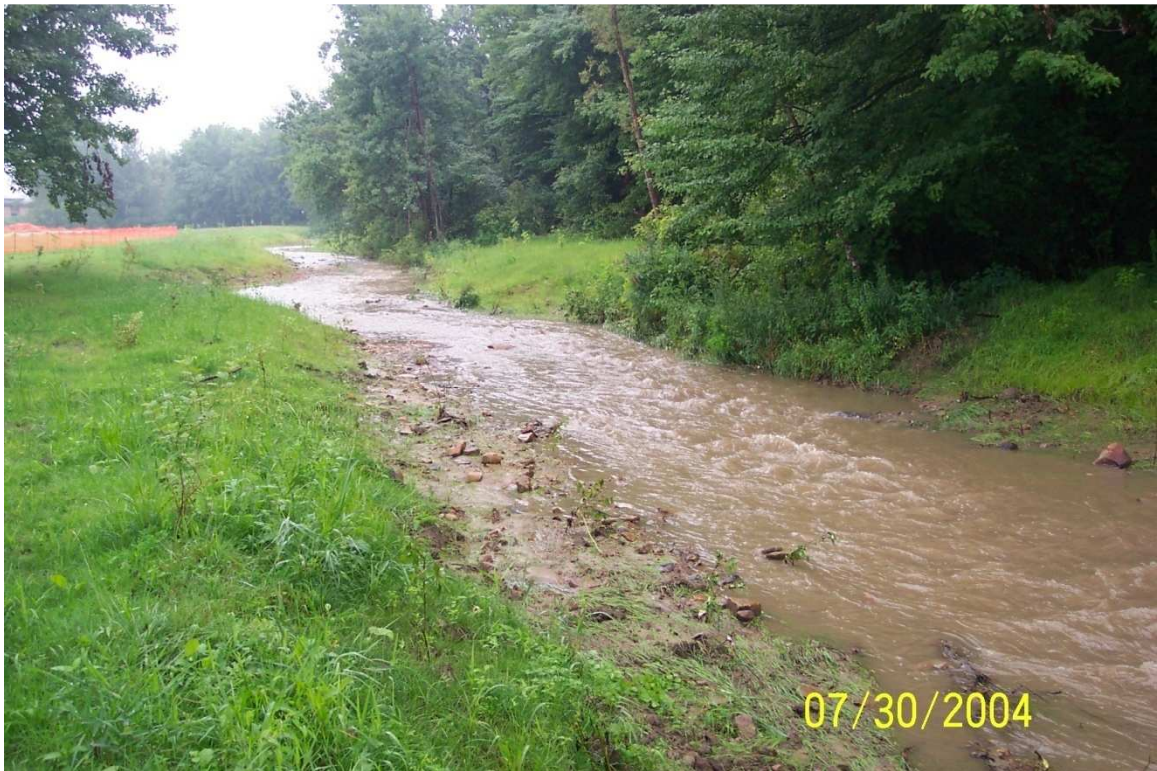
Meander Patterns: Meandering of Indian Run at the study site follows an irregular pattern (Figure 4.9). Hence, from Table 2.5, the meander pattern of the stream can be categorized as type M-3. Although the stream is classified as B4c type (Pant, 2010), from the longitudinal profile survey, channel sinuosity (k) was found to be only 1.06 (Table 4.4). According to the Rosgen Level II classification key (see Appendix), the expected sinuosity for a B4c type stream is greater than 1.2. The sinuosity of the study reach is

currently more typical of a much steeper type A stream. In designing the stream restoration, Wallace and Pancher, Inc., could not increase the sinuosity much due to the steep right bank.

Figure 4.9 Meander pattern in restored reach of Indian Run (WPI 2004).

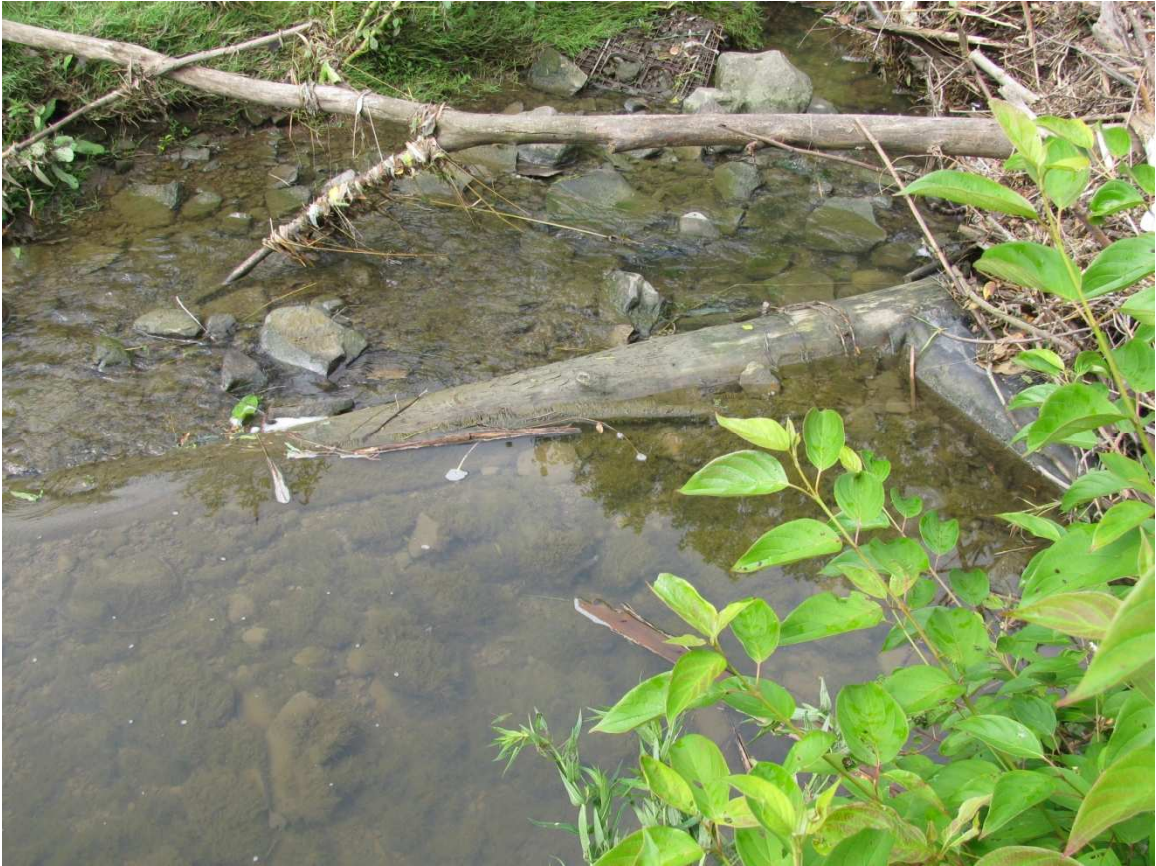
Debris and Channel Blockages: Debris and channel blockages were determined by visual observations during several field visits. Debris consisted of occasional small to medium sized material, such as tree branches and small logs that affect 10% or less of the active channel cross-sectional area (Figure 4.10). Hence, referring to Table 2.6, stream channel debris and channel blockages can be categorized as type D3 (Moderate).

Figure 4.10 Debris and channel blockages in the restored reach of Indian Run (July 2009).

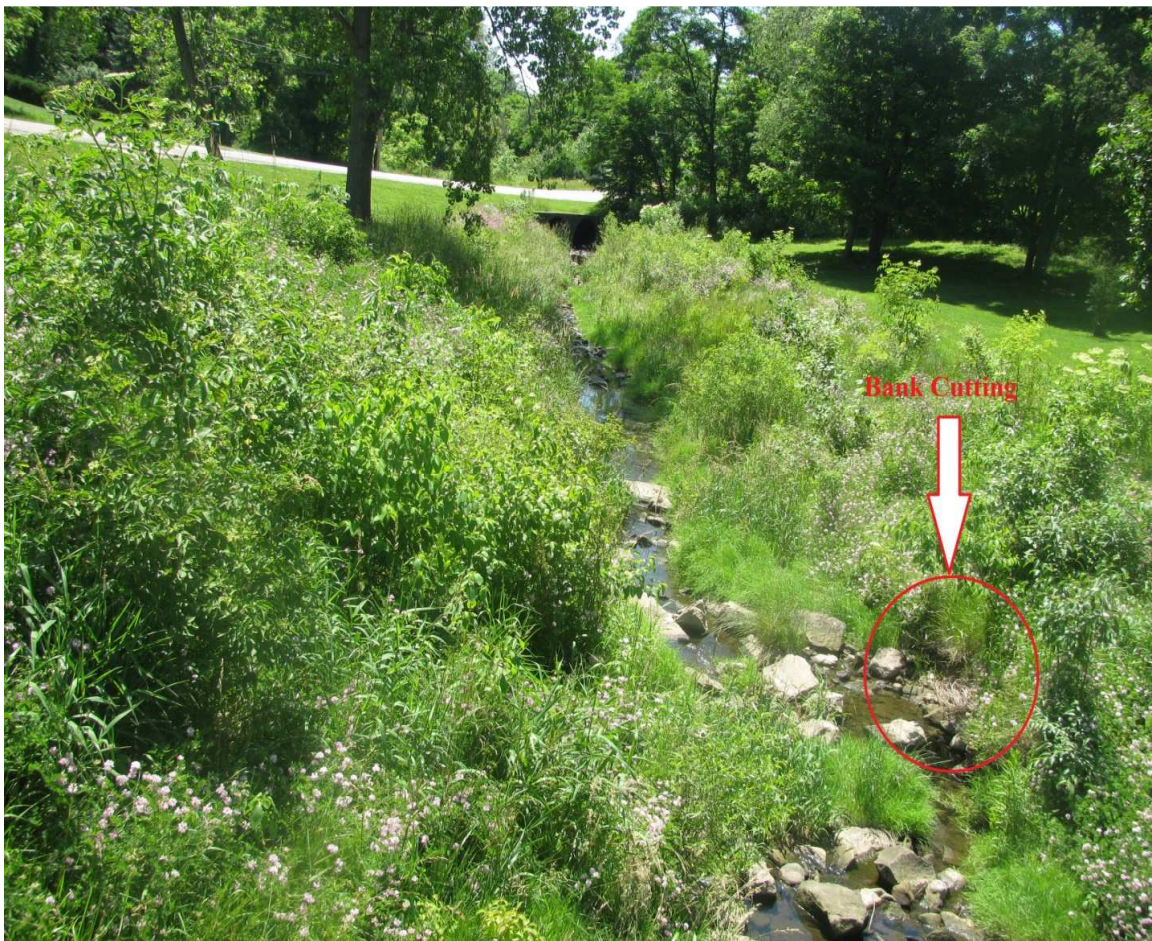
up to a foot deep (Figure 4.11). Mass wasting is infrequent and mostly healed over. There is low future potential of mass wasting in the stream reach. Although there is a small amount of debris present in the channel, the debris jam potential in the restored section is very low. Most of the debris found was small twigs and limbs. From the field visit, some newly formed bars were observed in the restored stream reach, as compared to the old photographs, mostly from coarse gravel. The only aquatic vegetation in the stream channel is algae formed in low velocity and pool areas. Seasonal algae growth has made rocks slick.

Figure 4.11 Bank cutting at Austintown Park site (June 2010).

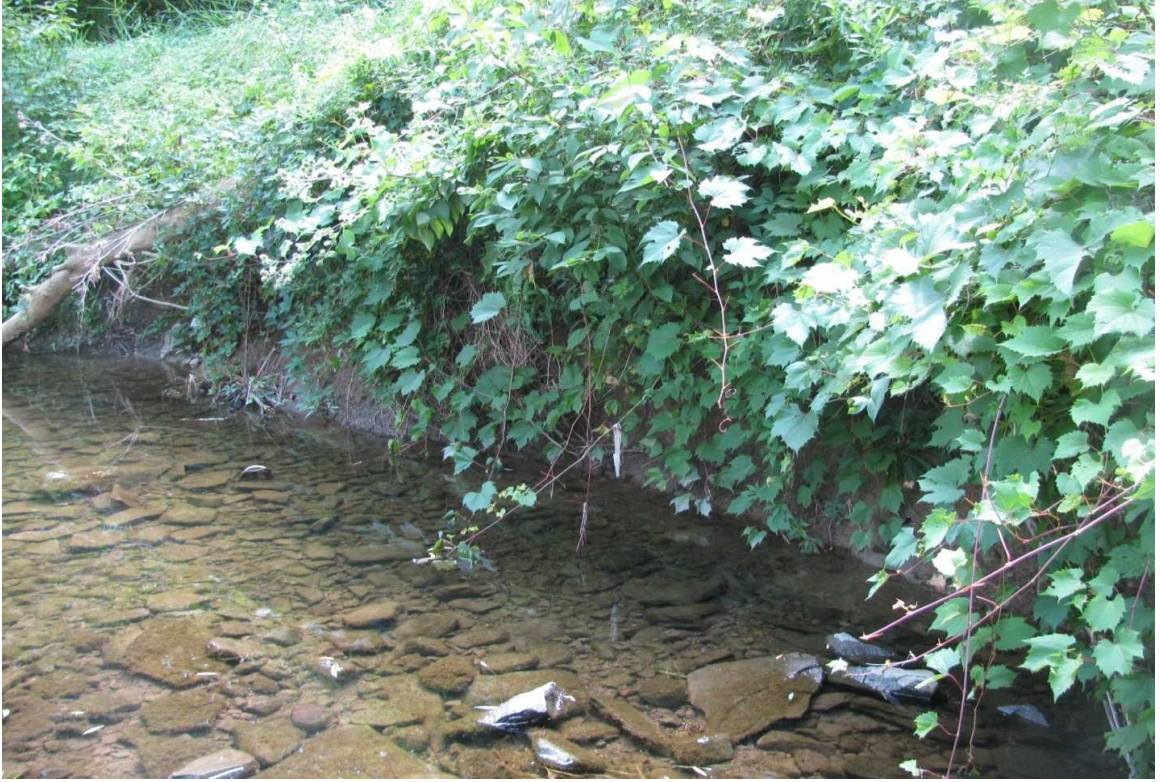
From the field observations and cross-sectional survey of Indian Run site, we obtained the average bank slope gradient of more than 40%. Some of the segments on the left and right bank of the restored section are very steep (Figure 4.12 and 4.13). This high steepness in gradient has resulted in bank erosion and also caused the high potential for instability of earth. From the cross-sectional survey, an average width/depth ratio of 34.06 was obtained (Table 4.4). Although there is a high width to depth ratio at bankfull stage, the channel capacity was found to be adequate as we observed a rare bank overflow during the field visit. Even after the restoration of the stream, there are still some intermittent lower bank cuttings along the right bank. During a field visit in July 2010, raw banks cutting up to two feet deep were observed (Figure 4.14 and 4.15). Mass wasting is infrequent and mostly healed over. There is low future potential of mass wasting in the stream reach. Although moderate debris was present in a few locations (Figure 4.16), the debris jam potential in the restored section is low. Most of the debris found was small twigs and limbs. From the field visit, some new bars were found in the restored stream reach, as compared to the old photographs, mostly from coarse gravel. Most of the aquatic vegetation was algae formed in low velocity and pool areas. Some are present in backwater and seasonal algae growth has made rocks slick.

Figure 4.12 Steep gradient on left bank of Indian Run (July 2010).

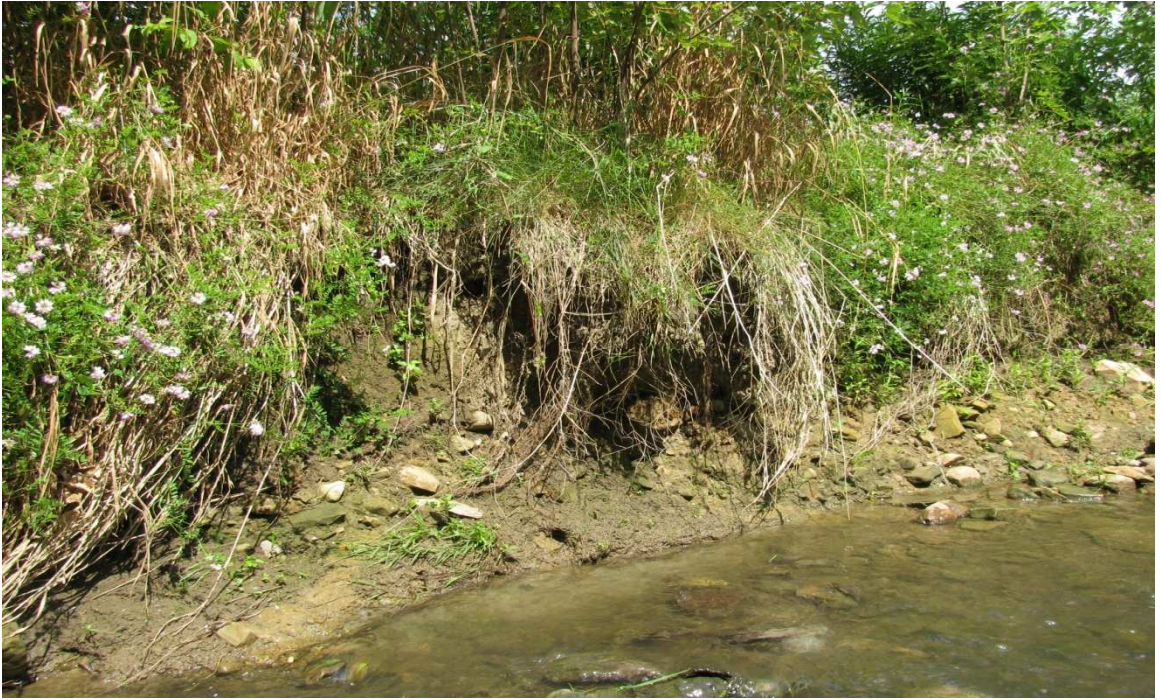
Figure 4.13 Steep gradient on right bank of Indian Run (July 2009).

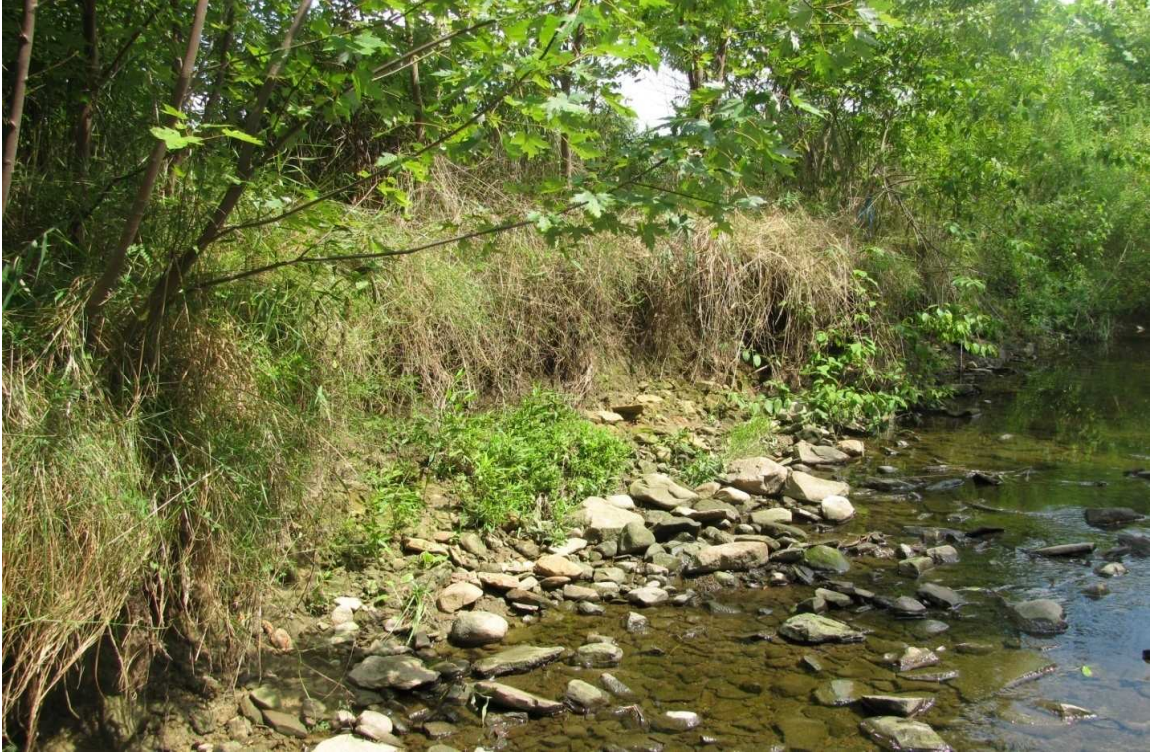
Figure 4.14 Bank cutting on left bank of Indian Run (July 2010).

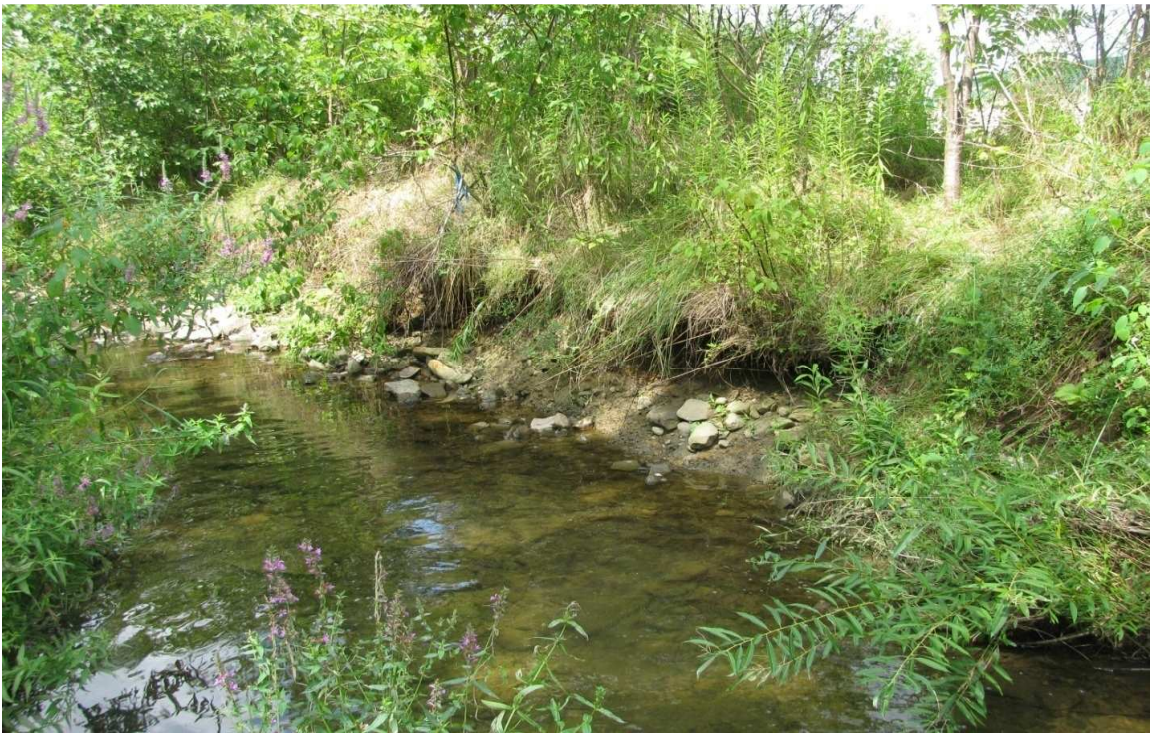
Figure 4.15 Bank cutting on right bank of Indian Run (July 2010).

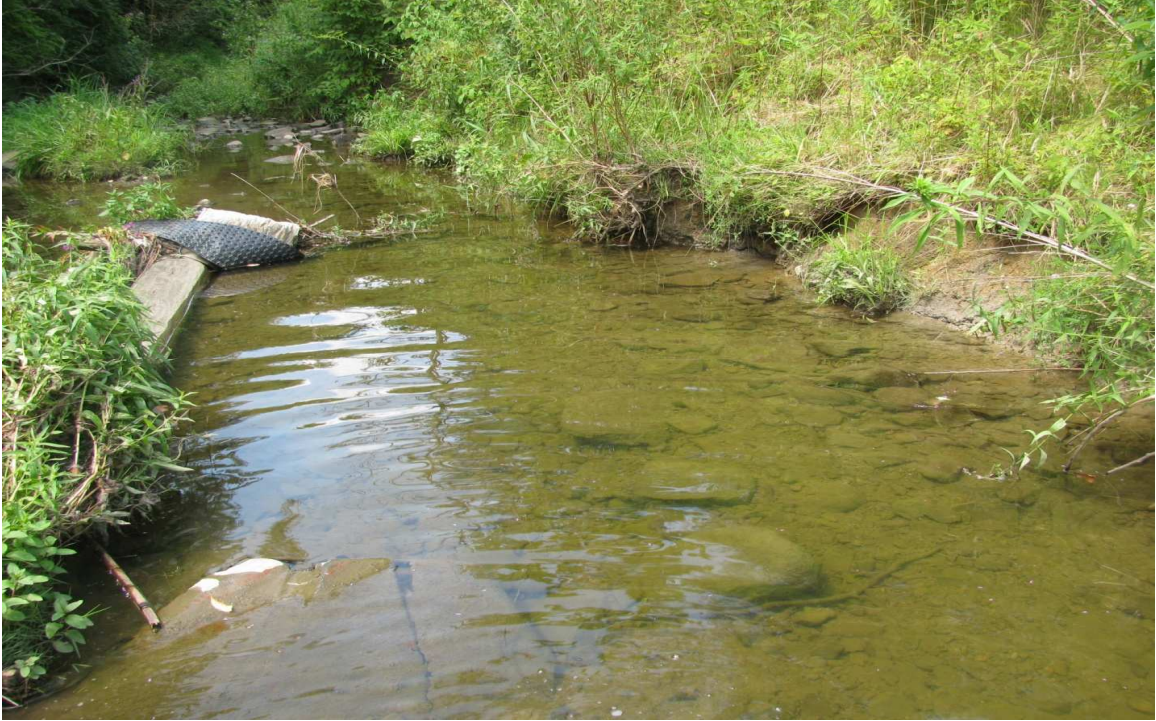
Figure 4.16 Debris jams on restored reach of Indian Run (July 2010).
