A Macroinvertebrate Study of the Shenango River Westinghouse Superfund
Site, Sharon, PA

Master of Science

YOUNGSTOWN STATE UNIVERSITY

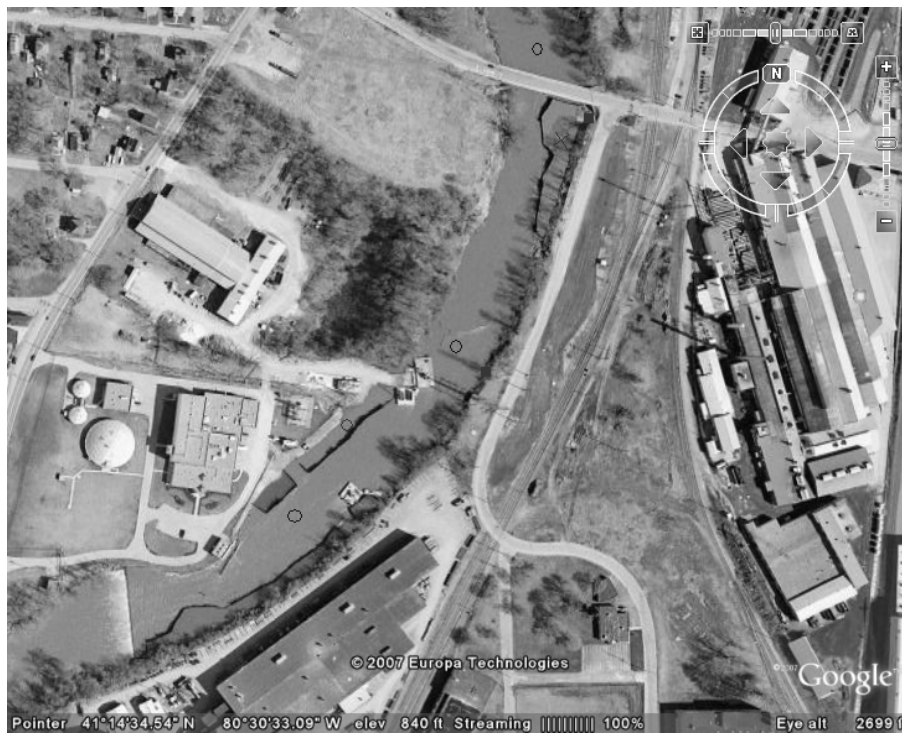
Figure 1.3 Shenango River Westinghouse Superfund Site. (Google Earth)

Samples were taken with respect to where the Shenango River was dredged during the superfund cleanup; starting from downstream and working up stream (Figure 2.0). Sampling was done on three separate dates representing three different seasons to ensure collection of all possible macroinvertebrates some of which emerge synchronously and could be missed by a single sampling effort. Landmarks and aerial photographs were used to mark each of the sampling locations for repetition.

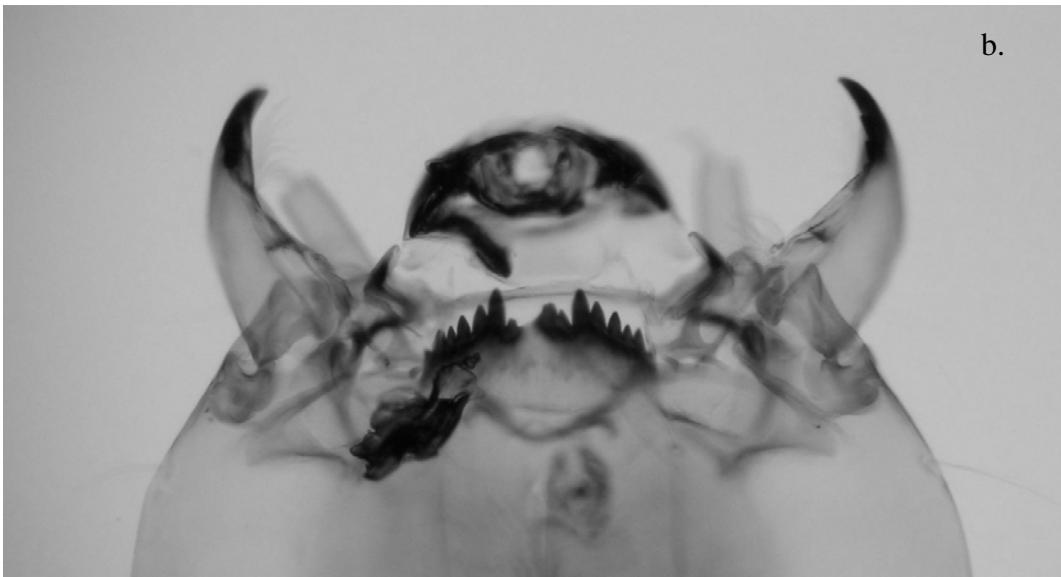
Figure 3 a.) Chironomid *chironomus*, no deformities. b.) Deformed Chironomid *chironomus*, medial gap. c.) Deformed Chironomid *chironomus*, missing left medial tooth, gap in mentum, missing medial tooth.

Figure 3 (cont.) a.) Chironomid *chironomus*, no deformities. b.) Deformed Chironomid *chironomus*, medial gap. c.) Deformed Chironomid *chironomus*, missing left medial tooth, gap in mentum, missing medial tooth.

The total deformities including all sites are 6 out of a total of 107 *chironomus* genera assessed giving an overall deformity percentage of 5.6%. The deformities in the nonremediated areas are 1 out of 17 *chironomus* assessed a deformity percentage of 5.9%. The remediated sites had a total of 4 deformities out of 64 *chironomus* assessed, a deformity percentage of 6.3%. The reference site totaled 26 *chironomus* and has 1 *chironomus* deformity giving it a deformity percentage of 3.8%. An example of a *chironomus* mentum without deformities can be seen below in figure 4a while an example of a deformed mentum can be seen in figures 4b and 4c.

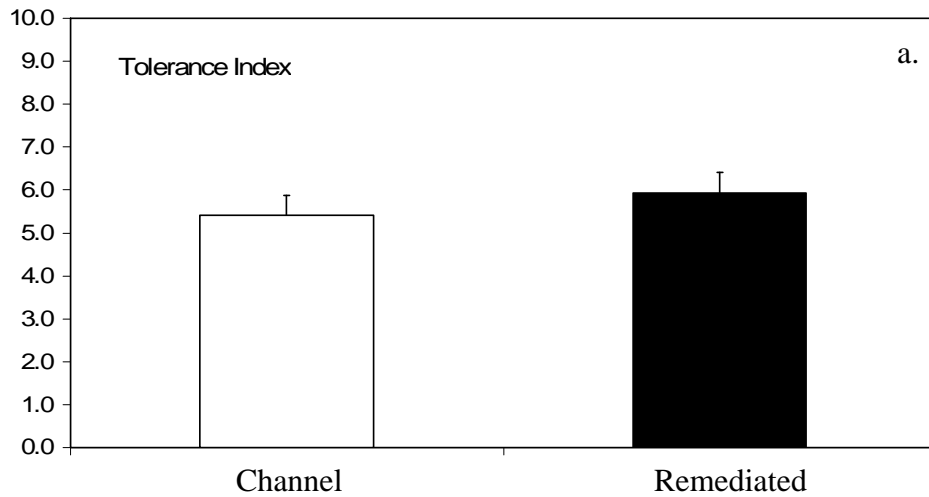
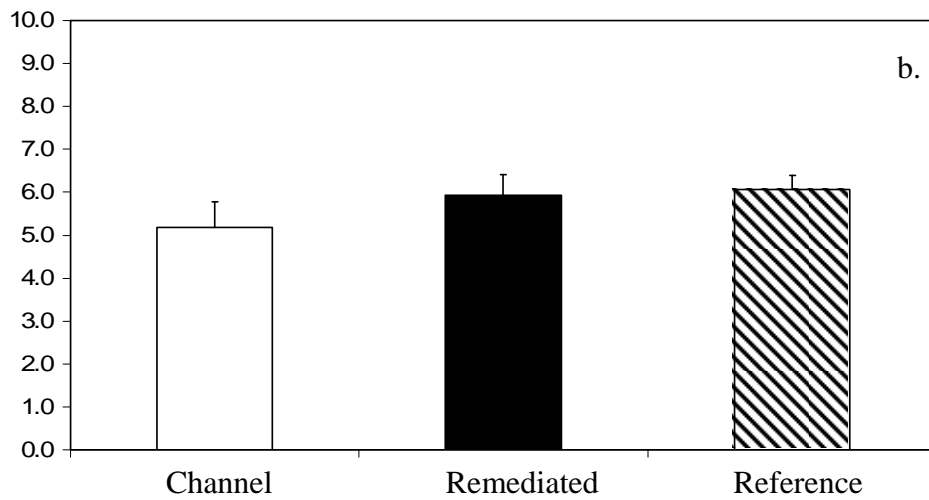
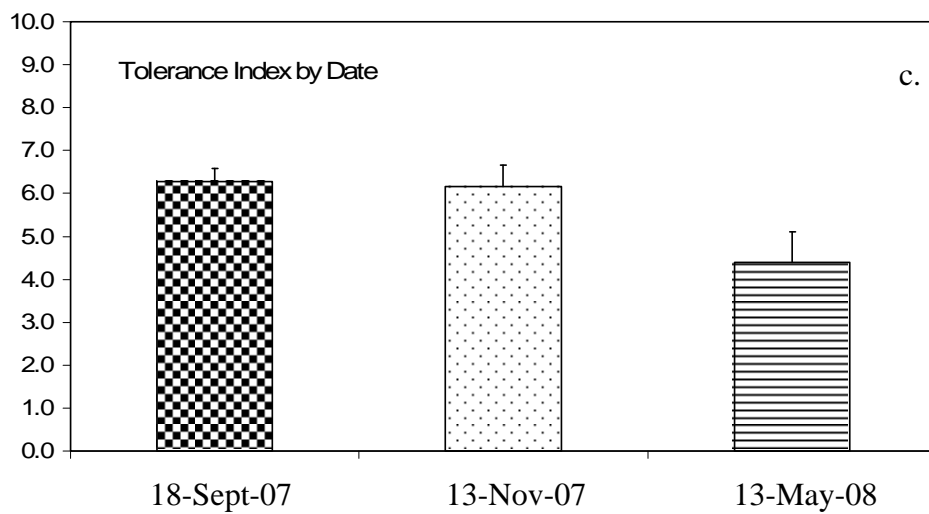
Figure 4 Tolerance index by a.) Non-remediated v. Remediated site. b.) Non-Remediated v. Remediated v. Reference site. c.) Date.

The total tolerance index for all sites is 5.6. The tolerance index value for the remediated areas is 5.4. The tolerance index value for the non-remediated area is 5.2. The index value for the reference site is 6.1. A visual comparison can be seen below in Figure 5. An interpretation of these tolerance values can be found in Appendix A.
