**Corrosion Detection in Oil and Gas Pipeline Using 3-D Bluetooth Enabled Printed
Microsensor**

Master of Science Engineering

Chemical Engineering

YOUNGSTOWN STATE UNIVERSITY

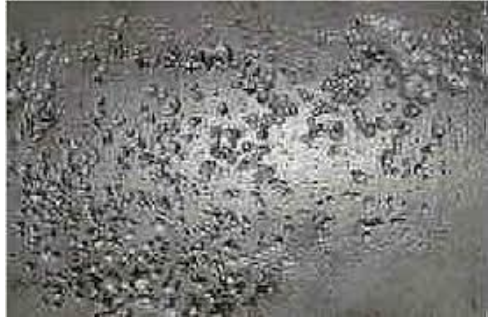
Figure 1.4. Pitting corrosion [108].

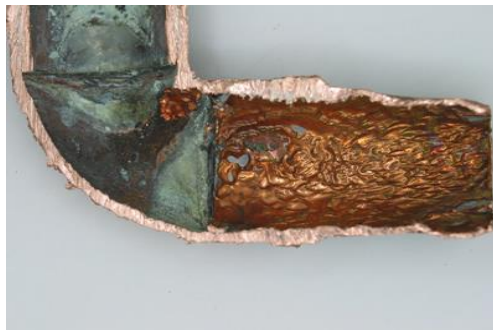
Figure 1.6. Erosion Corrosion on Inner Surface of an Elbow Pipe [110].

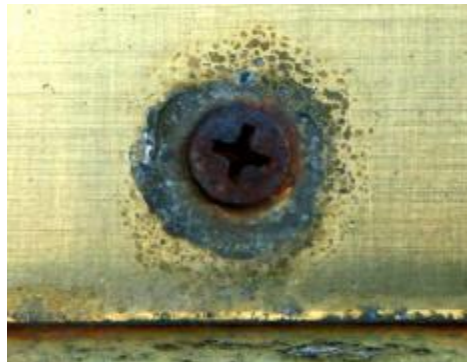
Galvanic corrosion occurs when two metals with distinct electrochemical properties are in close proximity, as shown in Figure 1.7, establishing an electrical connection, and then both metals are also in contact with an electrolyte. The driving force behind this form of corrosion arises from the potential difference generated between these dissimilar metals. The more active metal becomes the anode and corrodes faster. The less active, or noble, substrate acts as the cathode and corrodes slower. The ions are transferred from anode to cathode via the electrolyte. Most of the bimetallic corrosion takes place in marine environments, primarily because saltwater functions effectively as an electrolyte in these cases. Galvanic corrosion is influenced by the placement of the metal on the galvanic series. Therefore, opting for metals positioned closely to each other within the galvanic series can reduce the impact of galvanic corrosion [15].

Figure 1.7. Galvanic corrosion of two dissimilar metal [111].

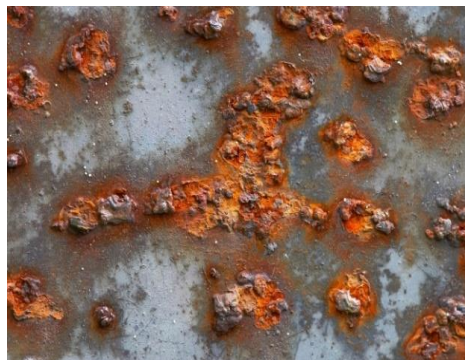
Intergranular corrosion represents a distinct type of corrosion typically observed along the edges of grains or adjacent to these boundaries, as shown in Figure 1.8. Intergranular corrosion primarily arises due to the development of precipitates and the separation of materials within the particular zone near grain boundaries [13]. Intergranular corrosion is typically limited to a small region; however, in certain instances, it can lead to the complete detachment of the entire grain due to the complete breakdown of boundaries. This corrosion significantly impacts the mechanical characteristics of the metal substrates. An illustrative instance of intergranular corrosion involves the sensitization of stainless steels or the decay of welded joints [13].

Figure 1.8. Intergranular corrosion of two dissimilar metal [112]

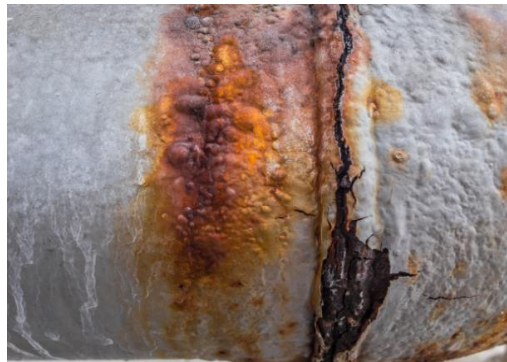
Stress corrosion cracking emerges from the synergistic impact of corrosive surroundings and tensile stress, as shown in Figure 1.9. This form of cracking can be prompted by either external or internal stresses [13]. It frequently manifests in regions subjected to elevated stress levels, including pressure vessels, bends in pipelines, and subterranean reactors. Besides metals, materials such as ceramics, pristine substances, and polymers are prone to stress-induced cracking in specific corrosive settings. Corrosive environments triggering such cracking primarily involve highly reactive corrosive ions like chloride ions (Cl^-) and ammonia (NH_3^-) in the medium [1].

Figure 1.9. Stress corrosion cracking [103]

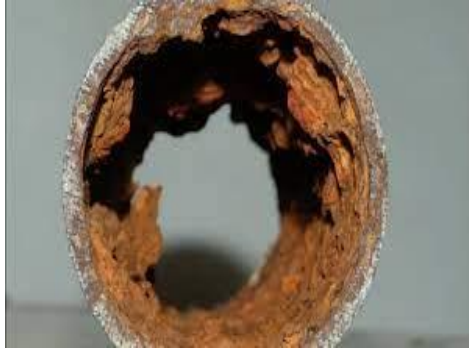
Figure 2.1. Internal corrosion of pipeline [120].

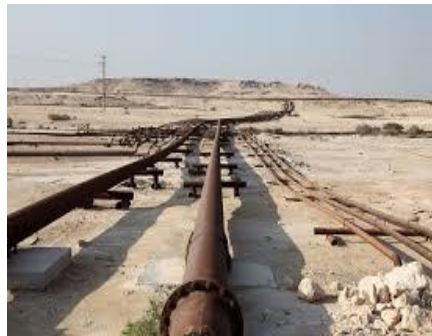
Figure 2.2. External corrosion of pipeline [121].

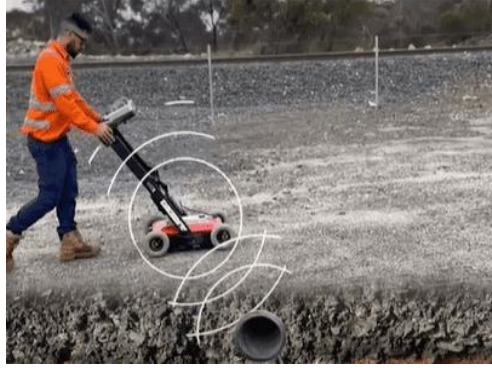
GPR detection of reinforcement corrosion is a novel challenge. Ground-Penetrating Radar (GPR), as shown in Figure 2.9, has been routinely used to find and map steel reinforcements in concrete structures with high speed and precision data gathering [78].

Figure 2.9 GPR for corrosion detection [125].

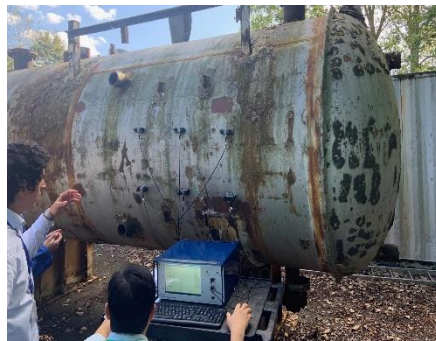
Figure 2.10 Acoustic sound detection for corrosion [126].

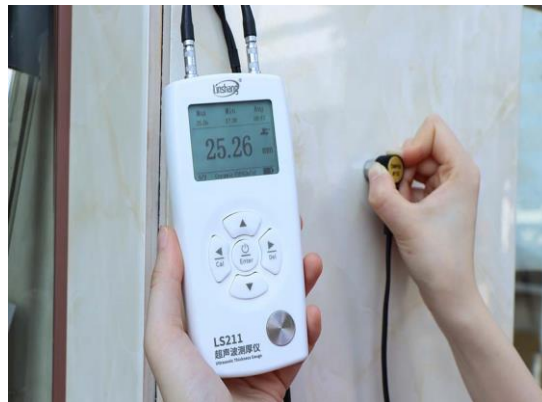
When the sites of concern are easily accessible, spot ultrasonic thickness measuring can be used, although, this is rather slow, if a large number of locations must be examined. Guided wave inspection [84] covers huge regions with a single transducer position and is widely used on pipework (Figure 2.11).

Figure 2.11. Ultrasonic Thickness testing for corrosion [127].

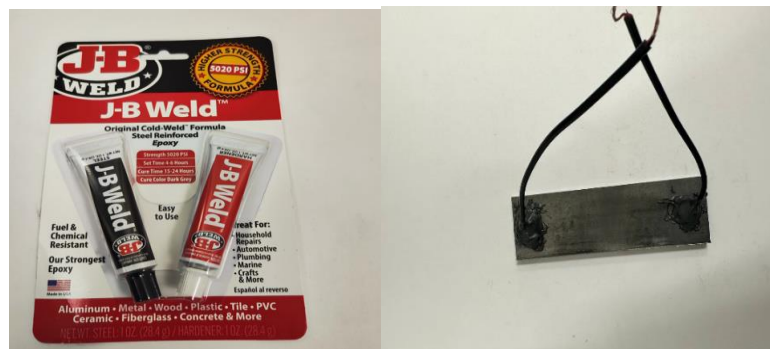
The J-B Weld Original Cold Weld two-part epoxy method provided a strong, long-lasting connection between the metal samples and the copper wire, as shown in Figure 3.2. It made a permanent bond when mixed at a 1:1 ratio and set to a dark grey tint in 4-6 hours at room temperature. The entire cure took 15-24 hours.

Figure 3.2. J-B weld 8265s epoxy was used for the experiment.

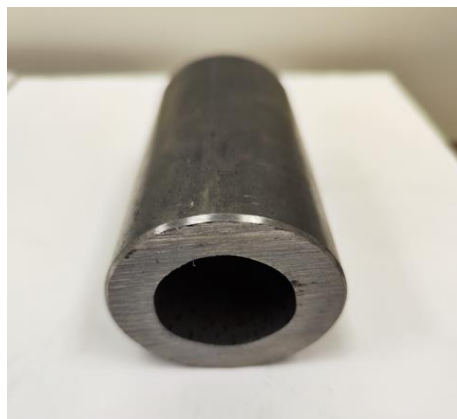
Figure 3.4. 0.5"4140 steel metal pipe before corrosion.

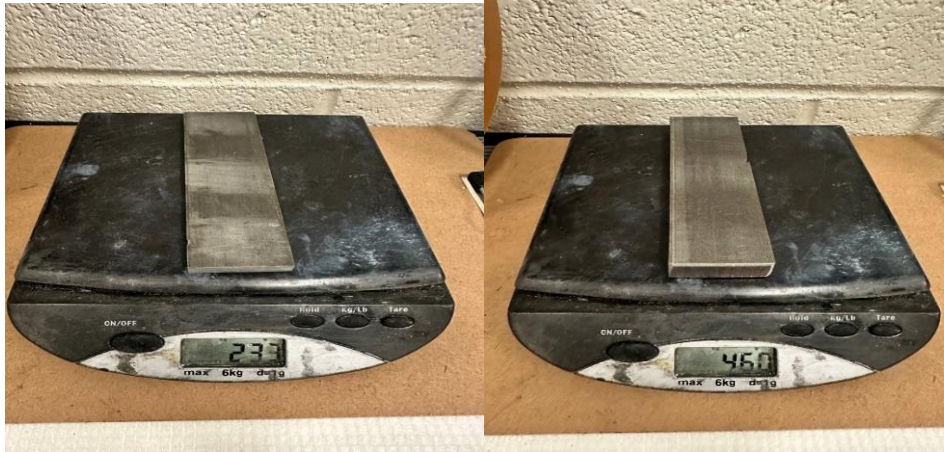
Figure 3.6. Weight of metal coupons being measured.

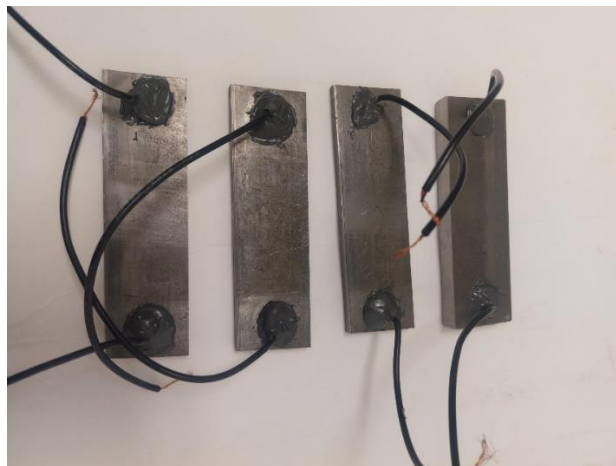
Figure 4.1. above shows image of metal before exposed to corrosion environments.

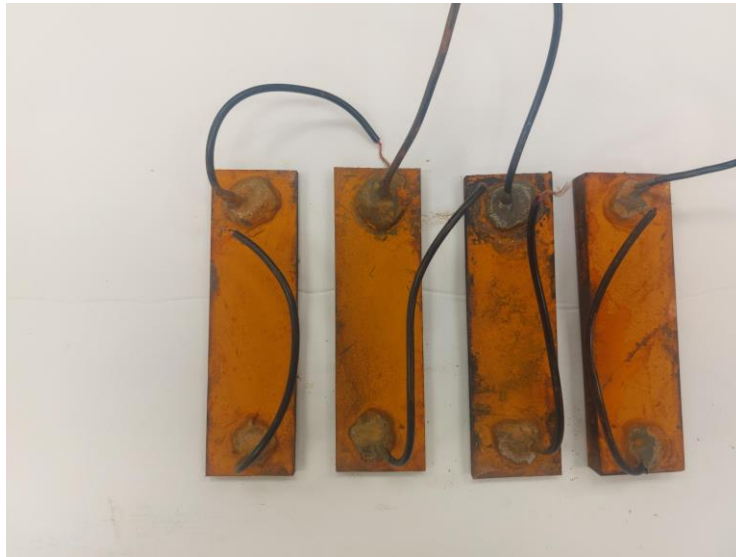
Figure 4.2 above shows image of coupons immersed in NaCl solution.

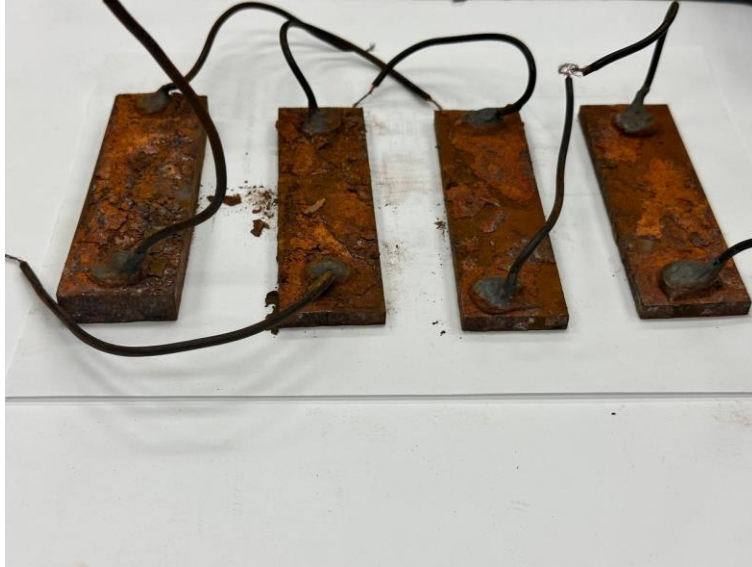
Figure 4.3 above shows image of coupons immersed in NaCl solution and dried.

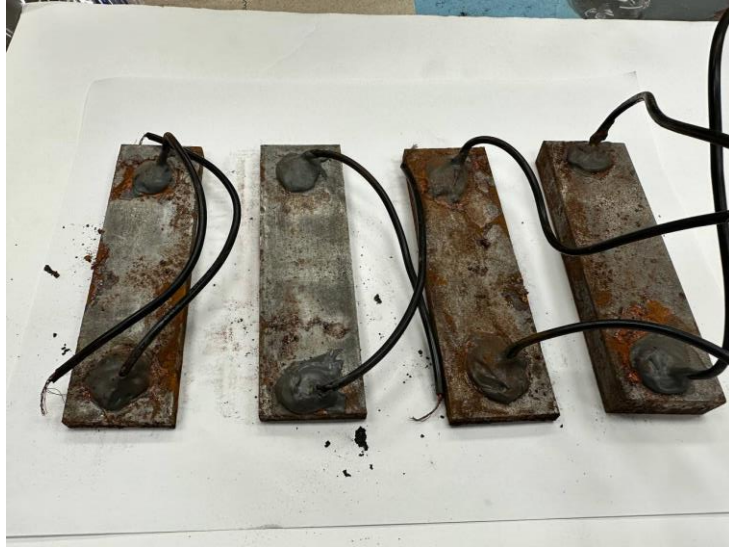
Figure 4.4. below shows image of metal coupons placed over NaCl solution.

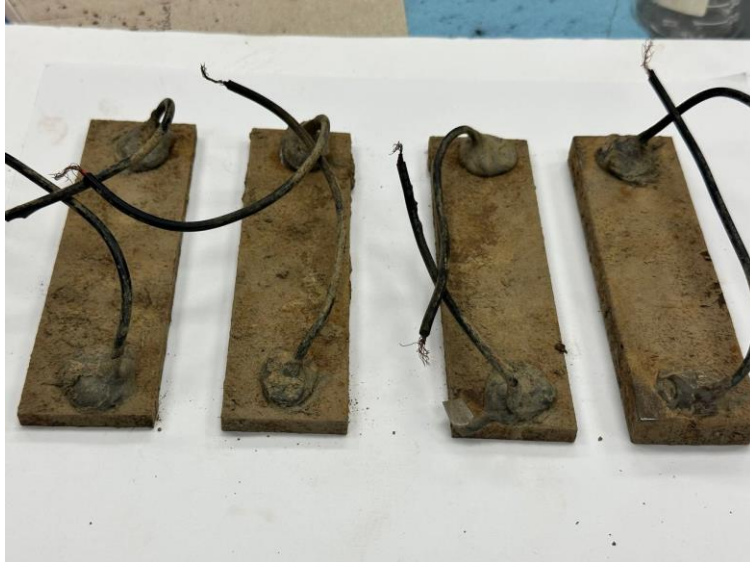
Figure 4.5 below shows image of metal coupons buried in wet dirt.

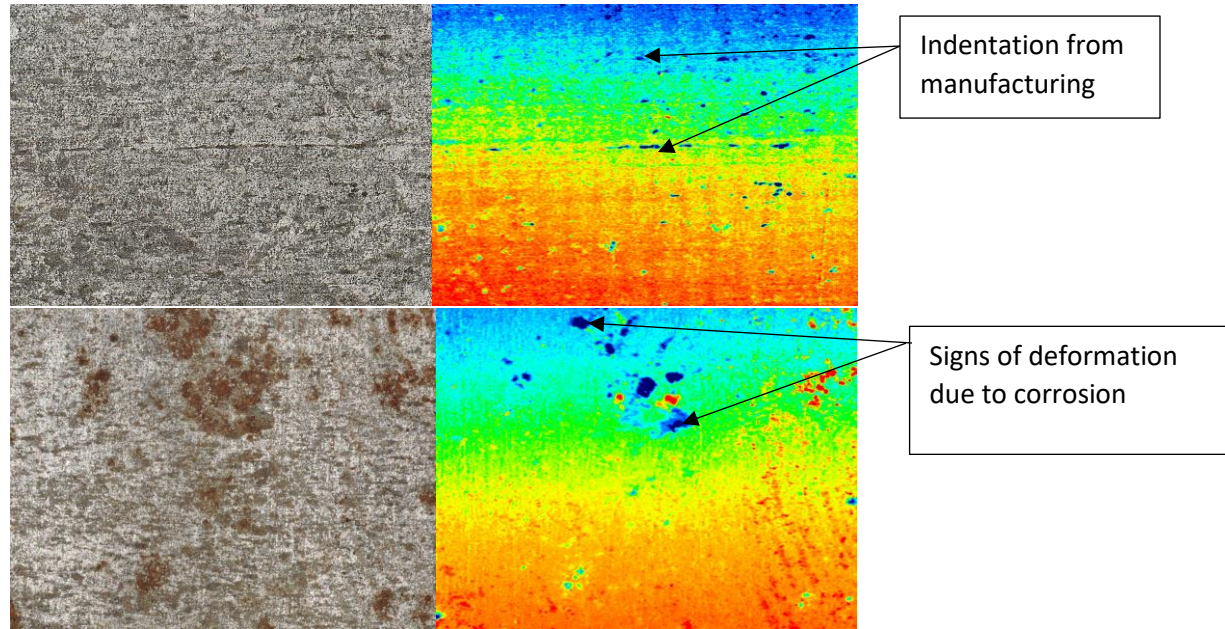
Figure 4.16. above shows images of sample 15 (0.25-inch size) taken with Keyence measuring system before and after placed over NaCl solution.

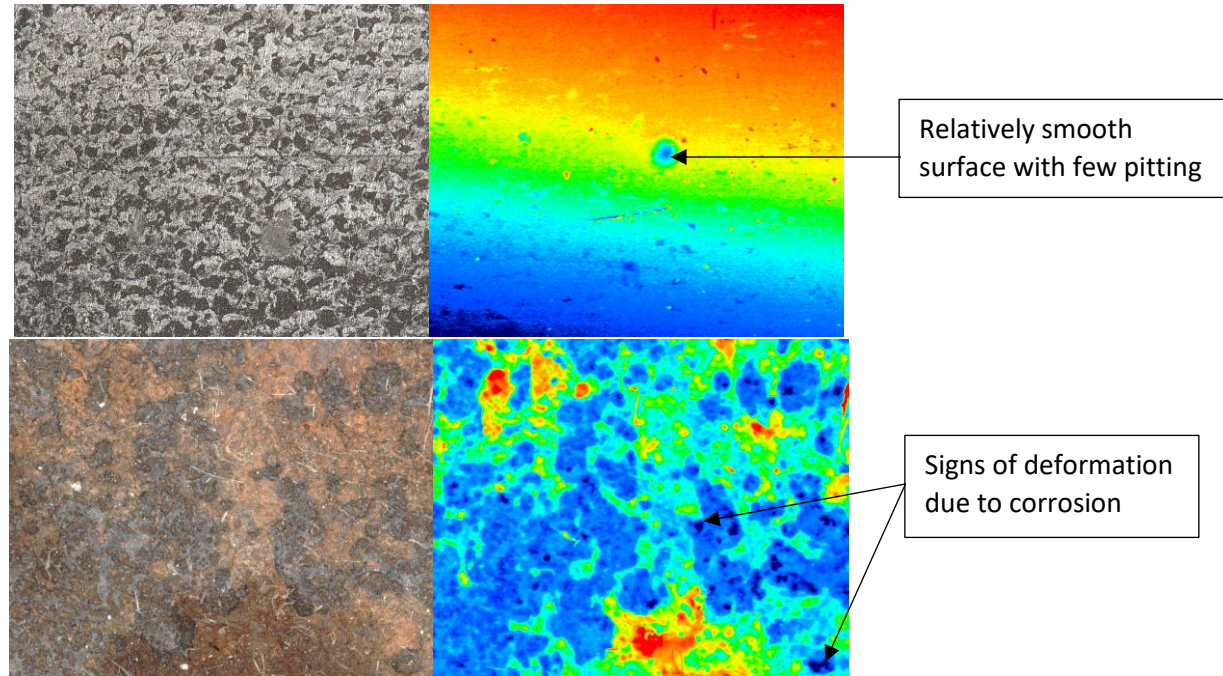
Figure 4.21. above shows images of sample 4 (0.5-inch size) taken with Keyence measuring system before and after placed in wet dirt.

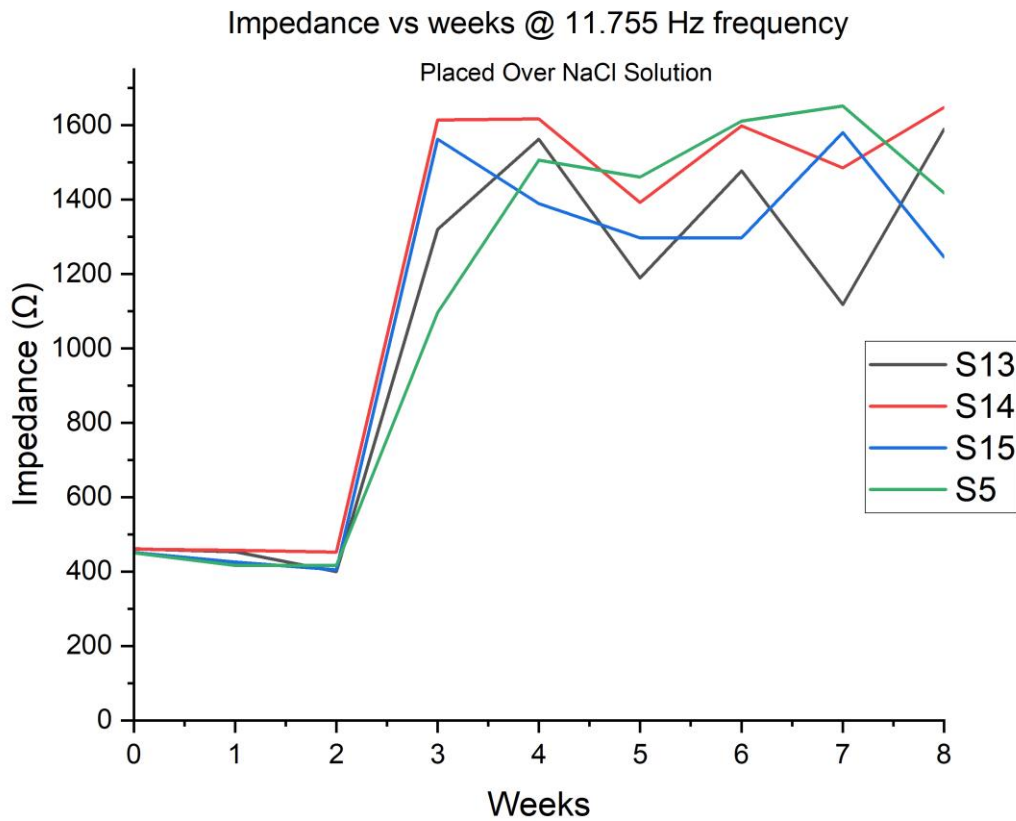
Figure 4.26. shows impedance value of samples placed over water.

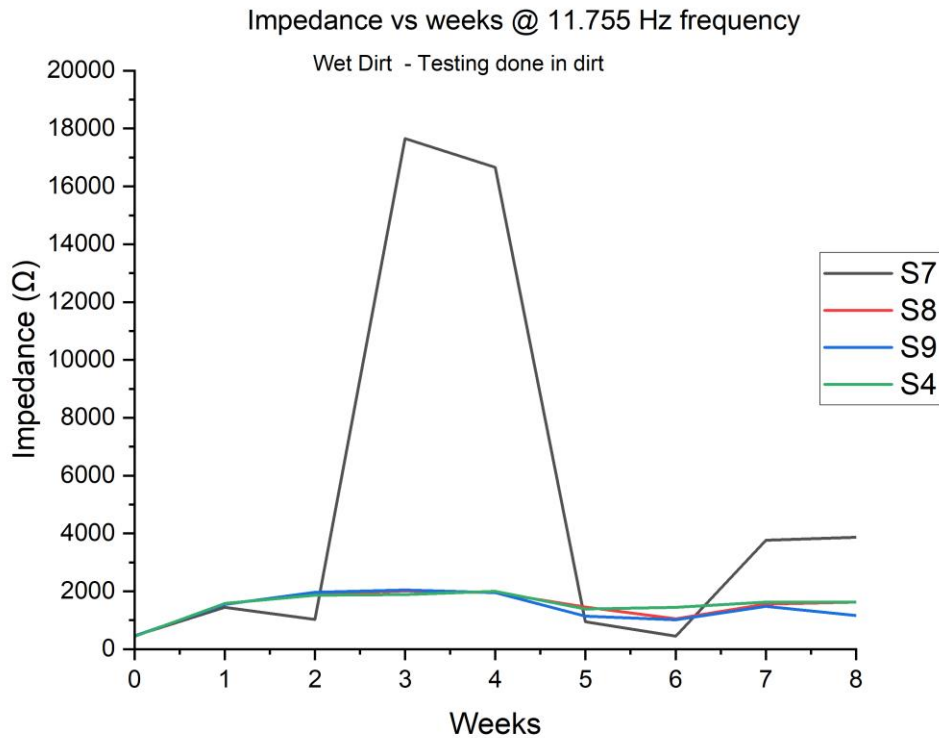
Figure 4.28. shows impedance value of samples buried under wet dirt. Test done with sample in wet dirt

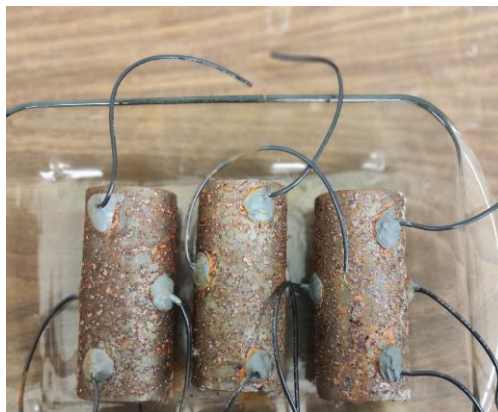
Figure 4.29. showing image of external corrosion of the three-metal pipe after the 8 weeks period.

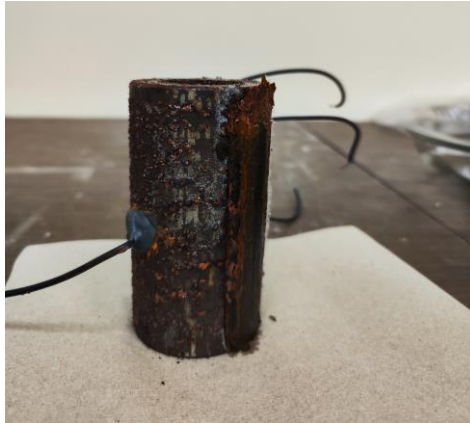
Figure 4.30. showing a closer look at the external corrosion of the metal pipe after the 8 weeks period.

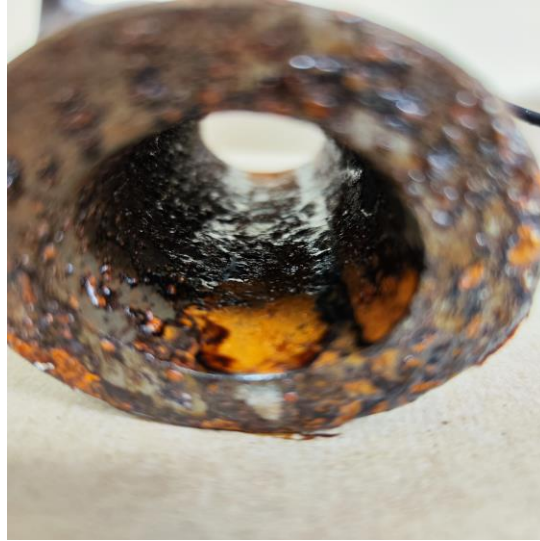
Figure 4.31. showing a closer look at the internal corrosion of the metal pipe after the 8 weeks period.

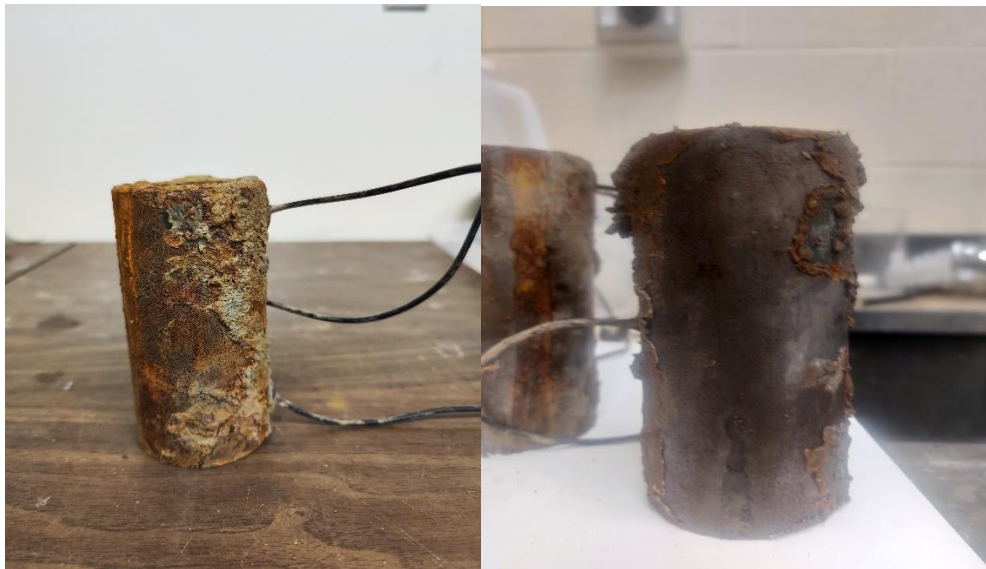
Figure 4.32. show metal buried under wet dirt wearing due to corrosion.

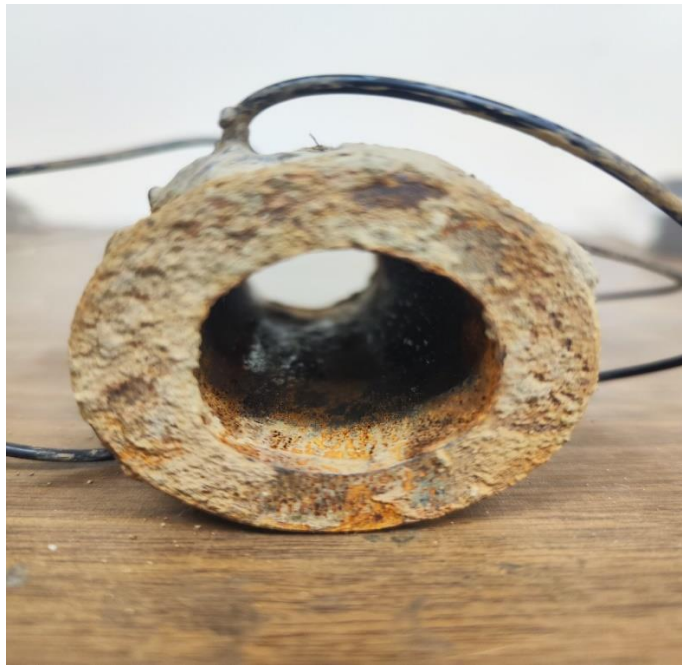
Figure 4.33. shows internal corrosion of metal buried under wet dirt.
