CAUSES OF CORROSION IN THE BOTTOM REINFORCEMENT OF PIER
CAPS SUPPORTING A PEDESTRIAN BRIDGE AT YSU AND POSSIBLE
SOLUTIONS

YOUNGSTOWN STATE UNIVERSITY

August, 2017

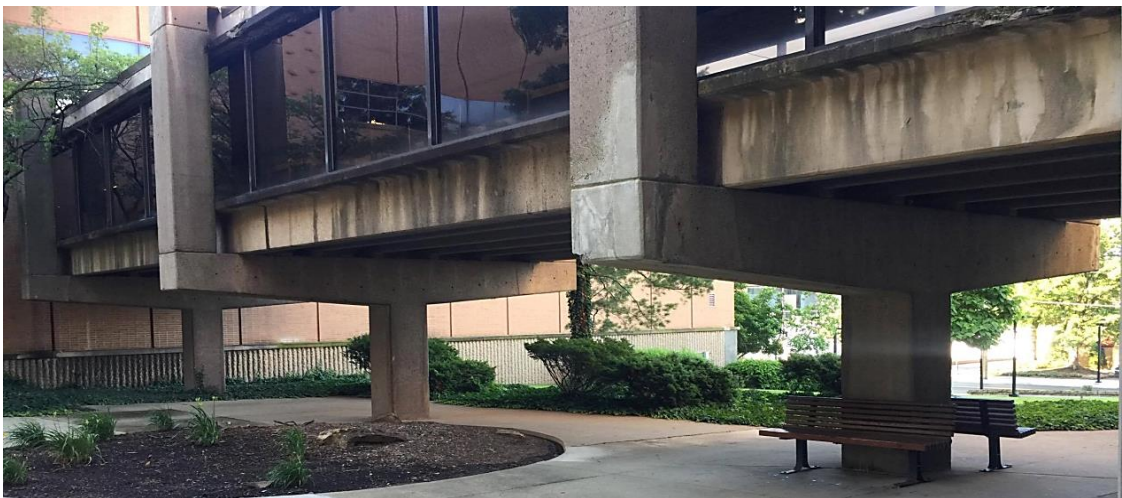
Figure 1-1: Pier caps supporting bridge between Moser and Cushwa Hall at YSU.

A pedestrian bridge linking Moser Hall and Cushwa Hall at Youngstown State University (YSU), as shown in Fig. 1-1, was constructed almost 40 years ago. Three hammerhead pier caps supporting the bridge deck are experiencing corrosion at the bottom reinforcement. Signs of corrosion at the bottom face of a pier cap are shown in Fig. 1-2. This corrosion has led to spalling of concrete at several locations, where noticeable loss of cross-sectional area of reinforcing bars is visible. In addition, at some other sites, corroded steel bars are visible through cracks generated due to increase in volume of rusty bars.

Almost 40-year old pedestrian bridge between Moser Hall and Cushwa Hall has the deck supported by three single-column hammerhead pier caps (Fig 1-1). The pier caps have several spots where lump of concrete has been chipped out. On a closer inspection, section loss of reinforcing bars can be seen as well. Examining the affected areas, it can be easily concluded that the corrosion process is continuing. Some patches of repair are seen on the site, but the corrosion problem continues to degrade the structure. If this issue is left unaddressed, corrosion in steel bars will be worsen with time creating a significant risk of potential damage and degradation of the substructure. Pictures of the pier cap with spalled concrete and corroded steel bars can be seen in Figs. 1-2 and 1-3, respectively.

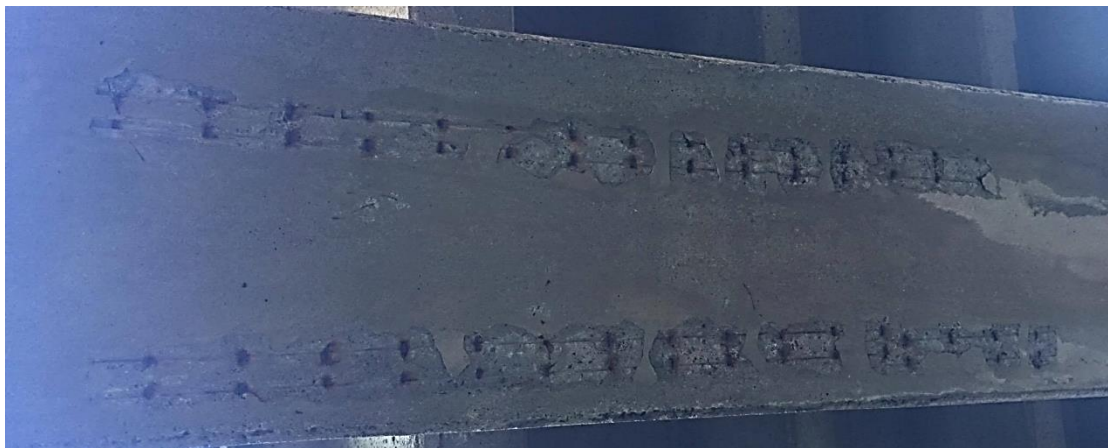
Figure 1-2: Bottom face of a pier cap.

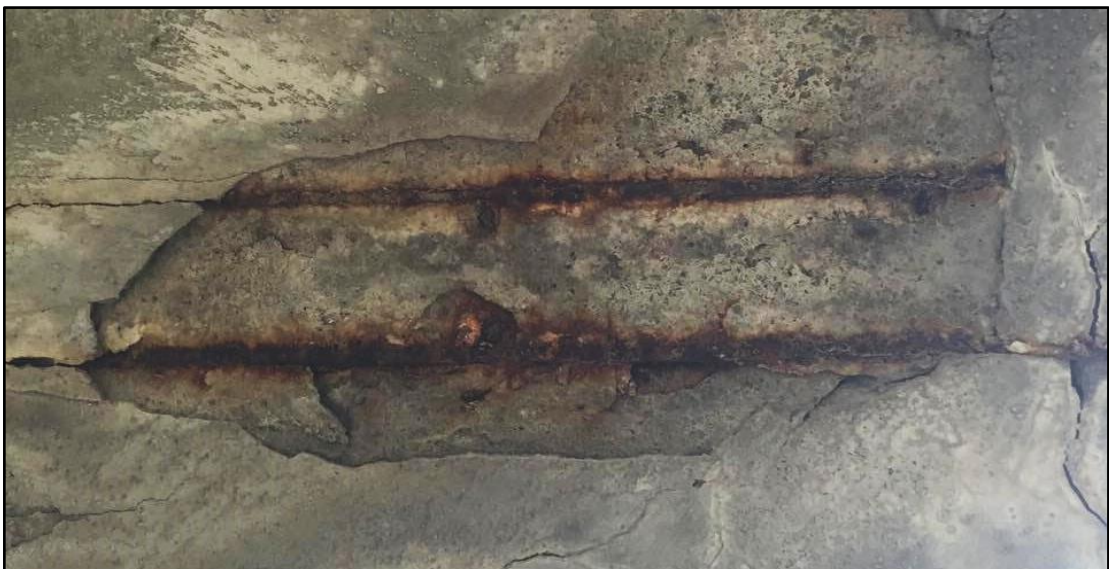
Figure 1-3: Close-up picture showing corroded reinforcement.

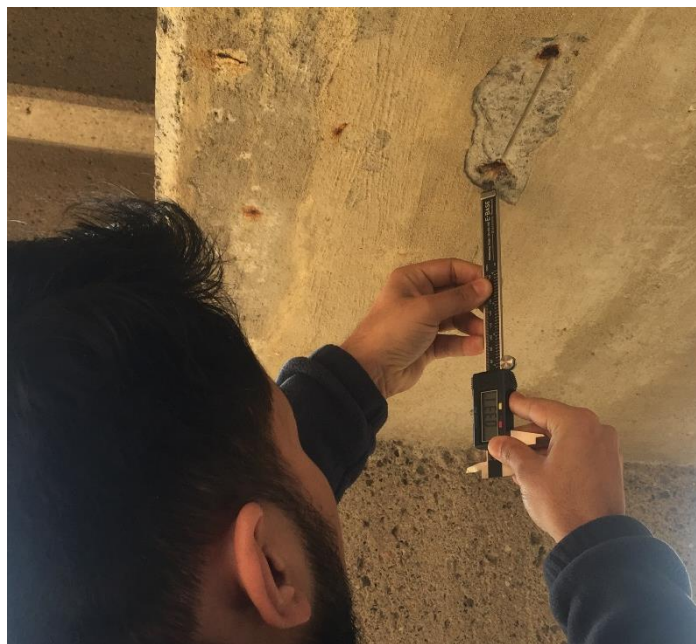
1. Clear cover was measured using a Vernier Caliper (Fig. 4-1) and was found to be around 0.30 in.

Figure 4-1: On-site concrete cover measurement using a Vernier Caliper.

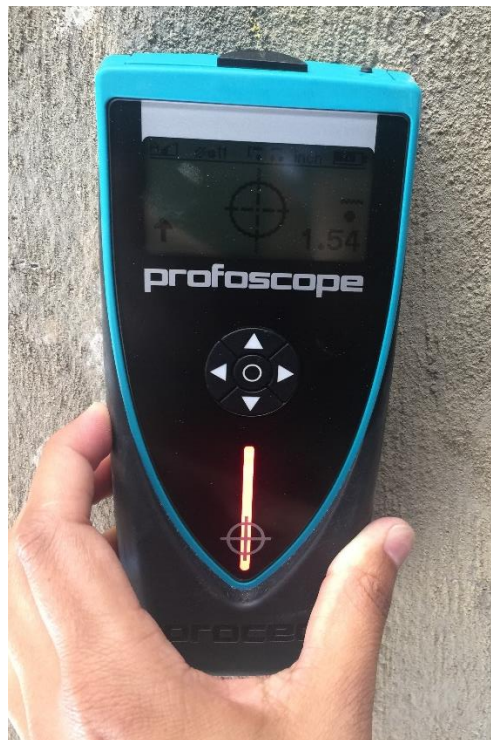
The corroded steel bars found on site were different and smaller in size, which researcher assumes contractors used those smaller bars as temperature and shrinkage reinforcements. In order to know more about the structure, a more advanced investigation was considered. The purpose of additional investigations was to confirm the use of #11 bars in the pier cap and the clear cover provided to that reinforcement. In order to learn more about the reinforcement inside the hardened concrete, a Profoscope was used (Fig. 4-2). Profoscope is a simple, handy scanning tool that uses magnetic lines to locate rebars inside concrete. It is capable of predicting rebar diameter as well as the clear cover provided to that reinforcement. Using a Profoscope at the bottom of hammer-head cap, it was confirmed that #11 rebars were used with a clear cover of 1.50 in. on average.

Figure 4-2: On-site concrete cover measurement using Profoscope.

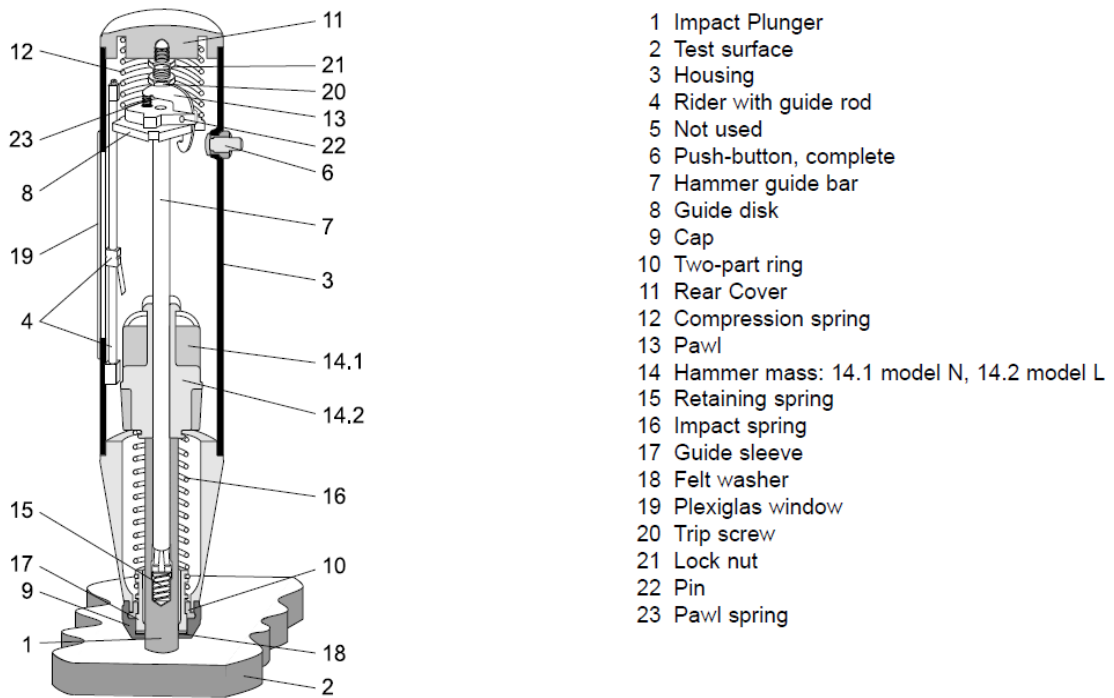
A standard rebound hammer consists of a casing, spring loaded weight that slides on a guide bar, locking and release mechanism, and a pointer to measure the rebound number. An N-type Schmidt hammer weighs about 2 kg and transfer the impact energy of 2.207 N.m onto the concrete surface through the plunger (Proceq 2016). A typical section of a Schmidt hammer is shown in Fig. 4-3.

Figure 4-3: Longitudinal section of a Schmidt hammer.

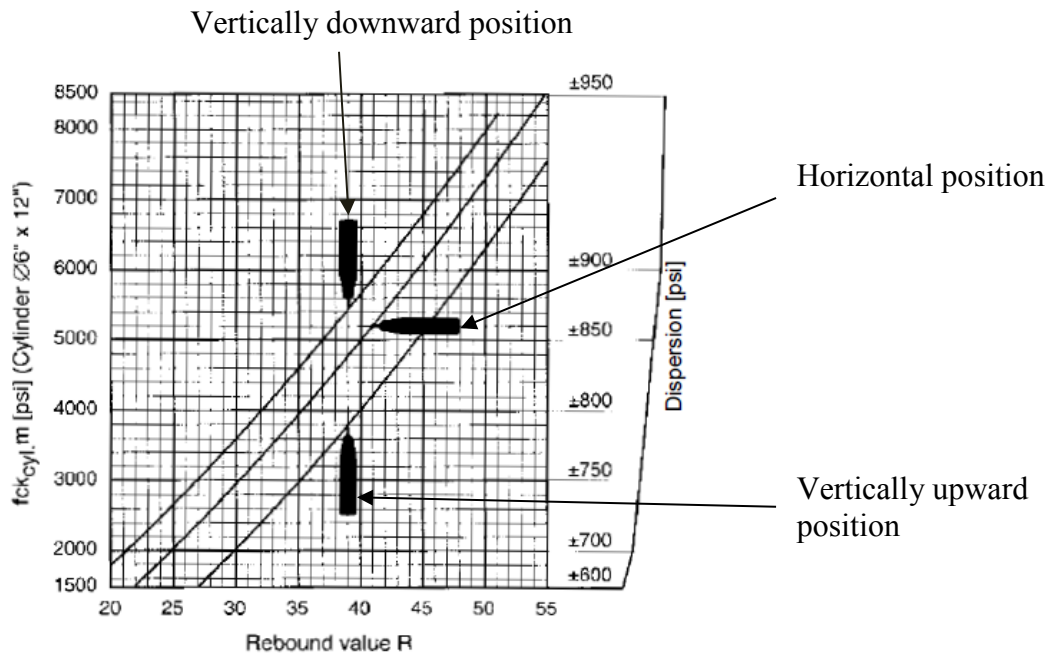
During the test, the plunger hits the concrete surface and bounces back through the hammer guide. The rebound number is due to the elastic reaction of the impacting mass and the hardness of the surface it strikes. Pressing the lock button, rebound number can be recorded. The hammer can be used in horizontal, vertically downward or vertically upward position as well as at some angles, provided that the hammer mass impacts the concrete surface perpendicularly. However, the position of the relative mass affects the rebound number due to the action of gravity. Therefore, a graph representing different positions should be used according to the testing position. A typical graph provided by the manufacturer for vertical, horizontal upward and downward position of equipment is shown in Fig. 4-4.

Figure 4-4: Conversion curves for different positions of Schmidt Hammer.

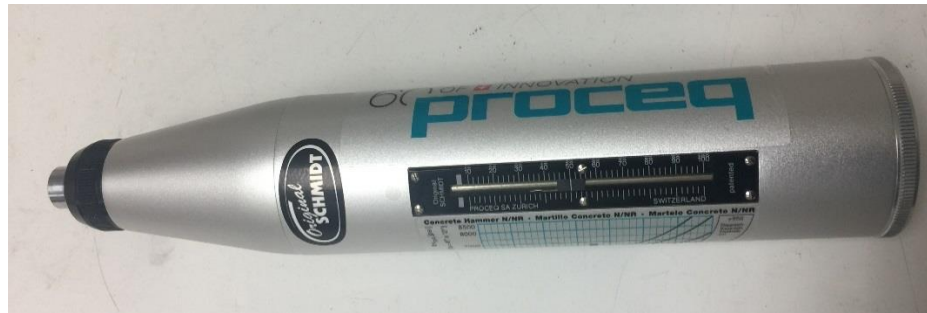
For this study, a standard N-type Schmidt hammer, as shown in Fig. 4-5, was used to estimate the compressive strength of concrete.

Figure 4-5: Standard N-type Schmidt Hammer.

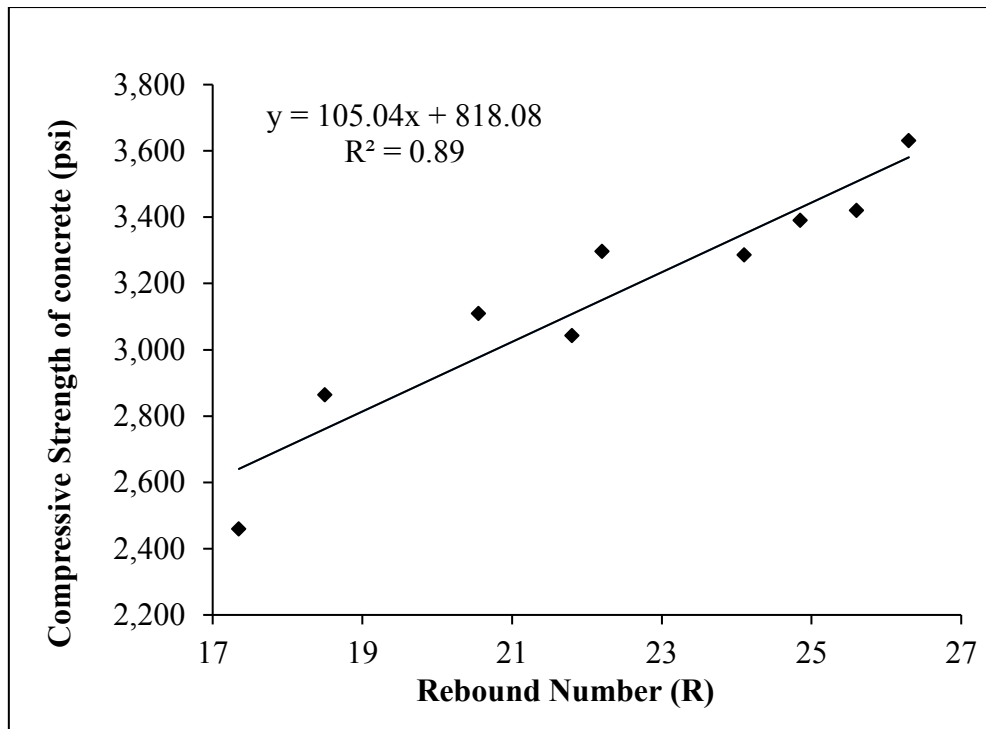
Paudel (2016) recently used the same Schmidt hammer for similar tests for his Master's thesis, where he calibrated it in a lab at YSU. So, the calibration data obtained by him in the lab has been used for this study. Nine standard cylinders (4 in. diameter, 8 in. height) were cast in the Strength of material lab in Moser Hall at YSU. For each cylinder, 10 rebound numbers, excluding the highest and the lowest, were recorded for the vertically downward position of the hammer. These samples were later tested for destructive compressive strength tests following ASTM C 39. They were loaded until failure to find the actual compressive strength of the samples. Using the average rebound number for each specimen and the results from the compressive tests, a calibration graph was developed as shown in Fig. 4-6.

$$y = 105.04x + 818.08 \quad (4.7)$$

Where, y is the compressive strength of concrete in psi and x is the rebound number.

Figure 4-6: Plot of rebound number and compressive strength of test cylinders.

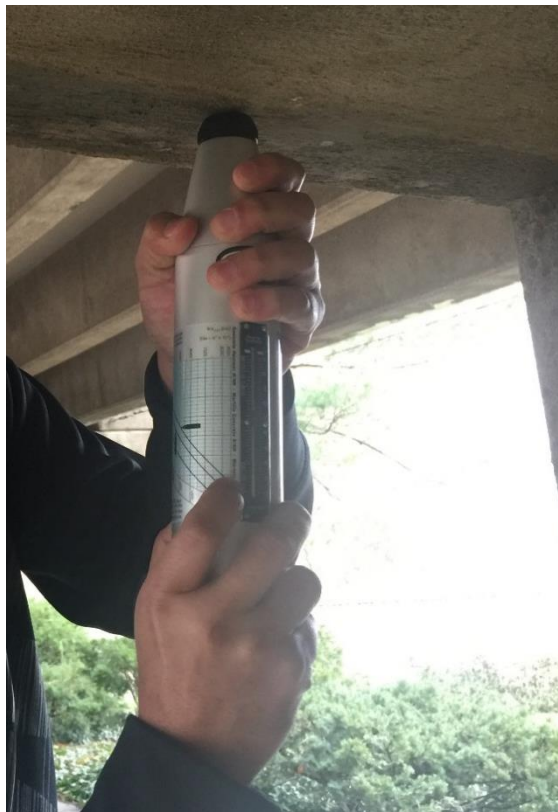
Fig. 4-7 shows a picture of the rebound hammer test performed on the bridge pier cap. From two locations, average rebound numbers of 10 readings were found to be 50.1 and 50.9. Necessary calculations including the application of the reduction and correction factors show the compressive strength of concrete used in pier cap to be 3.5 ksi (Appendix C).

Figure 4-7: On-site Rebound hammer test.

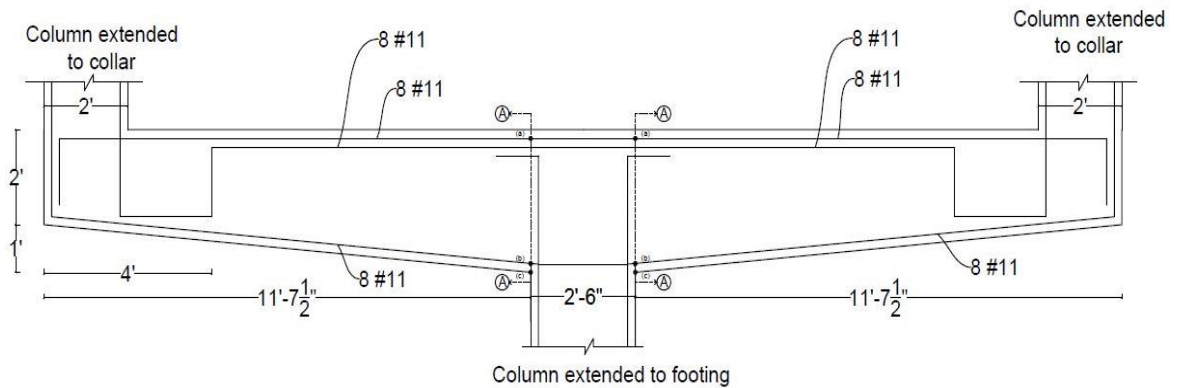
Using available construction drawings and appropriate dead and live loads, maximum factored bending moment on the structure was determined to be 1976.16 kip-ft at the cap-column interface of the hammerhead pier cap (Fig. 4-8). The moment capacity and stresses at various critical locations (Fig. 4-9) of the pier cap were determined for two

Figure 4-8: 2D elevation of pier cap.

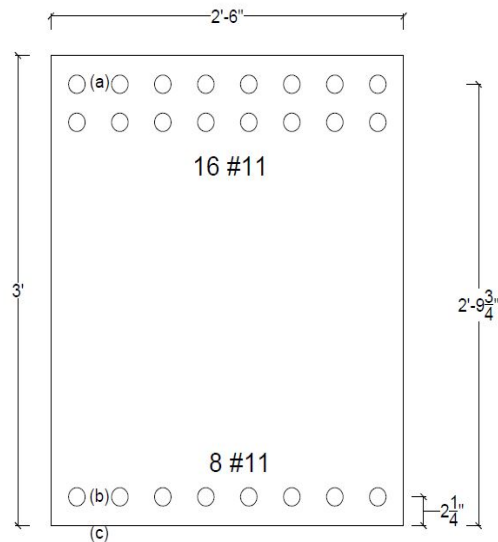
different conditions: (i) at the initial state without any corrosion in reinforcement and (ii) at the present state with reduced reinforcement area (Appendix E).

Figure 4-9: Section at cap-column interface (A-A) showing study locations.

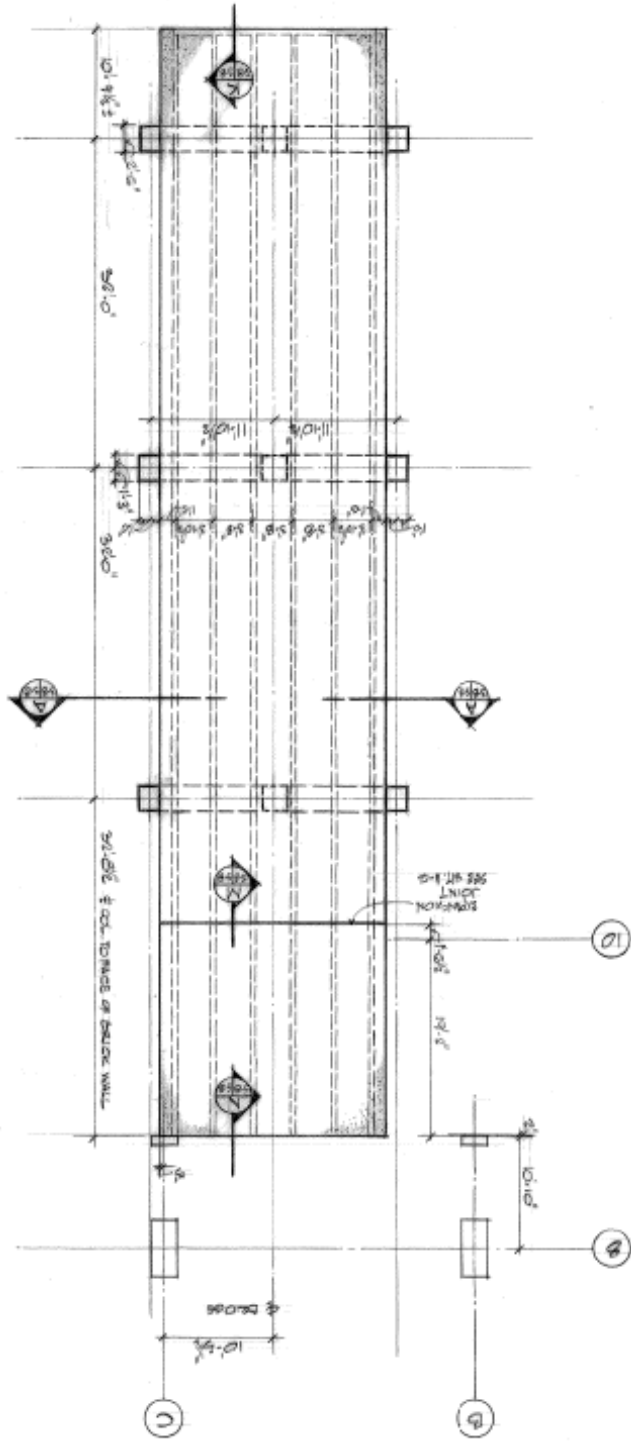
1. Bridge Plan

Appendix A. Structural drawings of bridge provided by FMS at YSU
