Mitigation of Microbially Induced Concrete Corrosion in Wastewater Infrastructure using
Surface Treatments

Master of Science in Engineering

YOUNGSTOWN STATE UNIVERSITY

May 2021

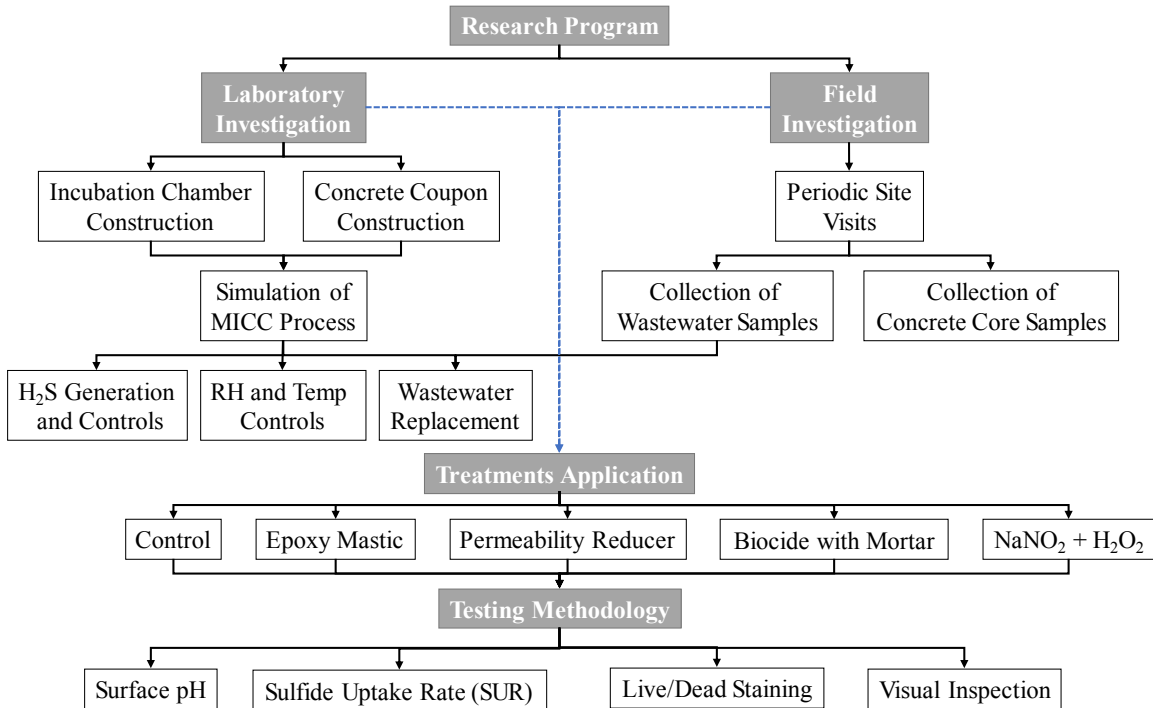
Figure 3-1, Flow chart for the Research Program

The research program herein was divided into two major, concurrent phases. An outline of this program is summarized in Figure 3-1. The first phase involved a laboratory investigation of possible MICC treatment methods applied to concrete coupons. The second phase included field trials and validation of results in a sewer wet well. Both the concrete coupons and core samples collected from the wet well were assessed using similar methods (discussed below) to appraise the difference between laboratory and field trials. Results from the two research phases were compiled to evaluate the applicability, practicality, cost-effectiveness, and longevity of each treatment. Construction of the laboratory experiment, field trials, treatment application methods, and testing setups are also described in detail in the subsequent sections.

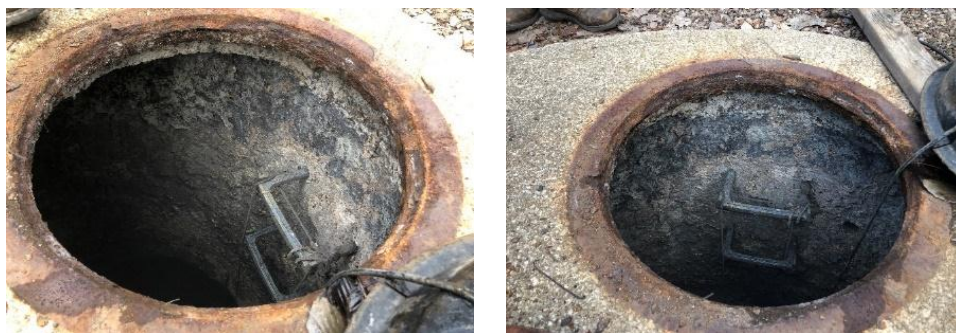
Figure 3-4, Severe deterioration of wet well at Meadowood Circle location , Poland, Ohio (pictures by Mostafa Nasr)

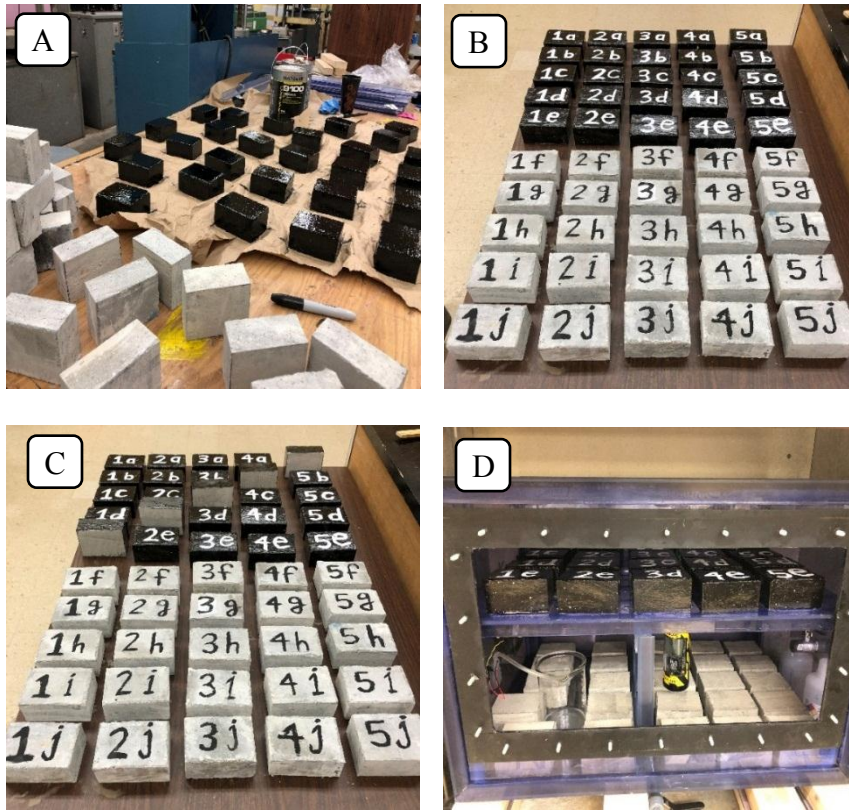
Figure 3-7, Epoxy coating and numbering of coupons (pictures by Mostafa Nasr)

As the concrete in the wet well is only exposed to H_2S and corrosion on one face, coupons were coated with DTM epoxy mastic on all but the exposed face, as shown in Figure 3-7 (A). Coupons were divided into two sets of 25 coupons each and then numbered with epoxy paint, as shown in Figure 3-7 (B-C). Four extra coupons, two from each set, were left as fresh concrete control for further comparisons. Afterward, the initial surface pH was measured and recorded, as shown in Section 7.3 - Appendix C, Table A3. After 14 days, coupons were placed into the incubation chamber, as shown in Figure 3-7 (D).

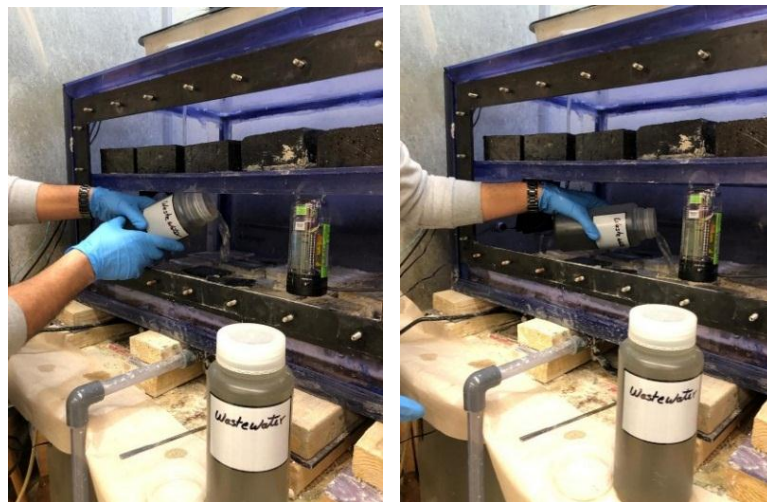
Figure 3-8, Domestic sewage addition (pictures by Mostafa Nasr)

The remaining set of 25 companion, and uncoated, coupons were partially submerged in the wastewater with the designated exposed surface facing upwards. This set of coupons was exposed to both the gas and the wastewater to simulate the waterline, another region that is generally highly corroded. Every seven days, the sewage was drained, and freshly collected wastewater was refilled and poured over the concrete exposed surface of the concrete, as shown in Figure 3-8.

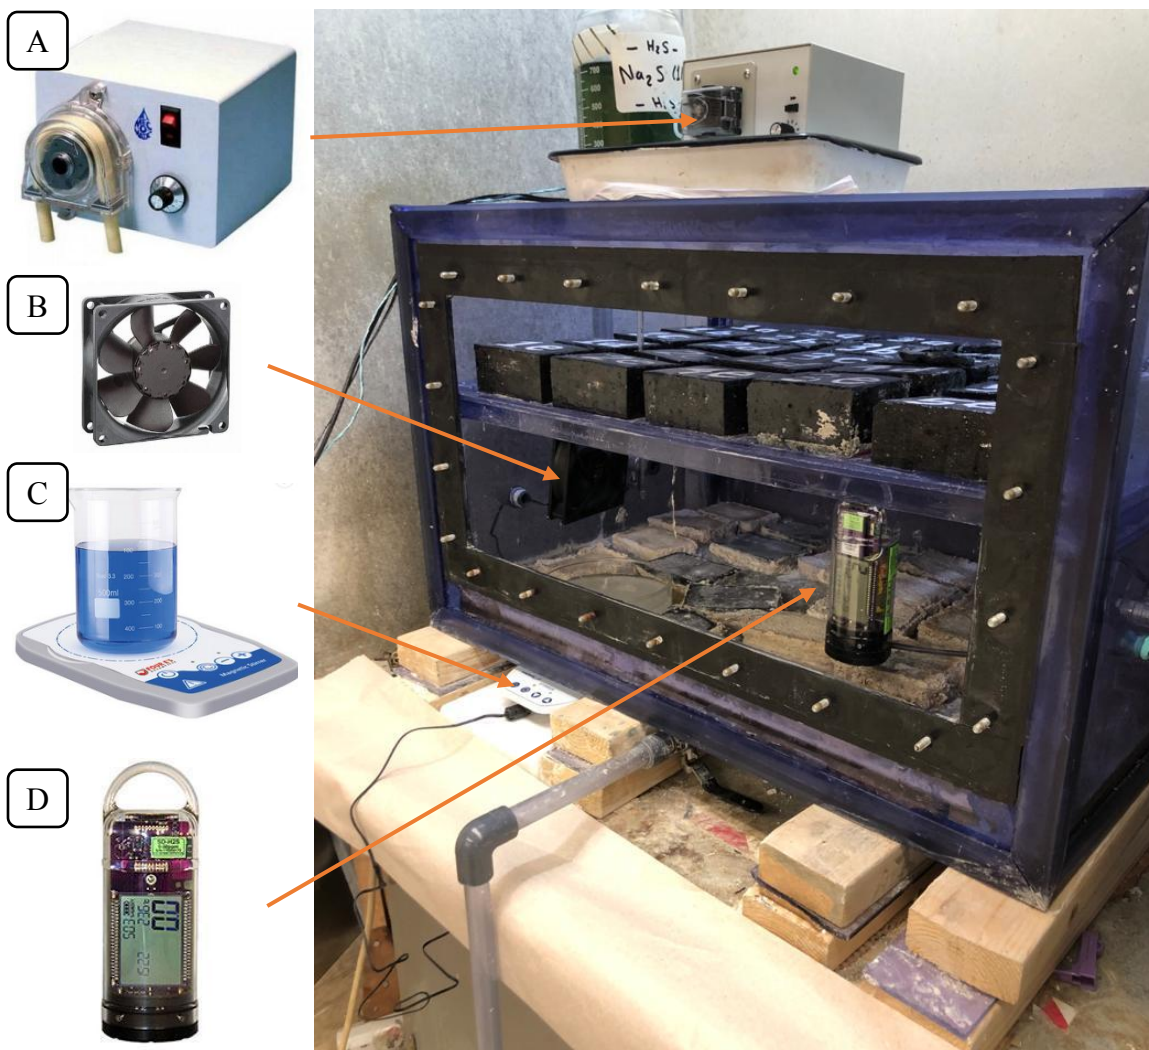
Figure 3-10, H_2S gas generation process and tools, (A)peristaltic pump, (B)waterproof axial fan, (C)magnetic stir plate, (D) AcruLogTM H_2S gas data-logger.

(National Instruments) and data acquisition system. As will be discussed in Section 3.1.6, this system was later programmed to adjust the pump flow rate in real-time and maintain a stable atmosphere of 50-150 ppm H_2S gas as needed.

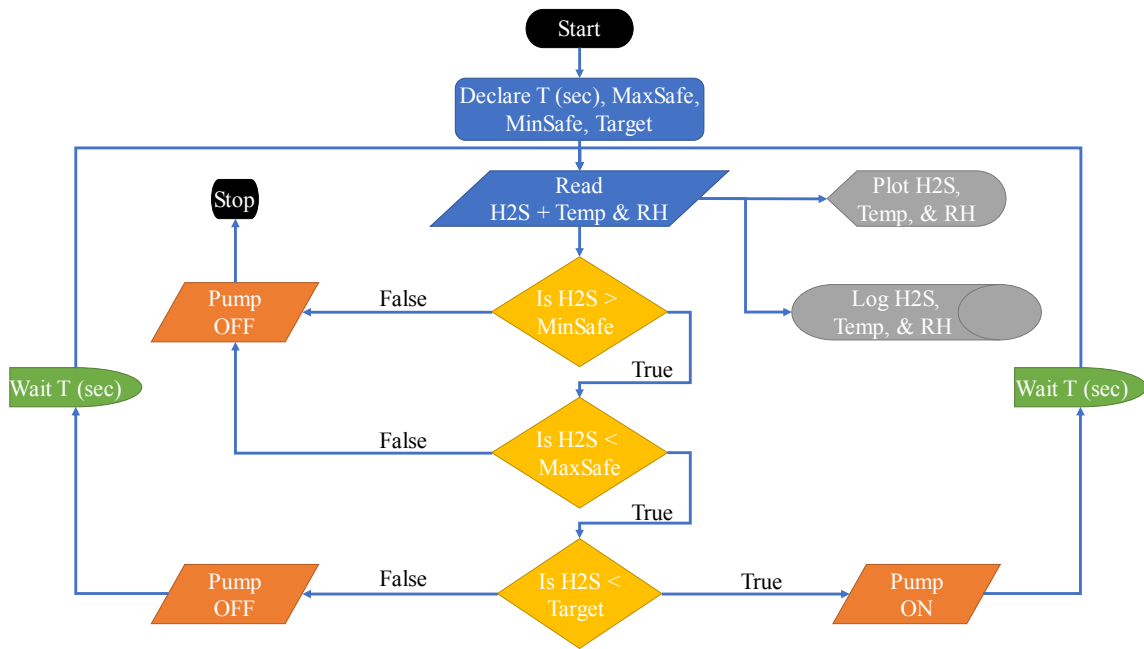
Figure 3-12, Process diagram of LabVIEW controls software (Designed and programmed by Richard Deschenes)

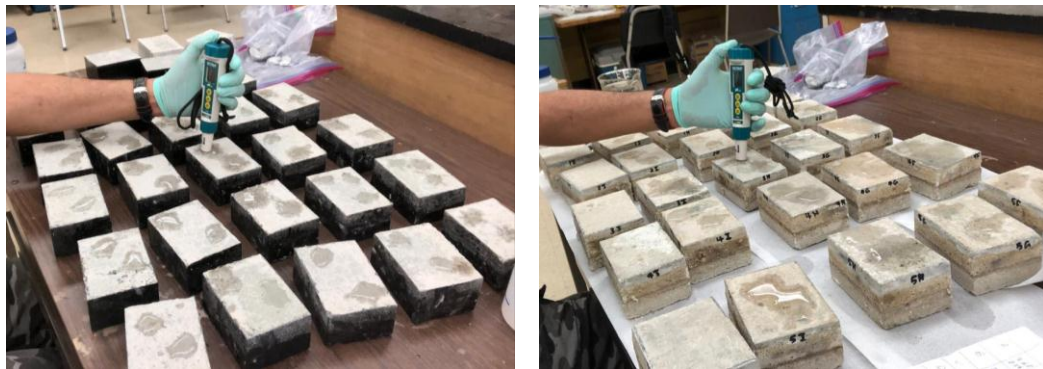
Figure 3-17, Surface pH measurement (pictures by Mostafa Nasr)

periodic surface pH measurement procedure was performed monthly to evaluate the resistance to acidic attacks and surface pH reduction of each of the treatment methods. The surface pH of concrete coupons and cores was measured directly using an Extech surface pH meter (PH100). The surface was pre-cleaned with deionized water to remove any existing dirt, concrete sealers, or adhesive residues. Afterward, 2 ml of ultrapure water, pH $\sim 7.00 \pm 0.2$, were dripped with a pipet on the concrete surface and allowed to equilibrate for 30 seconds. The flat surface pH electrode was then placed on the concrete surface and allowed to obtain a steady reading. The average surface pH was calculated from 3 different measurements performed at random locations on the surface of each coupon and core. The results were plotted on two separate graphs, one for the experimental coupons and the other for collected concrete cores. These graphs were then used to analyze and compare different treatment mitigation efficacy.

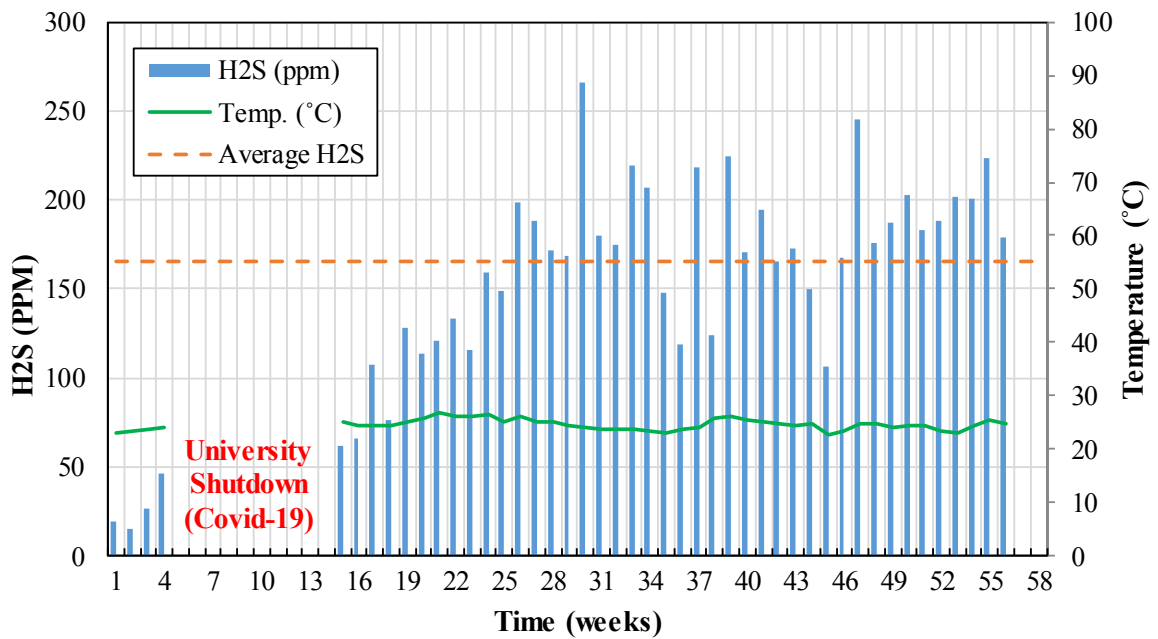
Figure 4-1, Average H₂S exposure concentration (ppm) for laboratory trials, measured using AcruLog™ H₂S gas data-logger.

Over the first few weeks, the H₂S concentration was low and unstable as the sodium sulfide solution flow rate and concentration were adjusted and optimized to establish a stable gas concentration. During this time, it was also discovered that the stirring of sulfuric acid was required to generate a stable gas concentration. These parameters were adjusted and refined, and then a stable concentration of H₂S was safely achieved.

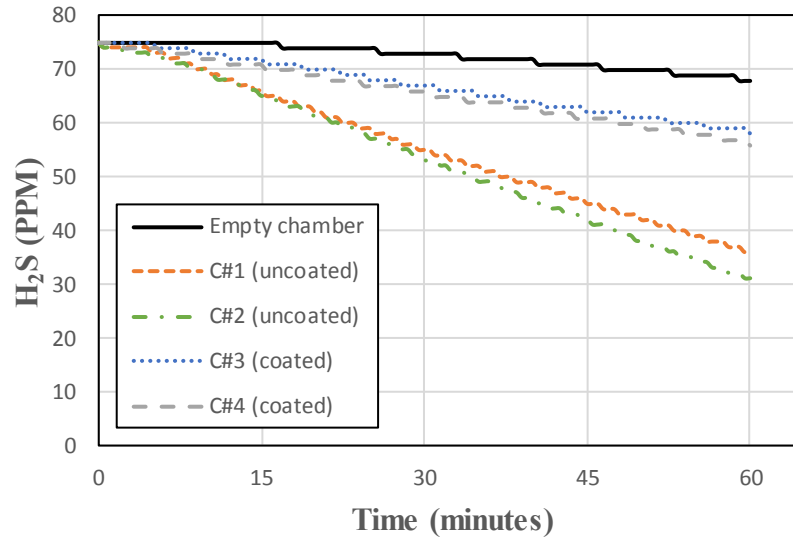
Figure 4-5, Initial sulfide uptake rate (SUR) of coupons before exposure or treatment.

measurements presented herein are in units of $\text{mg-S m}^{-2} \text{ h}^{-1}$ (milligram of sulfur per square meter per hour)

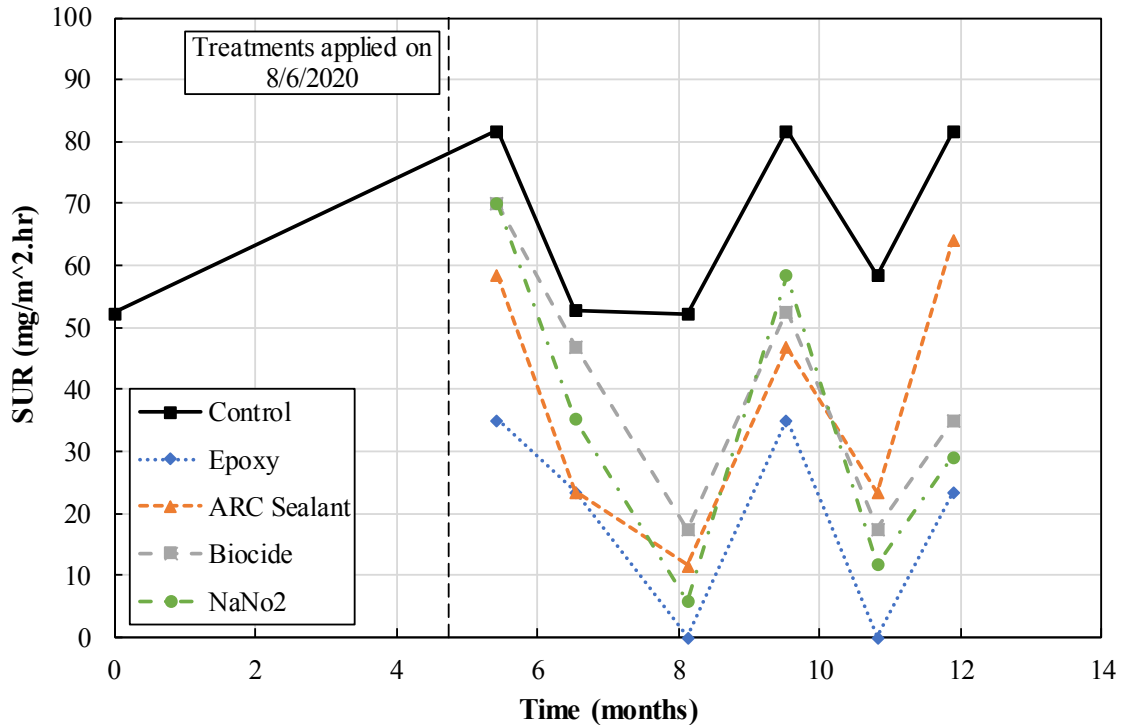
Figure 4-6, Sulfide uptake rate (SUR) over time for laboratory upper coupons exposed to humid, H₂S gas only. Error bars not included because duplicate measurements were not performed due to time and resource constraints.

During the seven months following treatment application, SUR measurements for all upper coupons varied over time. Consistent differences in SUR values are apparent, as shown in Figure 4-6. SUR measurements of the control specimens varied between ~52 and ~83, which were the highest recorded values among all tests. The epoxy treated coupons performed best overall with the lowest uptake rate of zero in some tests, while the highest was 35.10 in only one test, which was still 60 percent lower than that of the control at the same trial. ARC Sealant also indicated a lower uptake rate of 11.61 and 23.36 in some tests. However, a single higher measurement of 64.15 was recorded at the last test. Although the SUR reading was 22 percent lower than that of the control on the same test day, it made a significant change in the SUR trendline of the ARC sealant. In the case of the biocide in mortar, the variation in SUR measurements was between 17.52 (66 percent lower than control) and 70.09 (15 percent lower than control). Sodium nitrite (NaNO₂) treatment had a similar trend. The lowest SUR measurement for NaNO₂ was 5.8 (89 percent lower than control) while the highest was 70.09 (15 percent lower than control). It is apparent that the later SUR measurements for both biocidal treatments were lower than those recorded right after the treatment application, indicating that both treatments maintained efficacy over time.

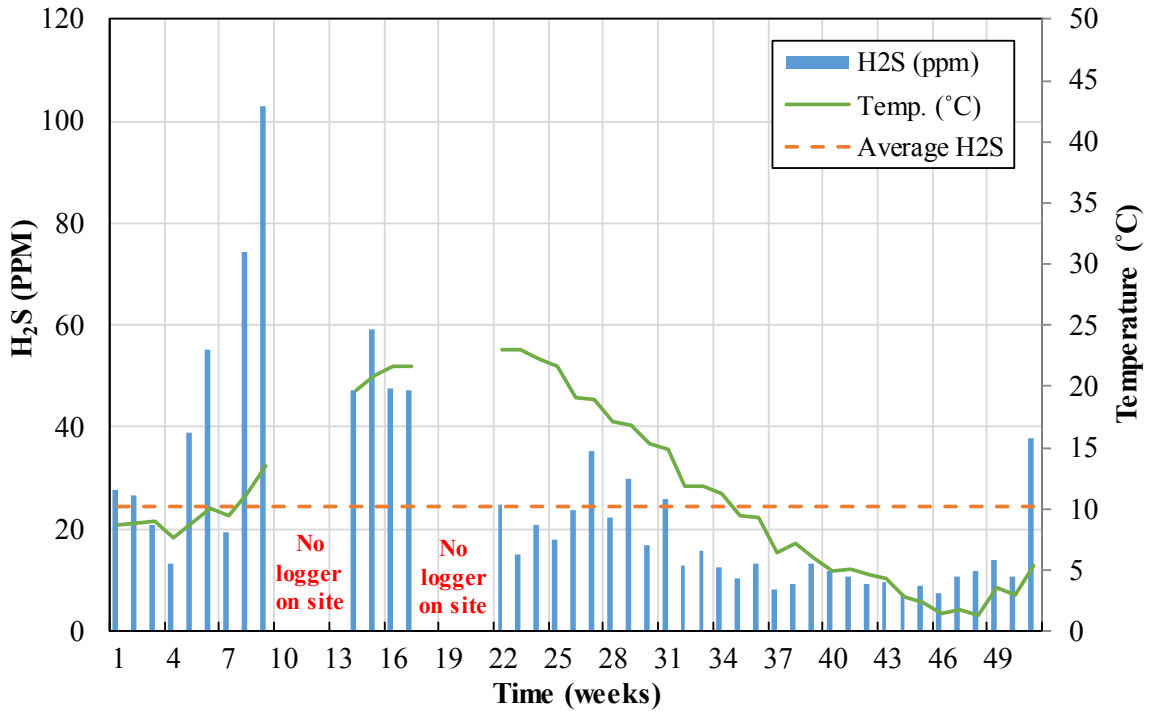
Figure 4-8, Average H₂S exposure (ppm) for the Ellsworth, Ohio wet well measured using an OdaLog LL1000, suspended at 10 feet below the wet well surface.

concentration and gas-phase temperature inside the wet well were continuously measured and recorded every 5 minutes using one of the two available H₂S loggers. Every three weeks, the logger was removed from the wet well, and the data offloaded to a computer. The average weekly H₂S gas concentration and temperature for the wet well location are summarized in Figure 4-8 (raw data is provided in Section 7.2-Appendix B, Table A2).

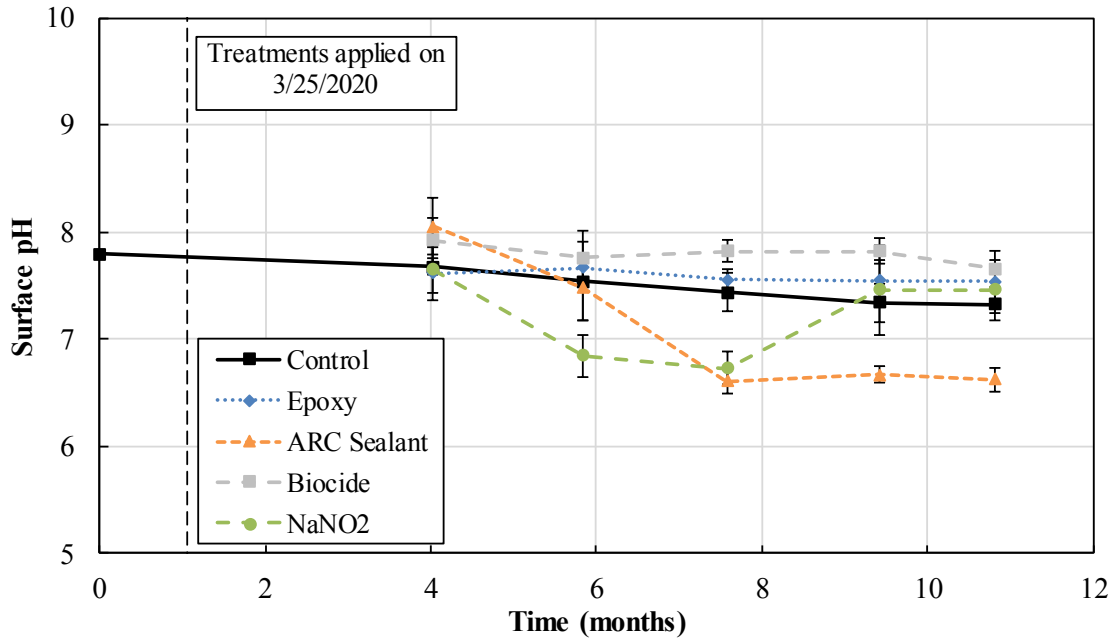
Figure 4-9, Surface pH measurements over time for concrete cores from Ellsworth, Ohio wet well location, Error bars indicate the 95% CI of the mean for n=4.

Overall, by observing the surface pH results summarized in Figure 4-9, the ARC sealant and biocide with mortar indicated a slight improvement after treatment with the pH jumping back up. However, the surface pH of the ARC treatment declined faster than the untreated control. Biocidal treatments and epoxy revealed a slower change in surface pH, with the epoxy performing best (80 percent slower rate of decrease in surface pH as compared to the control). The ARC sealant performed worse, with a rate of decrease in pH 309 percent faster pH than the control.

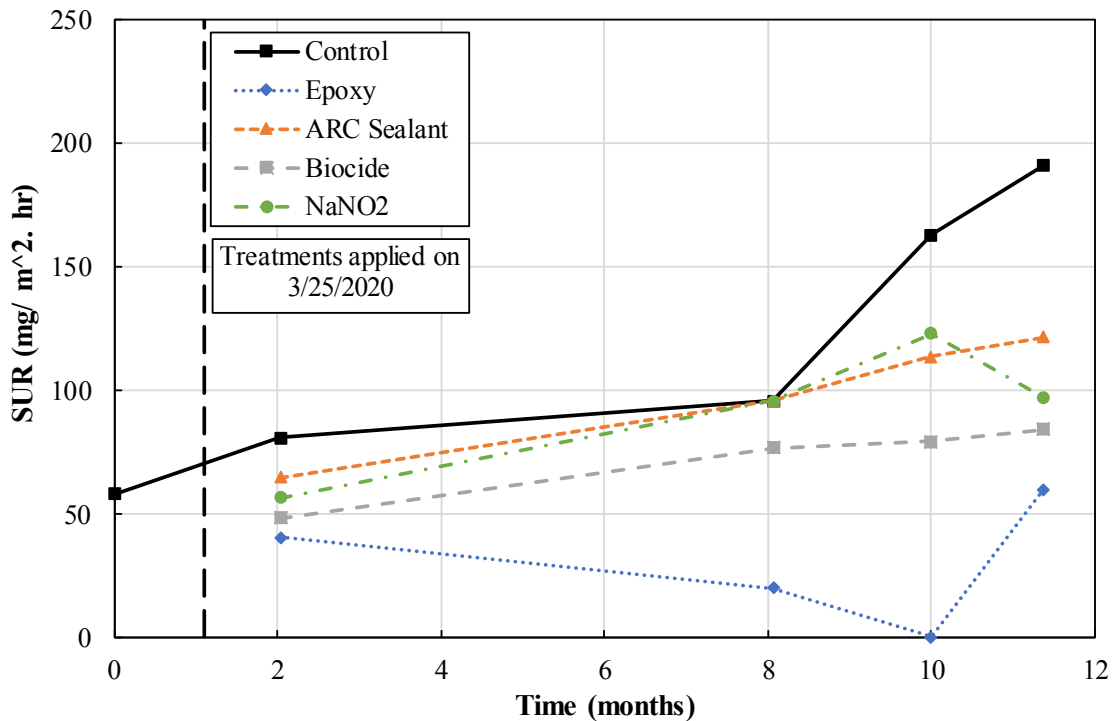
Figure 4-10, Sulfide Uptake Rate (SUR) over time for field concrete cores from Ellsworth, Ohio wet well location. Error bars not included because duplicate measurements were not performed due to time and resource constraints.

lower than control). Sodium nitrite (NaNO_2) treatment also indicated similar variation in the trend. The SUR measurement for NaNO_2 varied between 95.67 and 97.32, which were 0- 49 percent lower than control on the same trials. Some variations in SUR are expected due to changes in temperature, humidity, wastewater constituents, and other unmeasured variables. Therefore, a smooth trend is not expected.
