ORTHOPEDIC IMPLANTS: MATERIAL AND FAILURE EVALUATION

Two type 316 stainless steel orthopedic implants, Eggers plate and Jewett hip nail-plate, were examined in order to find the causes of failure. Unusual crack patterns were found on the cylindrical surface of the implants. Type 316 stainless steel tensile samples were tested with the presence of tensile stresses to determine the low-cycle fatigue characteristics and to determine whether or not low-cycle tensile stress would produce either of the crack patterns observed in the fractured implants.

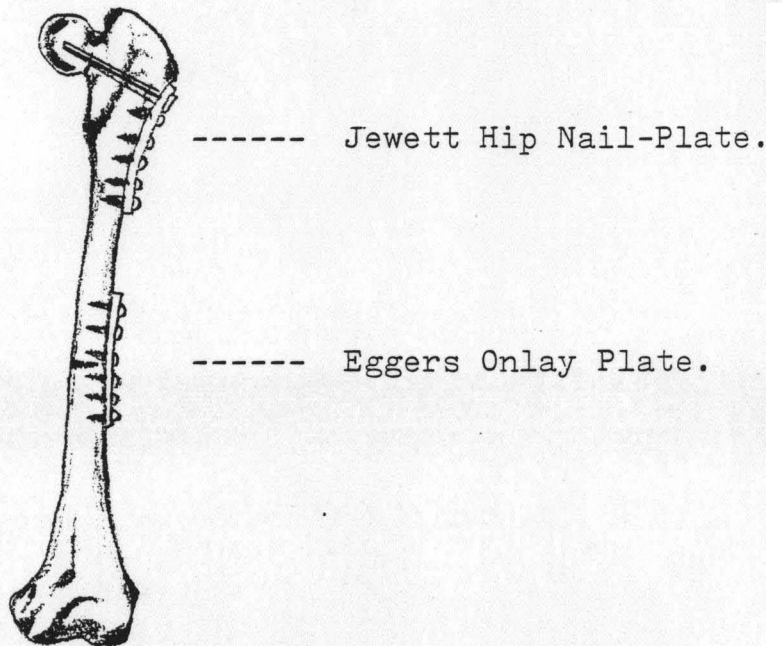
Figure 2. Sketch of How a Jewett Hip Nail-Plate and Eggers Onlay Plate are Attached to A Leg Bone.

The impetus for this work resulted from the examination of two orthopedic implants that failed in service. The failed devices were a Jewett hip nail-plate and an Egger onlay plate (Figure 1). Figure 2 is a sketch of how these two devices are attached to a leg bone. The two implants were examined with a scanning electron microscope (SEM) in order to determine the causes of the failures.

The holes in this device were punched too close to the edge (see Figure 2). A reduced cross section can make a stress riser in the area where high stresses would occur during walking, and cracks would initiate and propagate. Cahoon and Paxton (24) show that the entire section of the

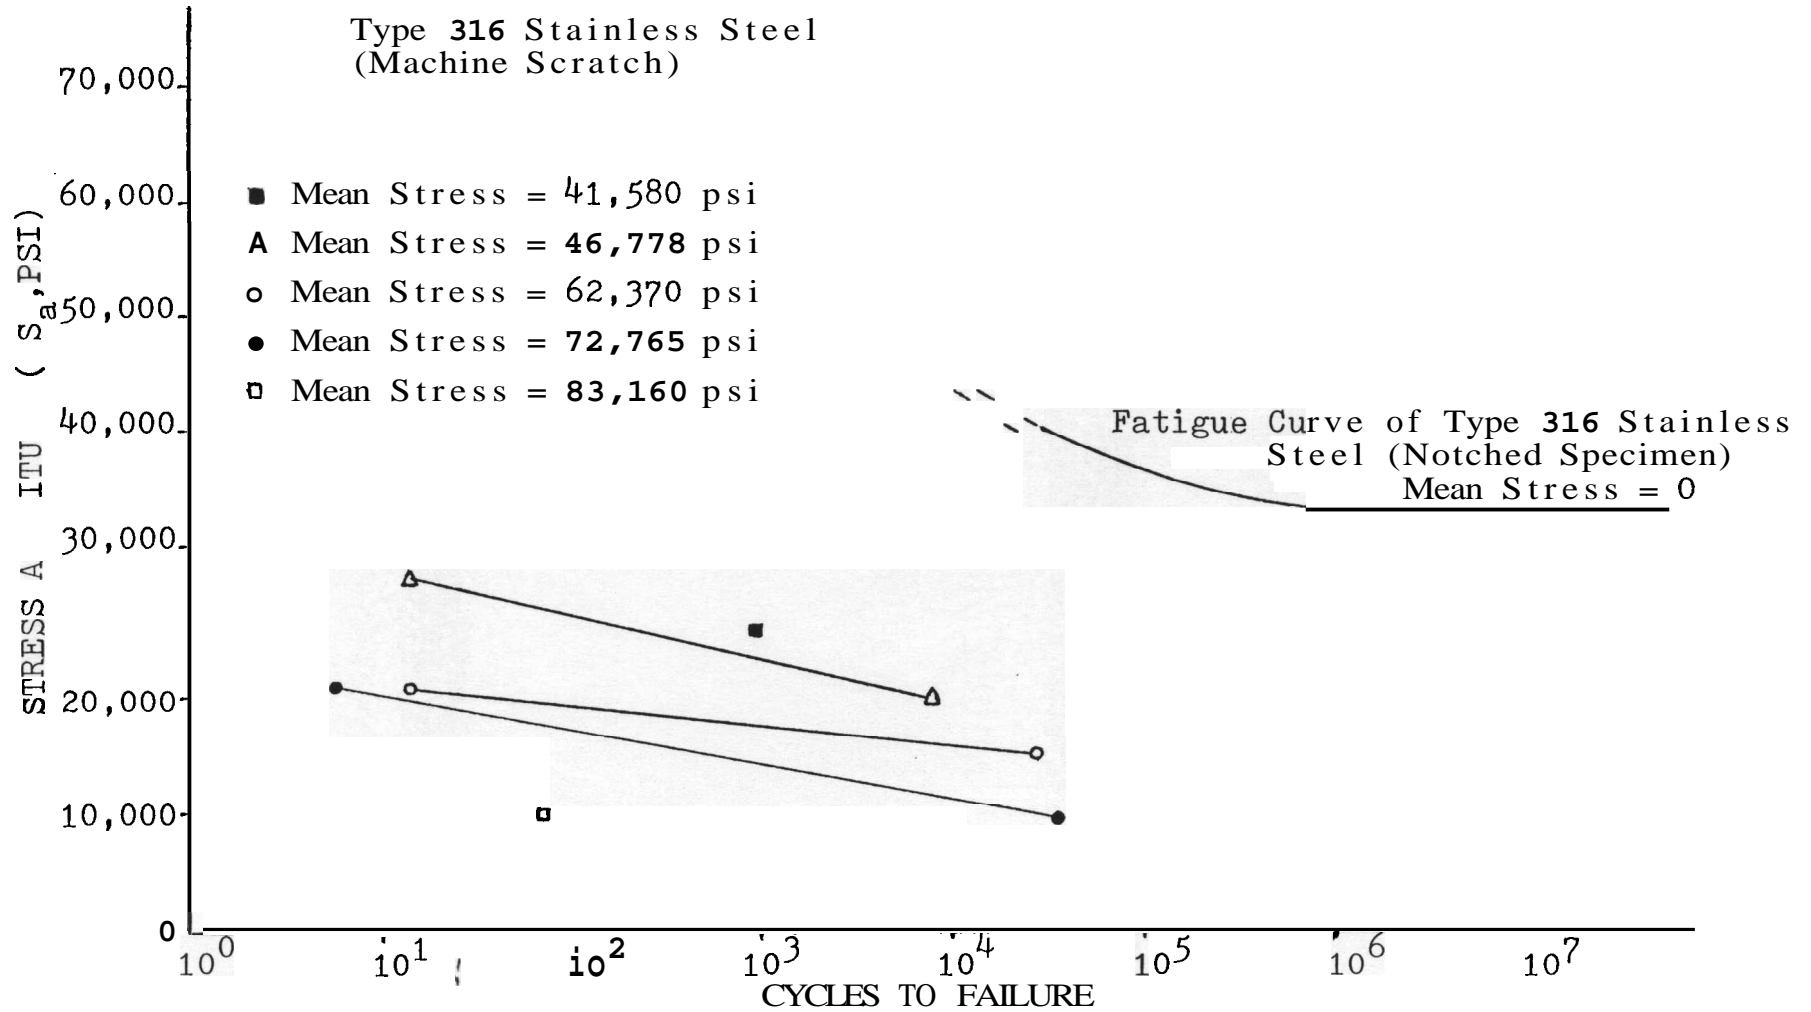
Figure 4. Graph Plotted Between Stress Amplitude ( $S_a$ ,psi) VS. Cycles to Failure.

that wave forms would have little effect on tests carried out in air at room temperature <sup>(21)</sup>. The test data are listed in Table 2 and a plot of stress amplitude ( $S_a$ , psi) versus numbers of cycles to failure (S-N diagram) is shown in Figure 4. Also, the accepted fatigue curve for type 316 stainless steel <sup>(22)</sup> is plotted on the same graph (see Figure 4).

The accepted fatigue curve <sup>(26)</sup> of type 316 stainless steel (notched specimen) was plotted in Figure 4 along with the results of this work in order to compare with the fatigue curves obtained in this experiment.

Since the largest part of the published fatigue data was obtained from fully reversed cycling (mean stress is zero) <sup>(27)</sup>, a family of curves were plotted with each line corresponding to a different mean stress, as shown in Figure 4, on the S-N diagram. The curves show that increased mean tensile stresses severely decrease the fatigue life of type 316 stainless steel (samples no. 3,

5 and 7). The fatigue curve of samples no. 3, 8 and 9 (mean stress of 47 ksi) shows that the endurance limit was reduced to about half of the actual endurance limit (no mean stress).

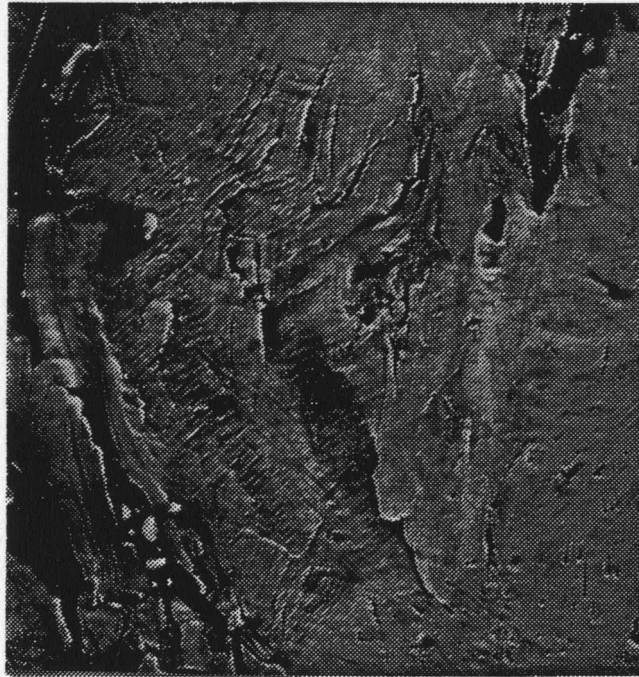
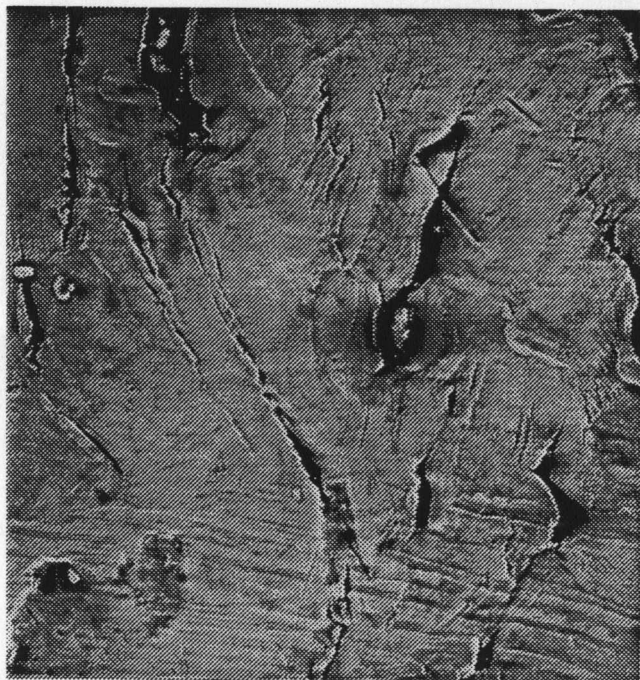
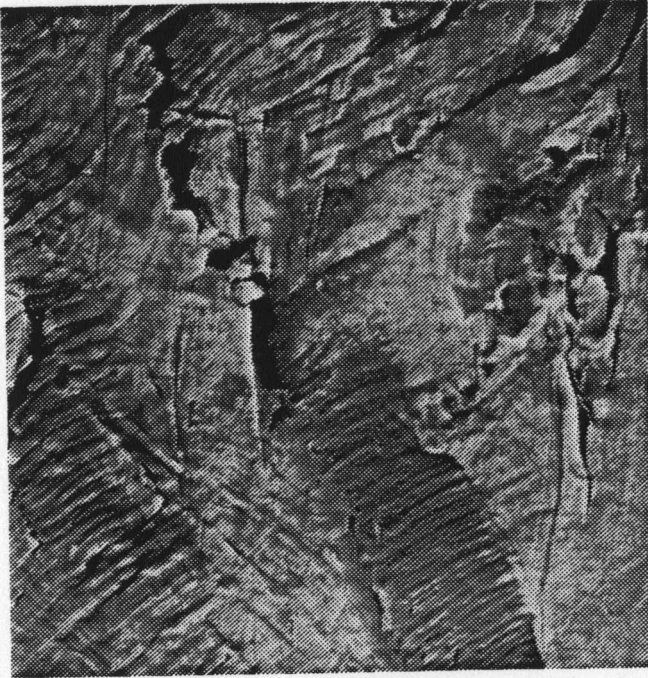
**In** the case of Jewett hip nail-plate the fracture surface was so badly disturbed that the cause of failure could not be determined from either a SEM or metallographic examination. A most unusual crack pattern was, however, found on the cylindrical surface immediately adjacent to the fracture surface (see Figures 19-22).

Figure 19. Crack Pattern Found on Cylindrical Surface of Jewett Hip Nail-Plate (SEM), at 400X.

Figure 20. Crack Pattern Found on Cylindrical Surface of Jewett Hip Nail-Plate (SEM), at 450X.

Figure 21. Crack Pattern Found on Cylindrical Surface of Jewett Hip Nail-Plate (SEM), at 1200X.

Figure 22. Crack Pattern Found on Cylindrical Surface of Jewett Hip Nail-Plate (SEM), at 1200X.

None of these crack patterns is similar to what we found on Jewett hip nail-plate. This means that a simple low-cycle tension stress was not the cause of failure of this device.
