REDUCING BUMPS AT PAVEMENT-BRIDGE INTERFACE

Amar Shukla

Youngstown State University

June 2011

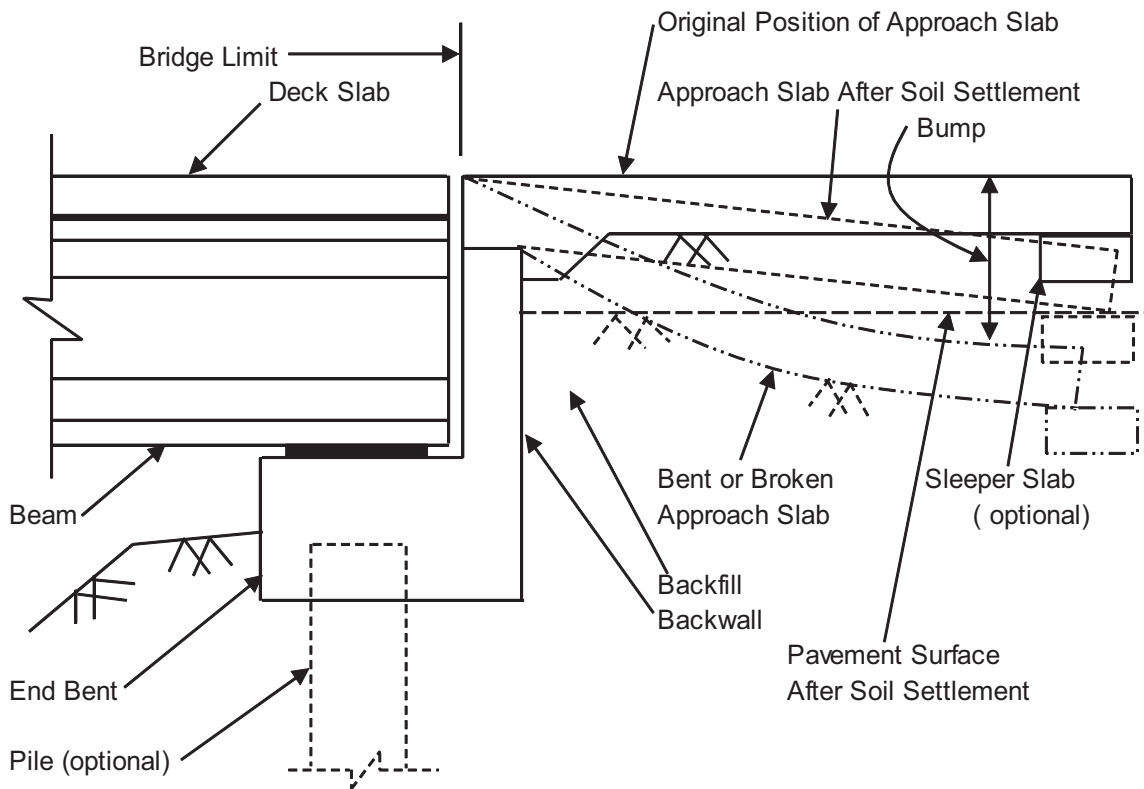
Figure 1.1 – Bump mechanism and behavior of approach slab due to pavement settlement.

Approach slabs are placed at the end of bridges for the better transition of vehicles from a bridge to a pavement, or vice versa. When the soil beneath an approach slab loses contact, the slab bends down to a concave shape. Figure 1.1 shows the behavior of approach slab due to pavement settlement. Approach slab near the bridge is placed on a back wall, which is supported by foundations. The other end of the approach slab is placed on the pavement, or sometimes on a sleeper slab. A bump is formed when the backfill under the approach slab loses contact with it. It can also be caused due to structural reasons if the approach

slab is designed insufficiently. Conditions become worse due to the combination of re-occurring soil settlement and continual impacts from vehicles running over the already created bump, if the problem is not fixed in a timely manner.

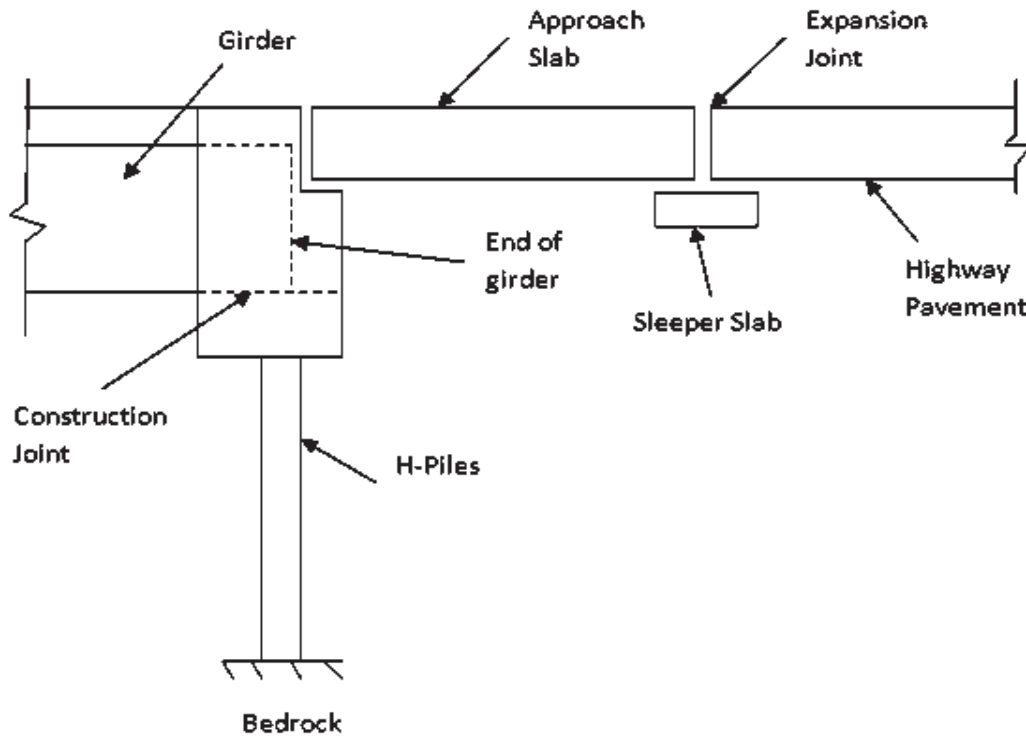
Figure 2.1 – Schematic of an Integral Abutment System with Sleeper Slab [10].

Approach slabs are placed at the ends of bridges to ensure a smooth transition of vehicles between a bridge and pavement, as shown earlier in Fig. 2.1. When the approach slab does not perform as intended, bumps can form. There are two basic ways that bumps can form – by structural failure, or by settlement, or by a combination of both. When an approach slab fails, it bends or breaks and takes a concave shape, as shown in Fig 5.1, which results in a bumpy ride. A sleeper slab is usually placed under an approach slab at the interface with the pavement. Excessive settlement of the sleeper slab can also result in the formation of bumps even though the approach slab has not failed, as shown in Fig. 5.2.

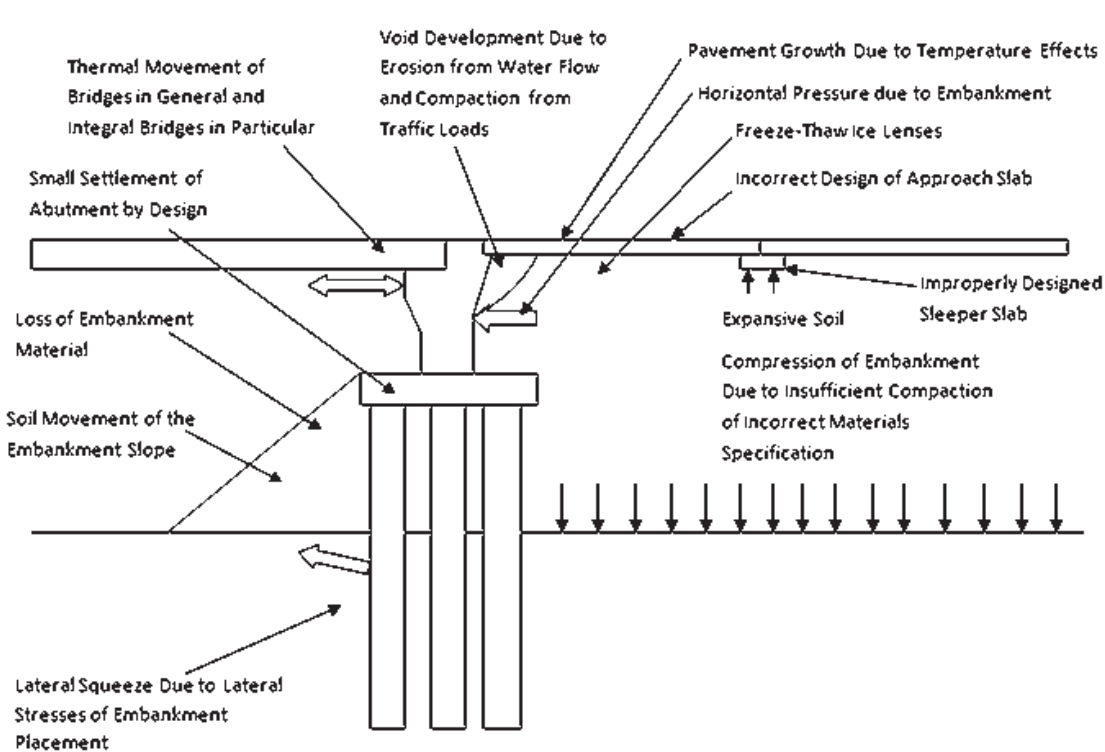
Figure 2.2 – Various factors that can result in formation of bumps [3].

Briaud *et al.* [3] investigated the causes of approach slab settlement and listed various problems that can lead to the formation of bumps, as shown in Fig. 2.2. According to this research, it is important to calculate both the short-term and long-term settlement for the structure. Settlement depends primarily on the type of soil. Rock, gravel and sand deposits show short-term settlement as soon as the load is applied. On the other hand, clay and silts are more likely to have long-term settlement problems. It is advisable to use granular fill materials as they are easy to compact. The compaction process and the quality of compaction vary depending on the type of abutment. The authors cited other factors that affect the performance of the bridge approach, including bridge-end conditions, construction methods, roadway paving and the bridge/roadway joint.

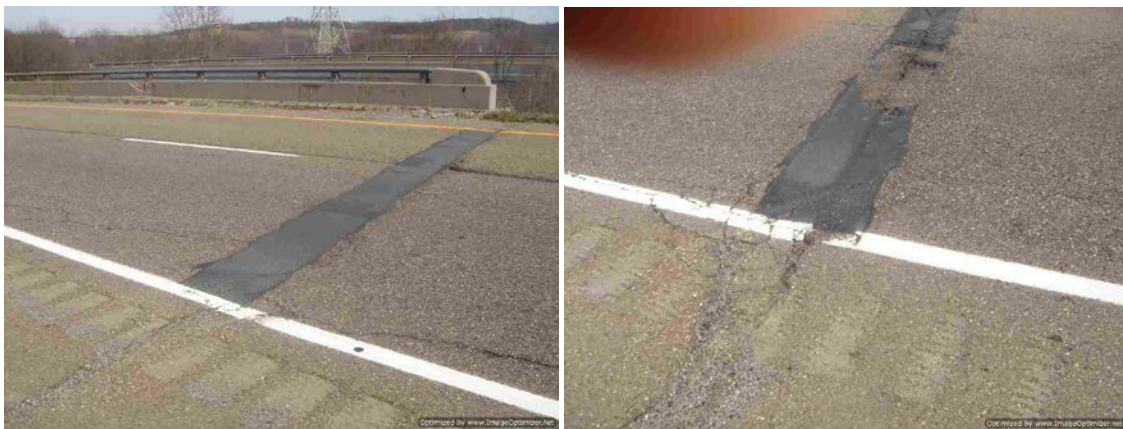
Fig. 3.1 – Pictures of bumps at Bridge No. COL 30 2578.

Tables 3.3 to 3.17 show the detailed test results of sieve analysis, plastic limit and liquid limit tests performed on soil samples collected from different bridge sites. Pictures of the bump condition are shown in Figs. 3.1 to 3.5. After comparing lab test results and reviewing the bump pictures of the bridge sites, it was found that the percentage of silt and clay present in the soil has significant effects on bump formation.

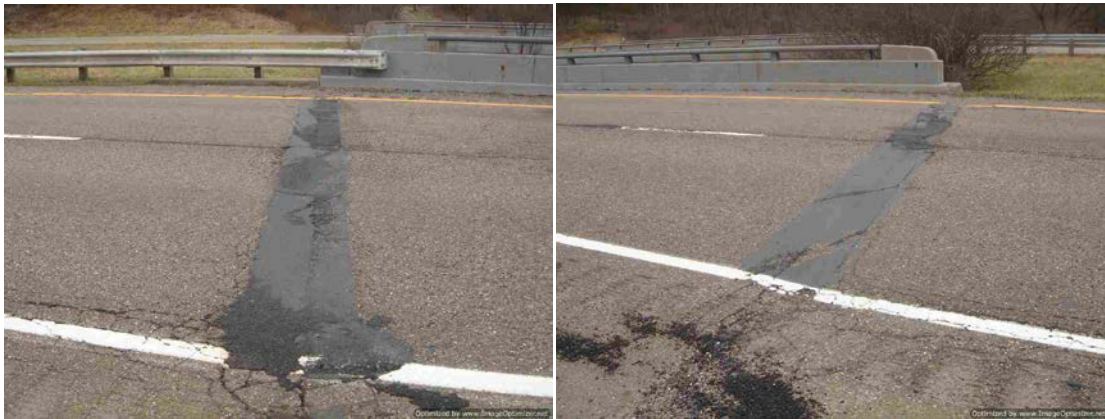
Fig. 3.2 – Pictures of bumps at Bridge No. COL 30 2667.

at this bridge was not as severe as some others (COL 30 11 2L was the worst); however, as shown in Figure 3.2, an attempt was made to repair the bump at COL 30 2667.

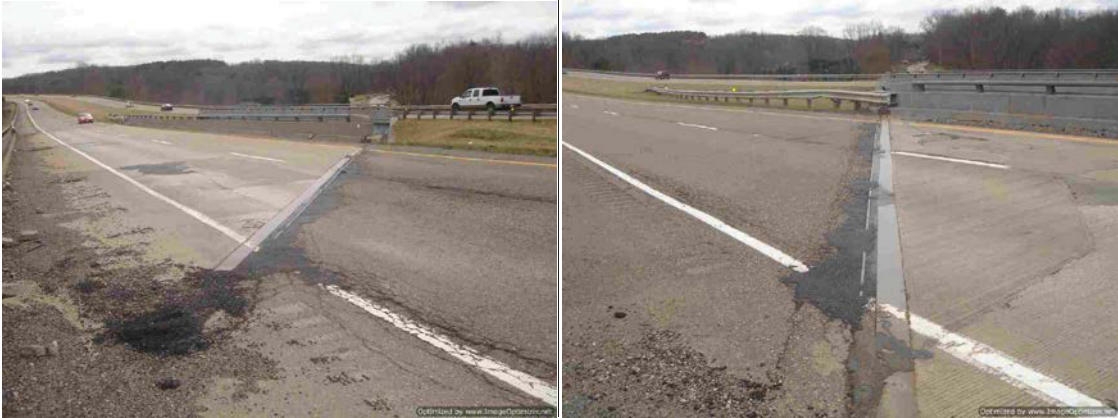
Fig. 3.4 – Pictures of bumps at Bridge No. COL 30 2670.

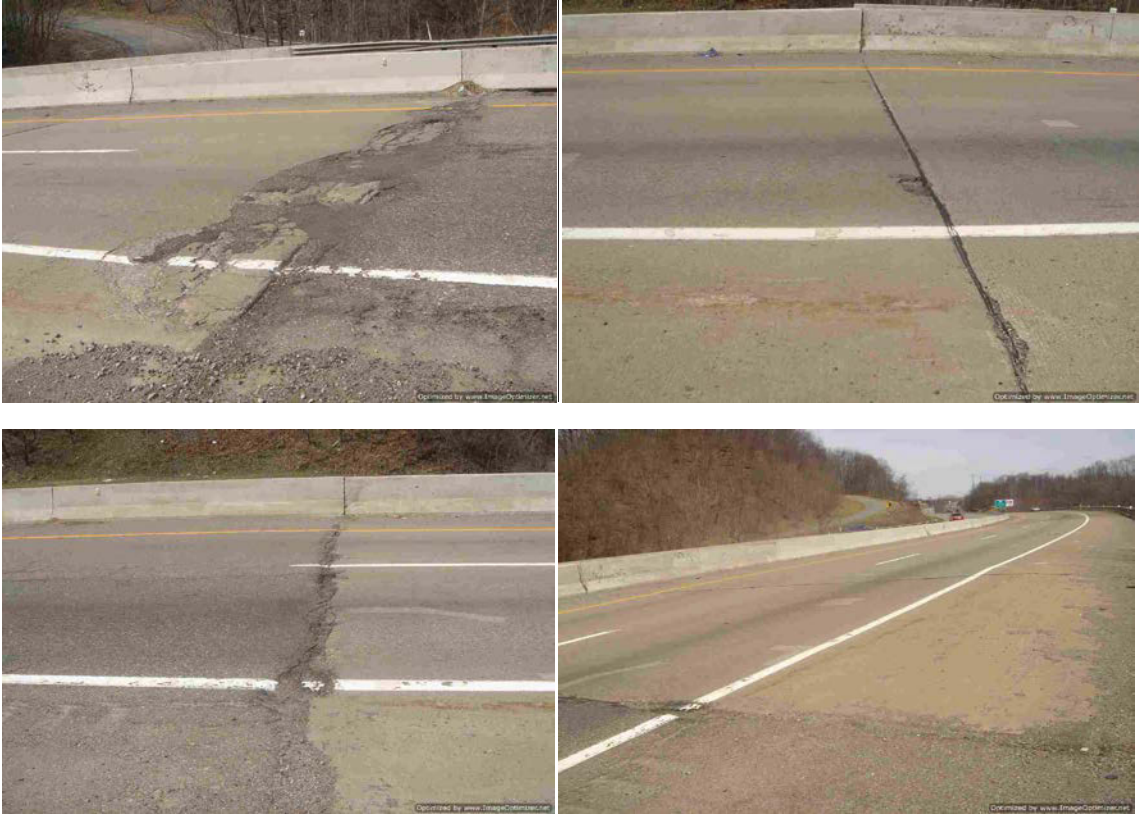
Fig. 3.5 – Pictures of bumps at Bridge No. COL 30 3182.

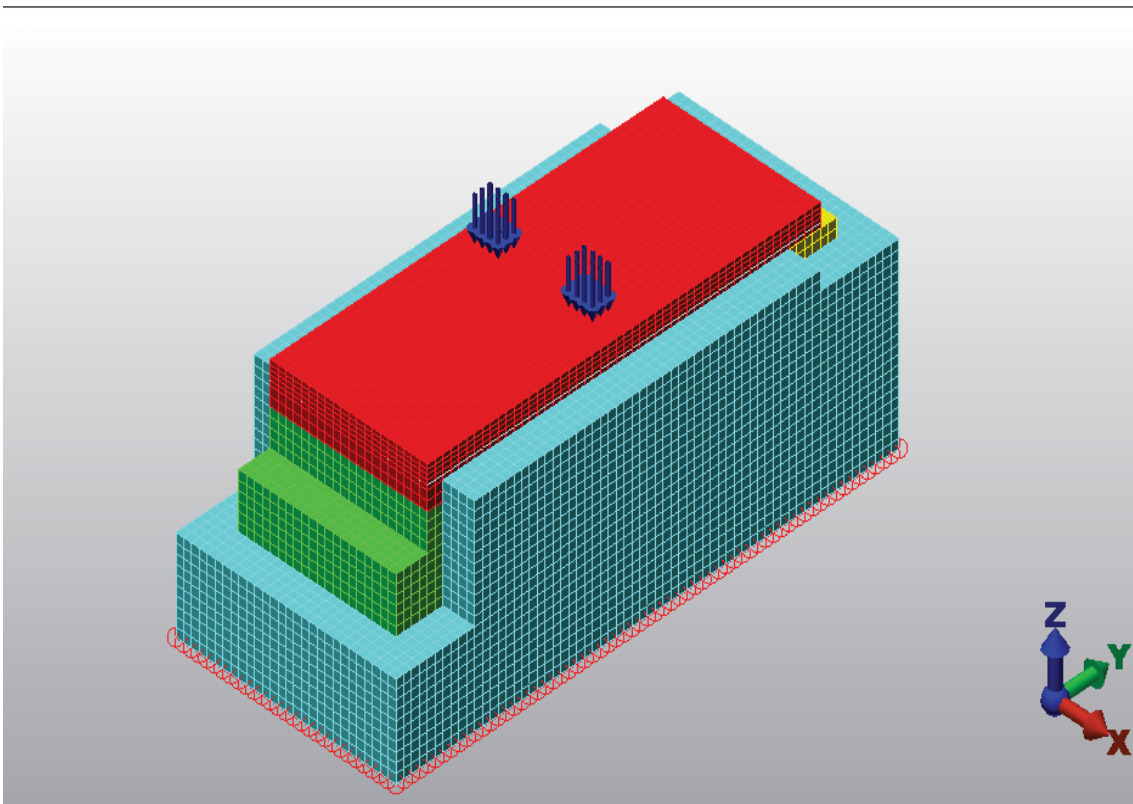
Figure 4.1 – FE Model A of approach slab with soil.

The approach slab is placed at the end of the bridges with its one end resting on an end bent and the other end on a sleeper slab. Movement of soil beneath the abutment is one of the most predominant causes for the formation of bumps. A parametric study was conducted on the design parameters, such as stresses and deflections. Two separate models were built in Autodesk ALGOR Simulation Professional 2010 [16] finite element analysis software. Model A (Fig. 4.1) had an approach slab with soil underneath, while Model B (Fig. 4.2) had an approach slab without any soil to replicate the situation of an approach slab where the soil underneath is assumed to have eroded or settled. Concrete below the neutral axis was neglected for Model B, to replicate a cracked concrete section, and beams with high stiffness were used to transfer loads to bottom reinforcement. The span length was 25 ft and width was 10 ft for both models; these are typical approach slab dimensions in Ohio. The thickness of approach slab was taken as 15 in, a bottom reinforcement of #10 bars at 6 in on center (to match nodes) and a top reinforcement of #5 bars at 18 in on center were

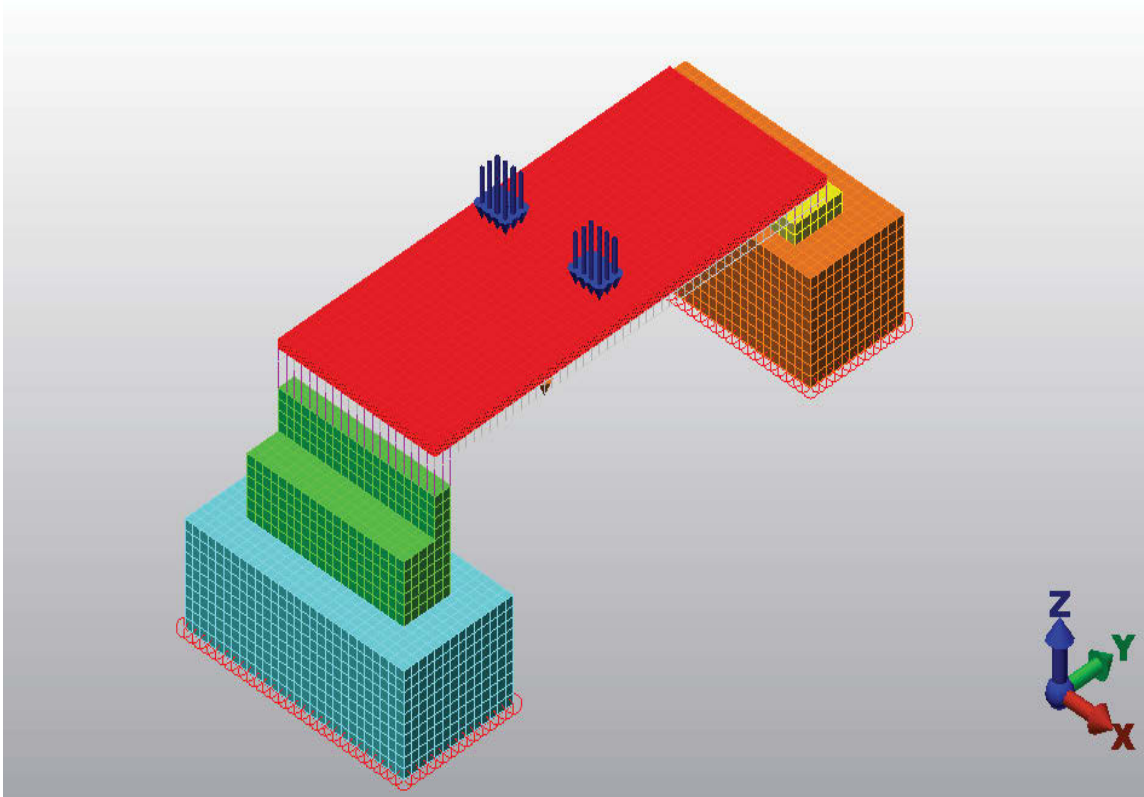
Figure 4.2 – FE Model B of approach slab without soil.

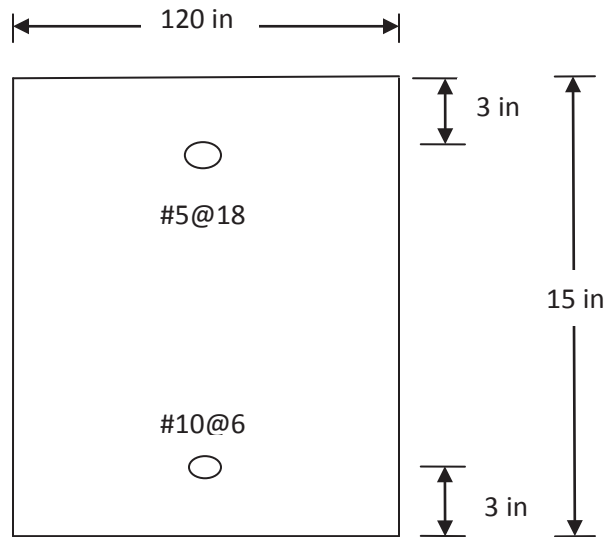
Figure 4.3 – Cross-section of approach slab models.

provided (Fig. 4.3); these values are based on ODOT recommendations. Due to the complexity of the structure, a manual meshing procedure was followed. For approach slab, a mesh of rectangle 6 in length and 3 in width was selected while for the other parts, such as end bent, sleeper slab and soil, a mesh of square 6 in was selected.

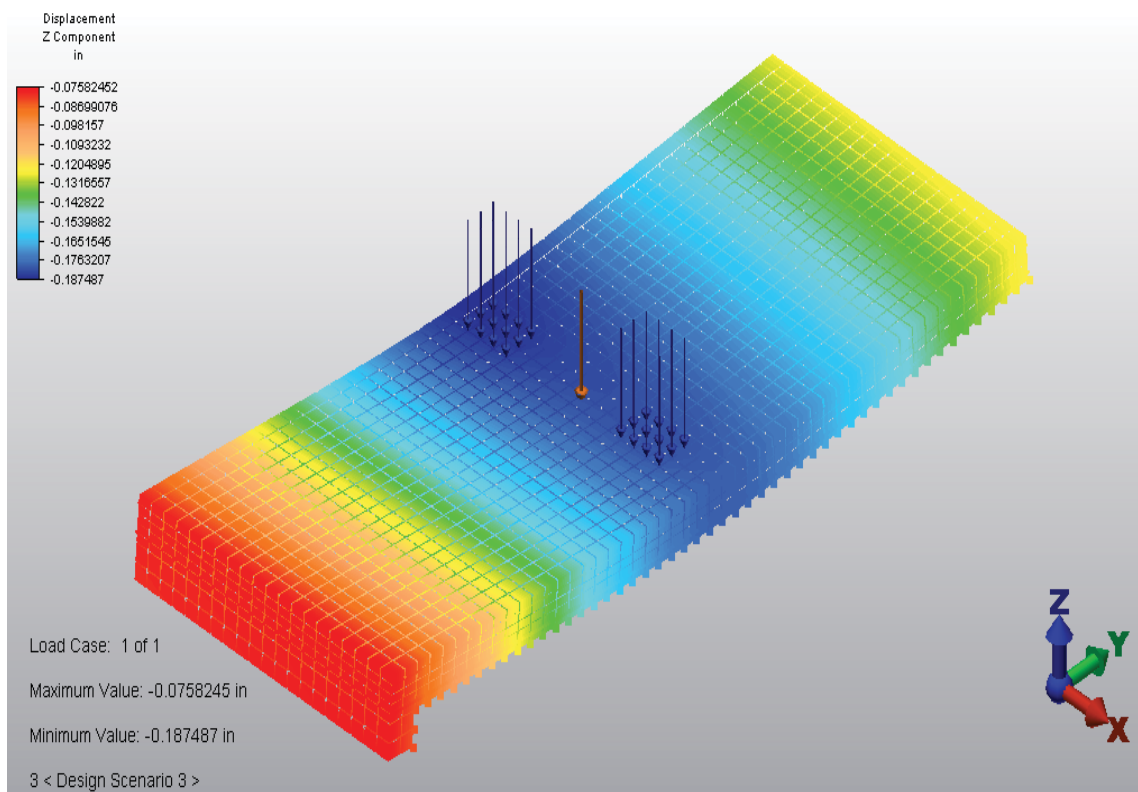
Figure 4.4A – FE Model A showing results of displacement.

Finite element analysis performed on an approach slab of 25 ft slab length, built according to ODOT specifications, shows that when proper soil support is maintained, deflections are modest (maximum of 0.19 in). However, when soil support is lost, the predicted maximum deflection is much larger (1.34 in). After thousands of repeated HL-93 truck loadings, it is likely that the approach slab will be damaged and develop cracks, reducing its structural capacity and eventually leading to failure. Therefore, based on the structural analysis performed in this study, and a review of the literature, bump problems at the bridge-pavement interface seem to occur primarily when soil support beneath the approach slab is lost or reduced.

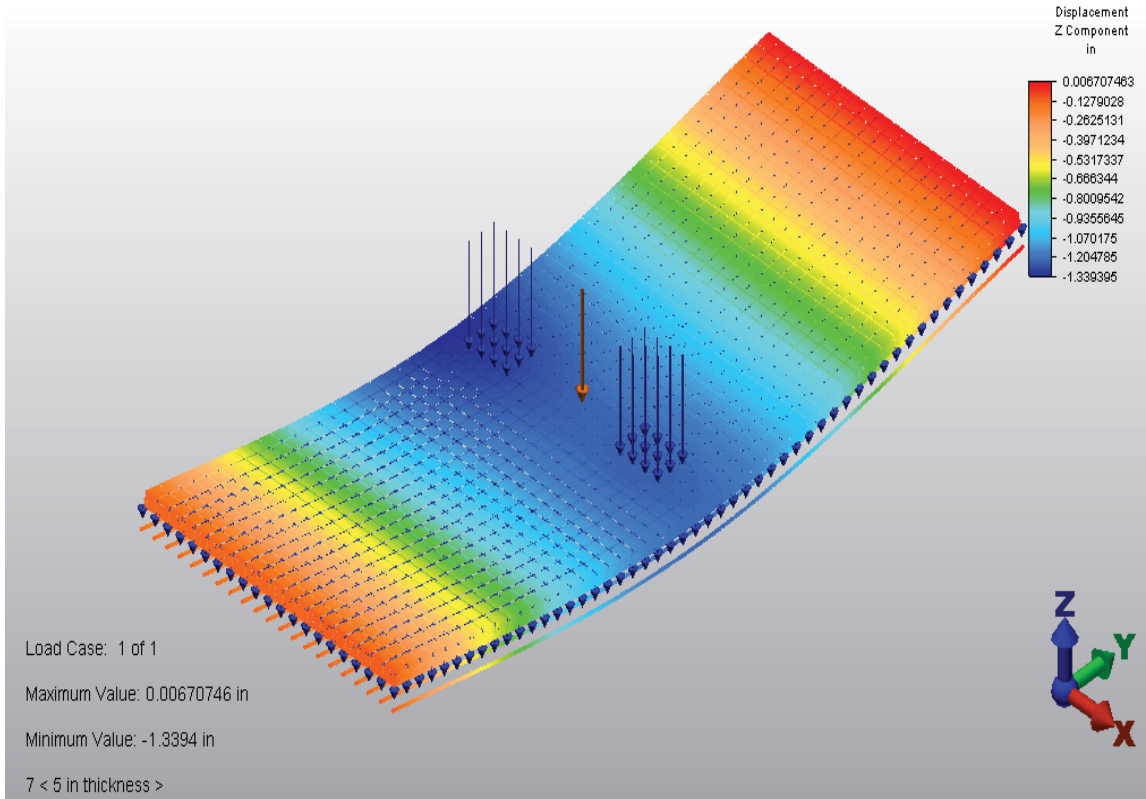
Figure 4.4B – FE Model B showing results of displacement.

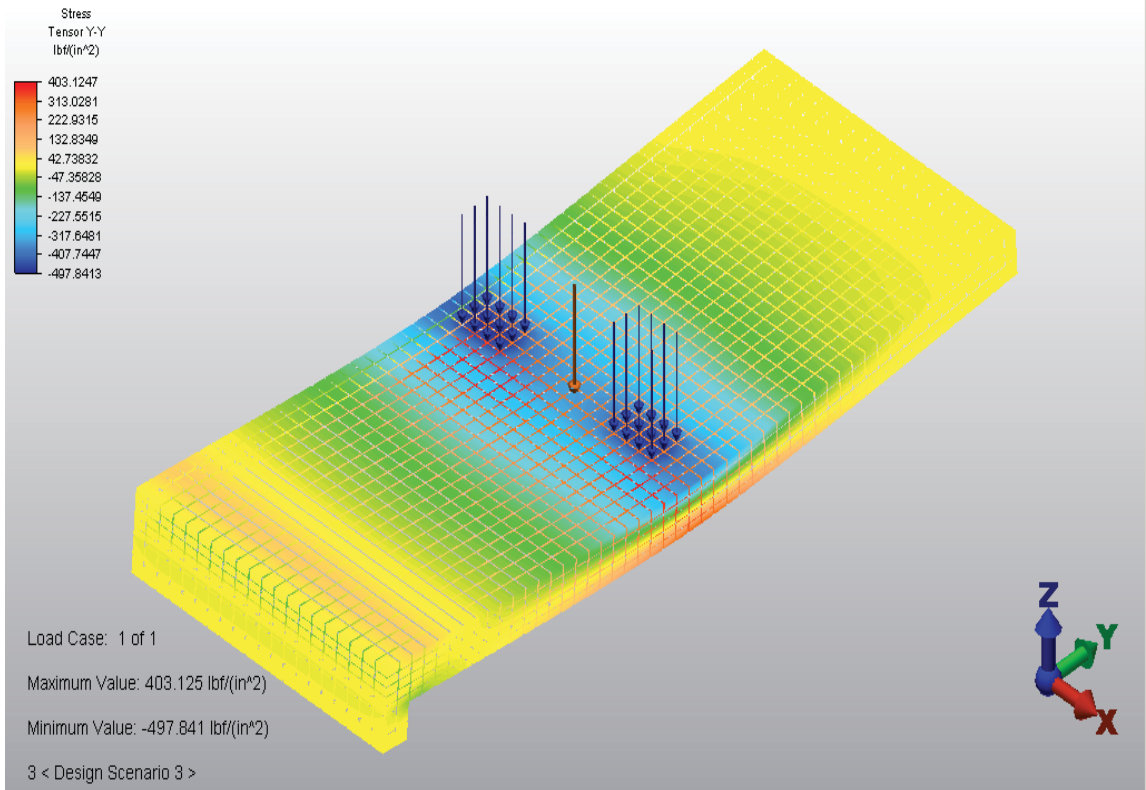
Figure 4.5A - FE Model A showing results of stresses in concrete.

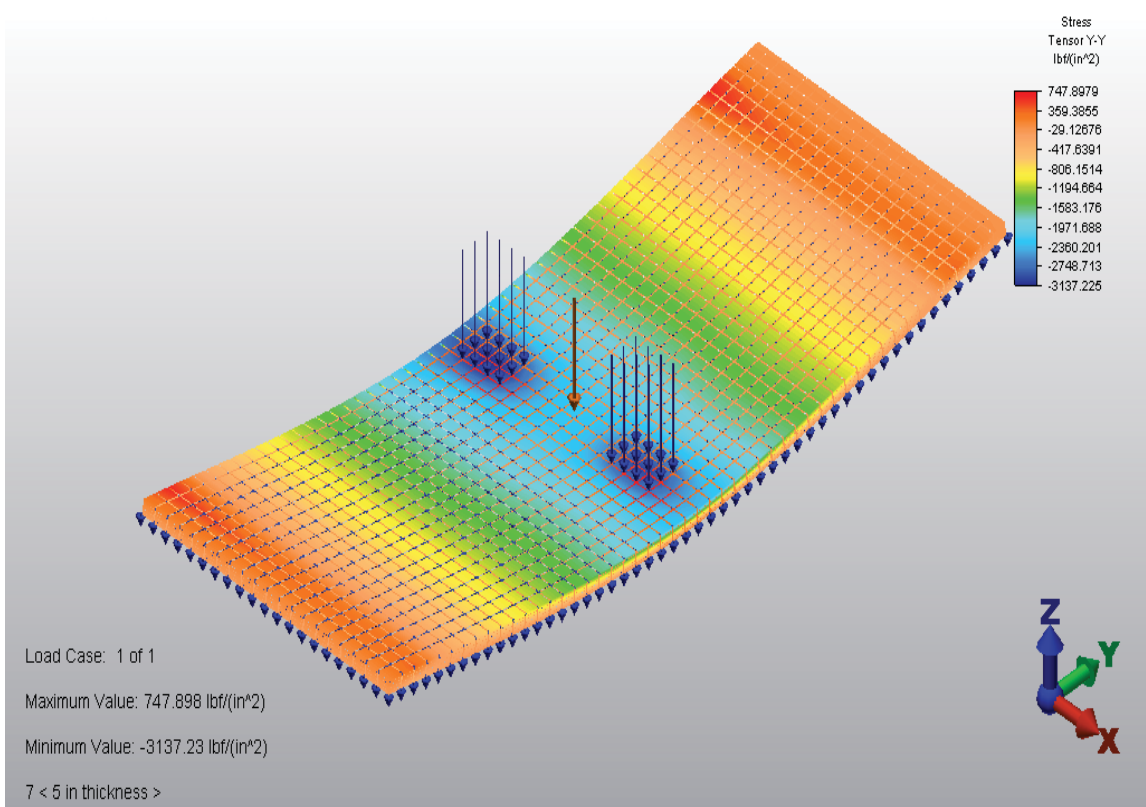
Figure 4.5B – FE Model B showing results of compressive stresses in concrete.

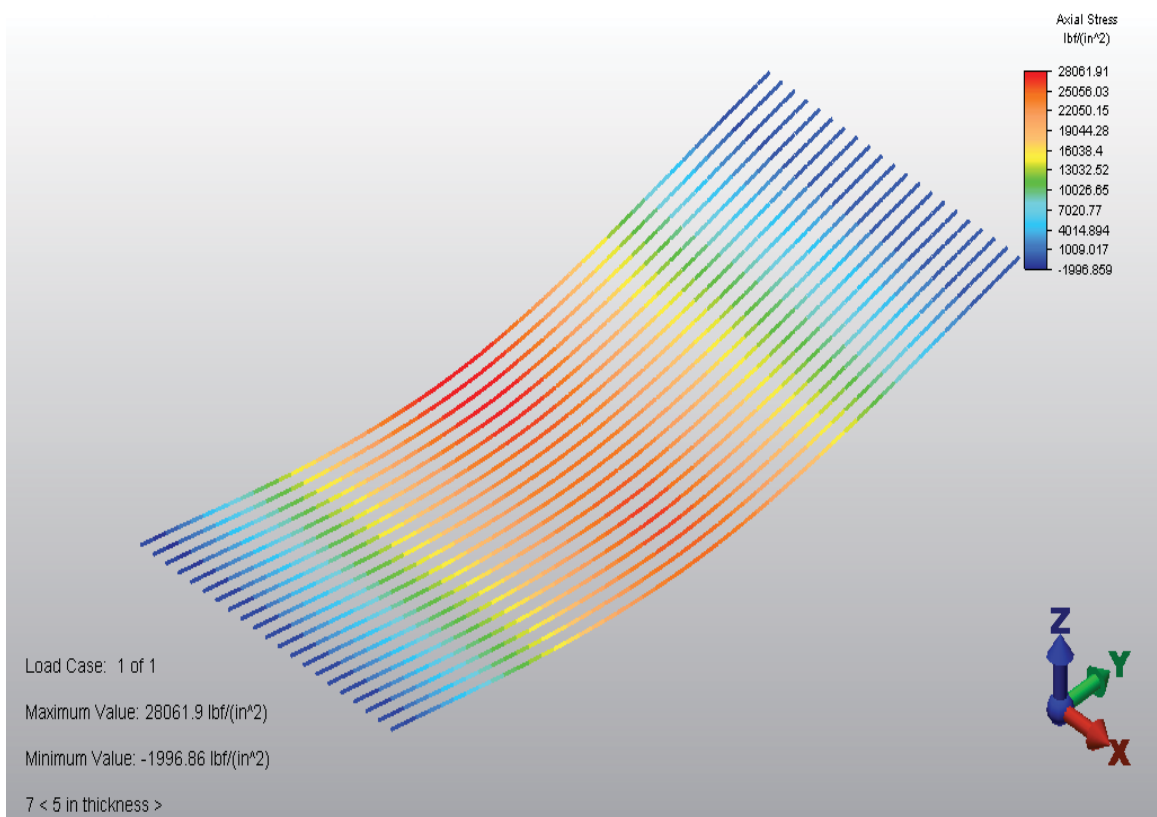
Figure 4.5C – FE Model B showing results of stresses in bottom reinforcement.

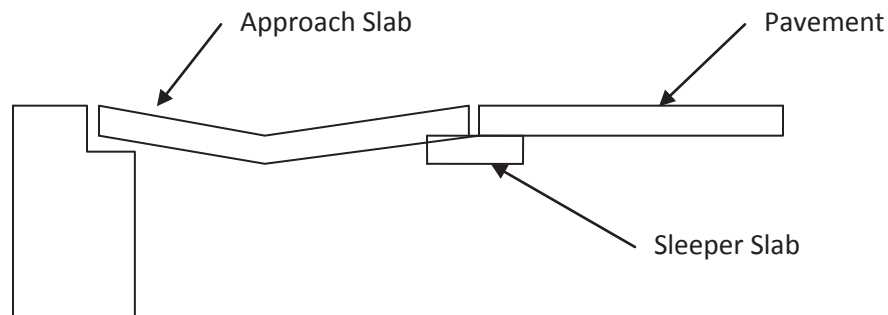
Figure 5.1 – Formation of bump due to failure of approach slab.

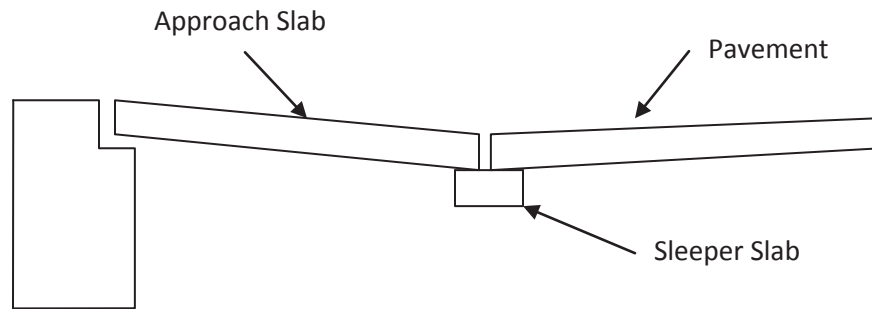
Figure 5.2 – Bump formation due to excessive settlement of sleeper slab.

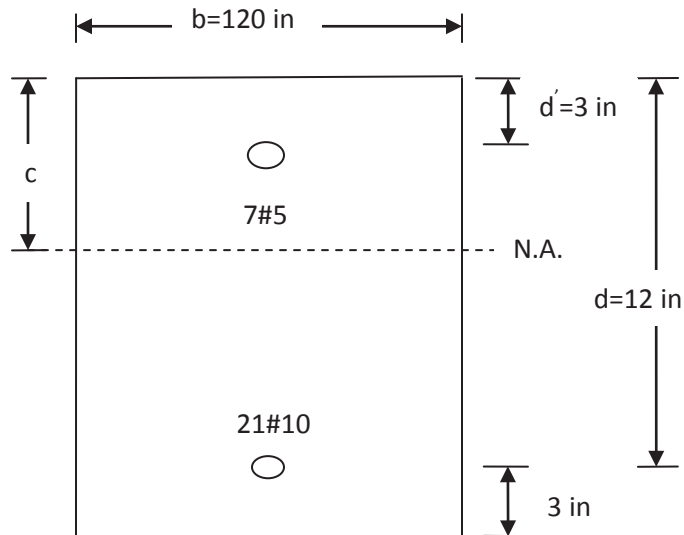
Figure C.1 – Cross-section of approach slab model.

$$A_s = (21 \times 1.27) = 26.67 \text{ in}^2$$
