Examining Regional Weather Effects on Single Ply Roofing Membranes

Master of Science in Engineering

YOUNGSTOWN STATE UNIVERSITY

May 2018

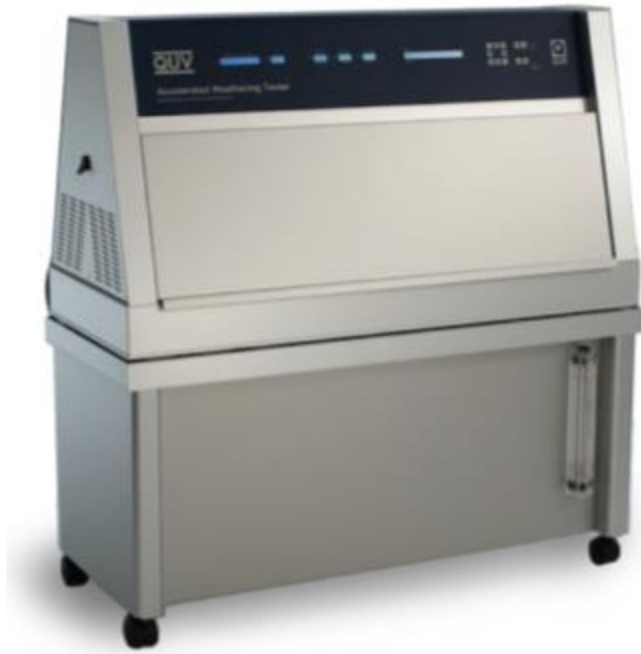
A QUV accelerated weathering tester provides cyclic corrosion due to the combination of sunlight, rain, and dew (Q-Fog, Cleveland, OH). It was used to expose the different roofing membranes to UV light through fluorescent UV lamps and humidity cycles for rain and dew simulation. Each cycle consisting of 8 hours of UV light exposure and 16 hours of humidity was used to determine the effect of the combination of the two conditions on the membranes (28). Although there are different ASTM methods for exposure on each membrane, they were all exposed to the same conditions to obtain direct comparison. Figure 1 below is an image of a similar QUV model.

Figure 1. QUV Accelerated Weathering Tester

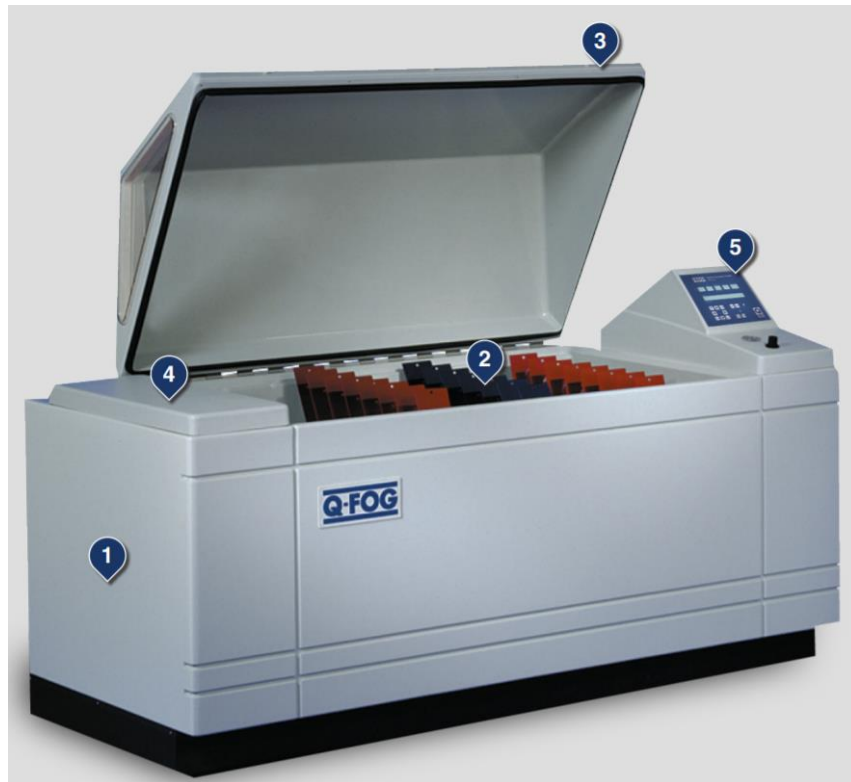
A cyclic corrosion tester was used to apply humidity and salt to the samples (Q-Fog, Cleveland, OH). Figure 2 below is a model similar to the one used for experimentation (28). Areas labeled 1 and 4 are the reservoir and lid, where the chamber was filled every 2-5 days. Area labeled 2 is where the samples were placed. Area 3 is a fiberglass lid with low thermal conductivity, used to enhance temperature control in the chamber. Area 5 is the control panel, where cycle was controlled and aging method was selected.

Figure 2. Q-Fog Cyclic Corrosion Test

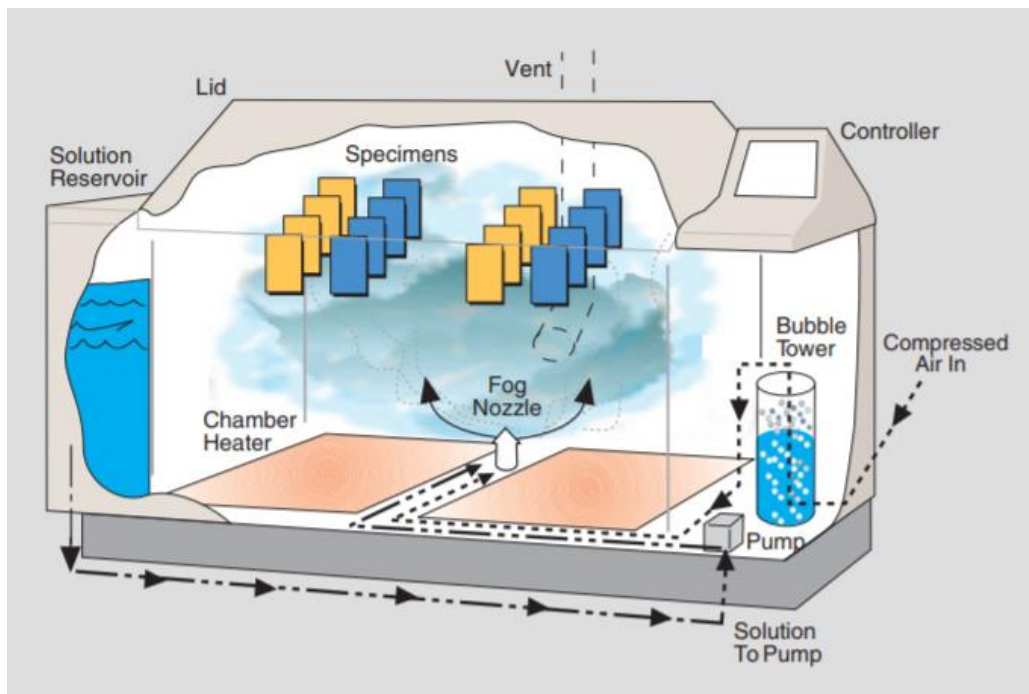
As seen in figure 3, the water (salted and unsalted), is dispensed from the reservoir into the pump, sending the solution to the fog nozzles. Concurrently, air is compressed through the bubble tower and is sent to the fog nozzles via the same pump. The solution and air are distributed onto the samples as fog mist (29).

Figure 3. Cyclic Flow in a Corrosion Tester

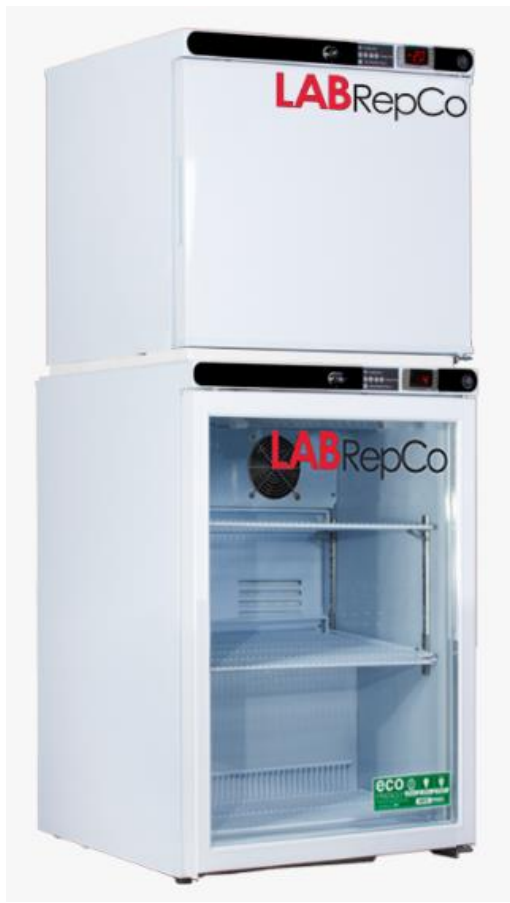
Samples were placed on shelves in the refrigerator, freezer, and ambient temperatures to simulate freeze-thaw conditions (LabRepCo, Horshem, PA). In the refrigerator, samples were placed in containers immersed in water and temperatures ranged between 1 and 10°C. The temperature was kept between 2 and 4°C during the experiment. The refrigerator contains a glass door and three shelves for samples to be placed, and it has a cyclic defrost. In the freezer, temperatures ranged between -15 and -25°C, but were kept between -21 and -23°C. The construction of the freezer consists of a solid door and three shelves for samples to be placed, and it auto defrosts. Figure 4 below shows a similar model as the one used in this experiment.

Figure 4. Refrigerator and Freezer

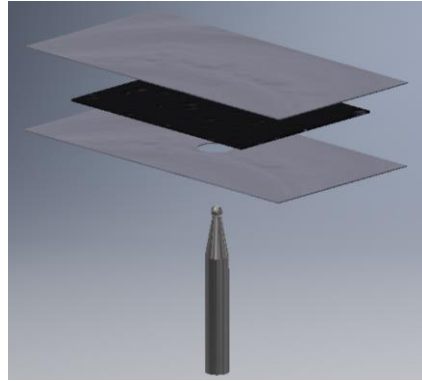
The black represents the roofing membrane, sandwiched between two steel plates, with a mandrel driven through the bottom until the membrane is punctured.

Figure 7. Autocad drawing of the puncture test

Samples were cut out using the same die used for weight, which were 3 inches in diameter. Samples were tested using an in-house testing apparatus (Made in House, Boardman, OH). During the test, the sample is sandwiched between two steel plates. Both the top and bottom plates have a hole in the center of them to allow a mandrel to be pushed through. The plates are secured together using vice grips. Once the sample is between the plates and the plates are secured together, a pneumatic hand pump is used to drive a mandrel up through the hole in the plates, passing it through the roof sample that is between them. The mandrel used for puncturing has a 10 mm ball on the tip. The force exerted on the membrane is recorded using a load cell (Made in House, Boardman, OH). Figure 7 below is an Autocad drawing of the test, without the hand pump and vice grips.

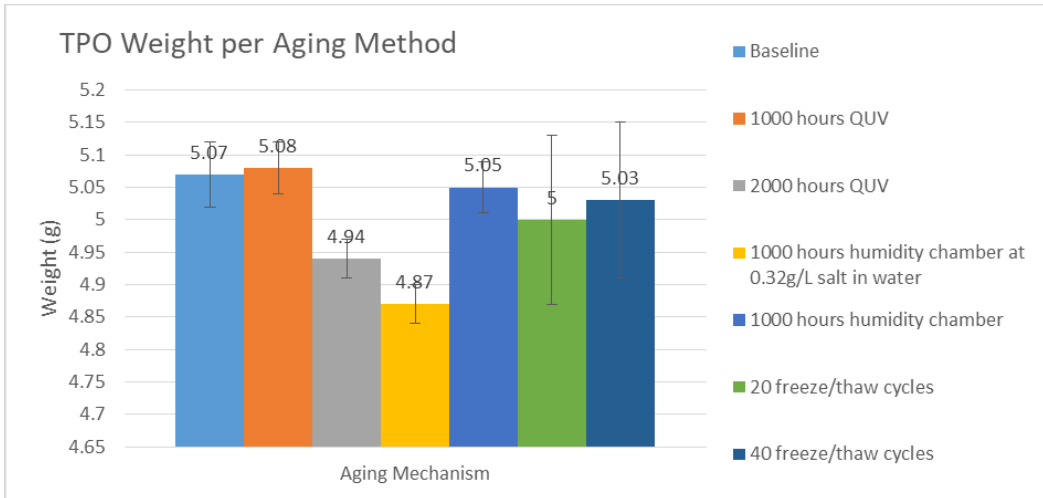
Figure 8. Weight of TPO Samples After Each Aging Mechanism

Figure 8 is a graphical representation of Table 1, in the form of a bar graph. The different aging cycles were compared against the weight in grams. Standard deviations bars are above each aging cycle. Each age mechanism is represented by a different color, with the legend on the right for identification. For all of the graphs presented, the same colors are used throughout this paper to represent each aging mechanism. Light blue represents the baseline results. Orange represents the 1000 hours in the QUV. Gray represents 2000 hours in the QUV. Yellow represents the salt and humidity. Bright blue represents the 1000 hours of the humidity cycle. Green represents 20 freeze-thaw cycles. Dark blue color represents the 40 freeze-thaw cycles.

When looking at Figure 8, one can see that there is a drastic decrease between the baseline and the 2000 hours QUV and 1000 hours of humidity and

salt spray. While all of the other techniques caused weight loss, with the exception of 1000 hours of QUV, the weight loss was ultimately minimal, with the largest percent decrease being 3.97%. The 1000 hours of QUV did experience weight gain, but with the standard deviations, the weight comparison between 1000 hours of QUV and the baseline is basically equal.

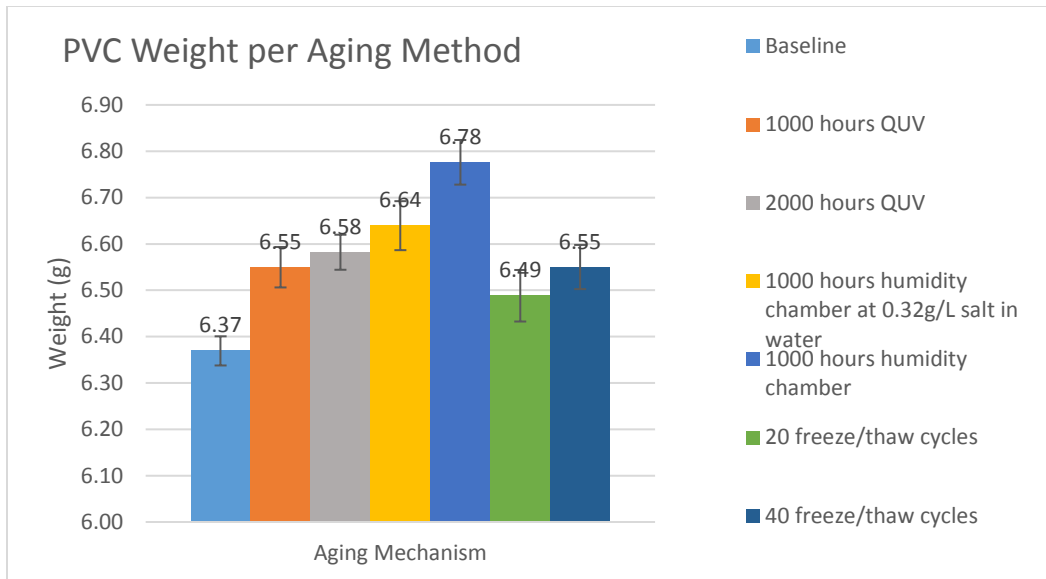
Figure 9. Weight of PVC after each Aging Mechanism

Figure 9 is a graphical depiction of Table 2 in the form of a bar graph. The different aging cycles were compared against the weight in grams. Standard deviations bars are above each aging cycle. Each age mechanism is represented by a different color, with the legend on the right for identification. There is a distinct increase in weight of 6.39% after 1000 hours in the humidity cycle, followed by the salt and humidity cycle with an increase of 4.24%. All of the other aging cycles are similar in weight gain, with the largest remaining increase being 3.34%.

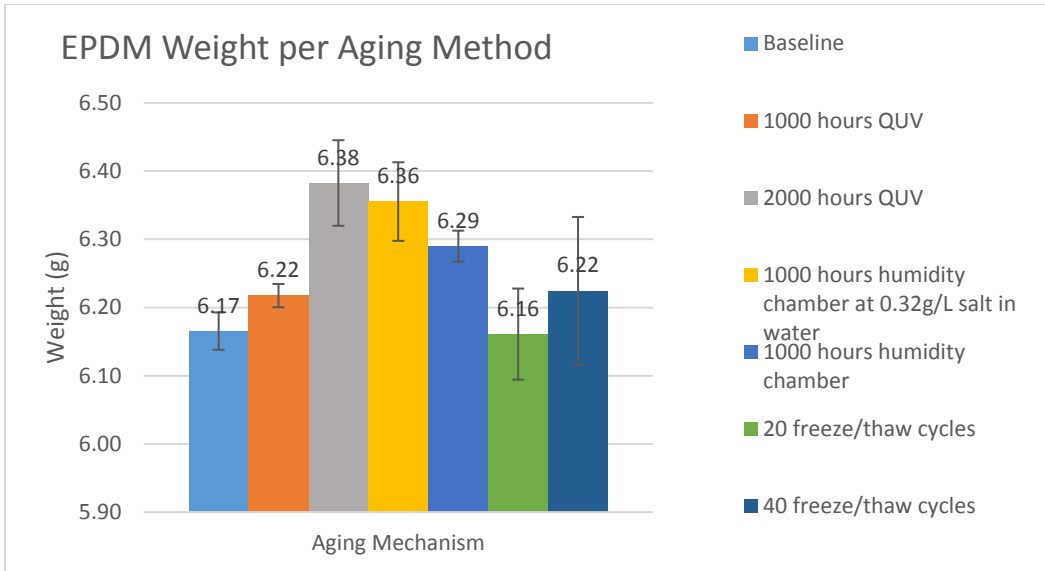
Figure 10. Weight of EPDM after each Aging Mechanism

Figure 10 is a graphical depiction of Table 3 in the form of a bar graph. The different aging cycles were compared against the weight in grams. Standard deviations bars are above each aging cycle. Each age mechanism is represented by a different color, with the legend on the right for identification. There is a clear increase between the two different hours in the QUV weathering tester, with an increase of 0.84% for 1000 hours and 3.52% for 2000 hours. Most of the weights did not exhibit a large increase from the baseline, with the largest increase of 3.08% for the salt and humidity environment, not including the two UV cycles.

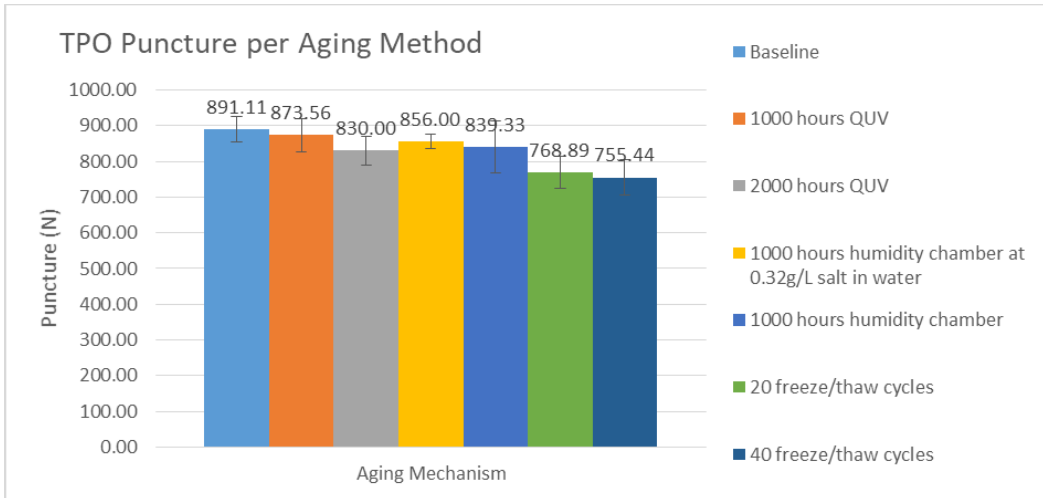
Figure 11. Puncture of TPO Samples after Each Aging Mechanism

Figure 11 is a graphical representation of Table 4, in the form of a bar graph. The different aging cycles were compared against the puncture in Newtons. Standard deviations bars are above each aging cycle. Each age mechanism is represented by a different color, with the legend on the right for identification. It is apparent how the puncture resistance of all the aged membranes decreased after each aging cycle, with the lowest puncture resistance seen at the end of the graph after the freeze-thaw cycles. From this graph, it can be seen that the puncture resistance decreased after being exposed to 1000 hours of humidity cycle, but with great deviation. The 1000 hours in the QUV has a negative impact on puncture with a decrease of 1.97%, but not as high as the one caused by the humidity cycle, with a decrease of 5.81%. The humidity cycle caused a greater decrease in puncture of 3.94% as compared to the combination of salt and humidity with a decrease of 3.94%. There is a direct negative correlation

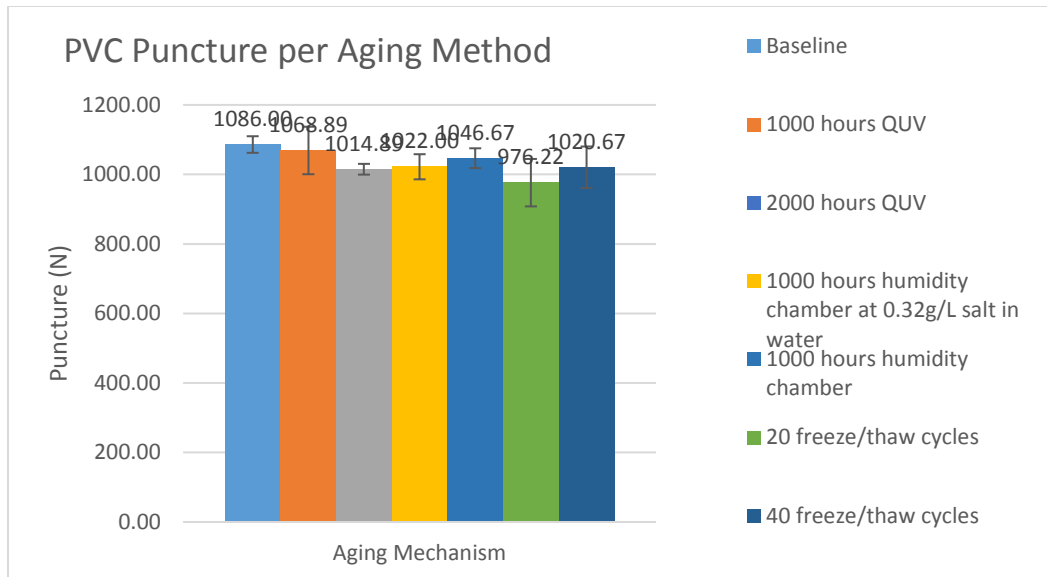
Figure 12. Puncture of PVC after each Aging Mechanism

Figure 12 is a graphical representation of Table 6, in the form of a bar graph. The different aging cycles were compared against the puncture in Newtons. Standard deviation bars are above each aging cycle. Each aging mechanism is represented by a different color, with the legend on the right for identification. It is apparent from the graph how the puncture of PVC decreases after aging mechanism, with emphasis on the lowest puncture value after 20 freeze-thaw cycles (green), with a decrease of 10.11%. The 1000 hours in the QUV has a negative correlation to puncture resistance with a decrease of 1.58%, but not as high as the one caused by the humidity cycle, which decreased by 3.62%. The combination of humidity and salt cycle caused a greater decrease, of 5.89%, in puncture resistance compared to the humidity cycle alone. There is a direct negative correlation between increased time in the QUV and puncture

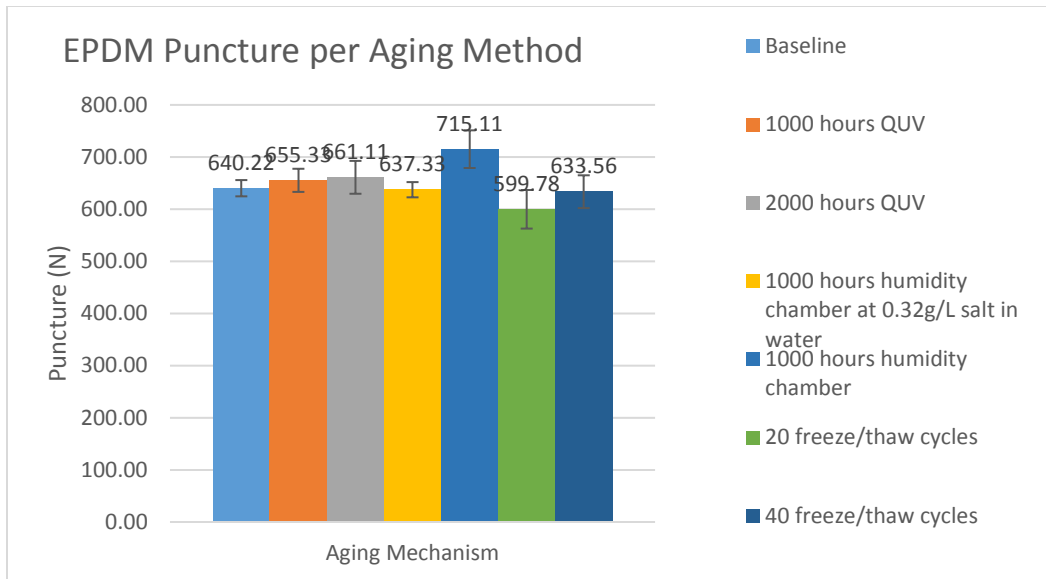
Figure 13. Puncture of EPDM after each Aging Mechanism

Figure 13 is a graphical representation of Table 8, in the form of a bar graph. The different aging cycles were compared against the puncture in Newtons. Standard deviations bars are above each aging cycle. Each age mechanism is represented by a different color, with the legend on the right for identification. It can be seen that the humidity cycle caused the highest increase in puncture resistance in the EPDM membranes, with an increase of 11.7%, whereas the salt and humidity combination cycle resulted in an overall decrease of puncture resistance of 0.45%. The 1000 hours in the QUV resulted in a slight increase in puncture resistance of 2.36%, whereas the humidity cycle causes a much higher increase of 11.7%. After 2000 hours in the QUV, the samples increased slightly in puncture resistance, with some deviation, by 3.26%. After only 20 cycles of freeze-thaw, there is a loss of puncture resistance compared to

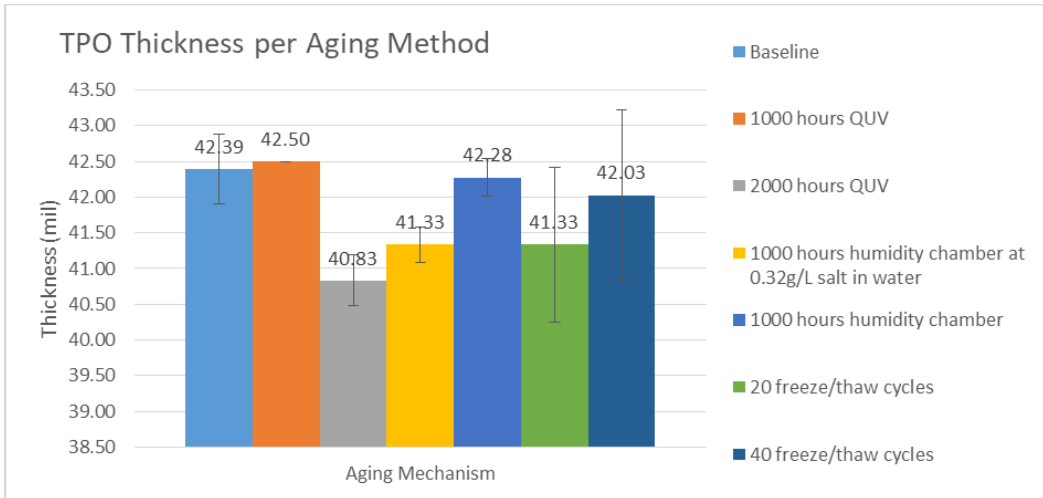
Figure 14. Thickness of TPO Samples after Each Aging Mechanism

Figure 14 is a graphical representation of Table 10, in the form of a bar graph. The different aging cycles were compared against the thickness in mils. Standard deviations bars are above each aging cycle. Each age mechanism is represented by a different color, with the legend on the right for identification. It can be seen how the thickness of most of the samples are decreased, distinctly after the 2000 hours in the QUV, with a decrease of 3.67%, and 1000 hours of salt and humidity exposure, with a decrease of 2.49%. The samples from the QUV increased in thickness by 0.26%, but the sample thicknesses decreased in the humidity chamber by 0.26%. The first 1000 hours in the QUV caused minor thickness increase of 0.26% as compared to the baseline, but more time in the QUV (2000 hours) caused a more drastic decrease in thickness of 3.67%. After 20 cycles of freeze-thaw, the thickness decreases by 2.49%, but with more cycles, the

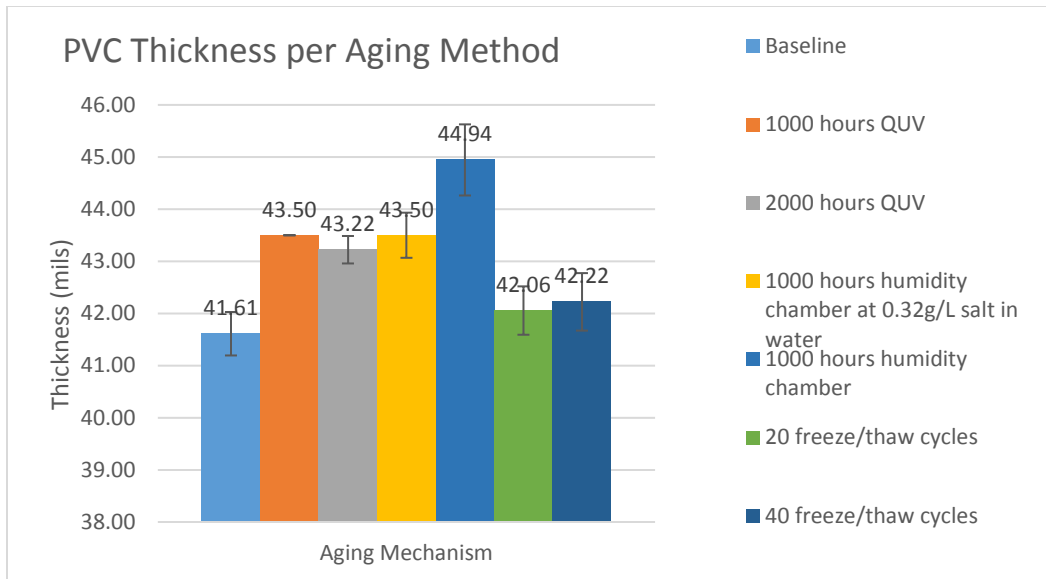
Figure 15. Thickness of PVC after each Aging Mechanism

Figure 15 is a graphical representation of Table 11, in the form of a bar graph. The different aging cycles were compared against the thickness in mils. Standard deviation bars are above each aging cycle. Each age mechanism is represented by a different color, with the legend on the right for identification. The increase in thickness can be seen, especially after the 1000 hours of humidity exposure, with an increase of 8.01%. The lowest increase is seen after the freeze-thaw cycles, with an increase of 1.07% for the 20 cycles and a slightly higher increase of 1.47% for the 40 cycles. Salt and humidity cycle caused a 4.54% increase in thickness, where 1000 hours resulted in a 4.54% increase, whereas the 2000 hours resulted in a 3.87% increase from the baseline.

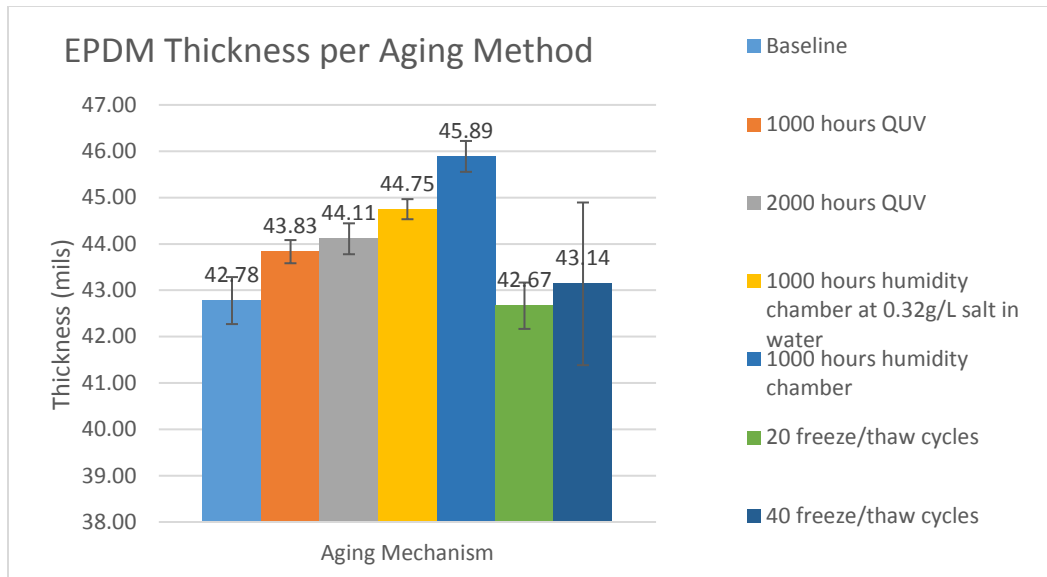
Figure 16. Thickness of EPDM after each Aging Mechanism

Figure 16 is a graphical representation of Table 12, in the form of a bar graph. The different aging cycles were compared against the thickness in mils. Standard deviations bars are above each aging cycle. Each age mechanism is represented by a different color, with the legend on the right for identification. The thickness of the samples increased linearly, through the 1000 hours in the humidity chamber, which increased by 7.27%. 1000 hours of salt and humidity exposure caused an increase of 4.61%. After 1000 hours in the QUV, sample thickness increased by 2.47%, whereas 2000 hours caused an increase of 3.12%. For both the freeze-thaw cycles, the linear trend did not exist, with a decrease of 0.26% in the 20 freeze-thaw cycle and an increase of 0.84% in the 40 freeze-thaw cycle.
