Determination of Structural Health of the Lincoln Parking Deck at YSU

M.S. in Civil Engineering

YOUNGSTOWN STATE UNIVERSITY

May, 2018

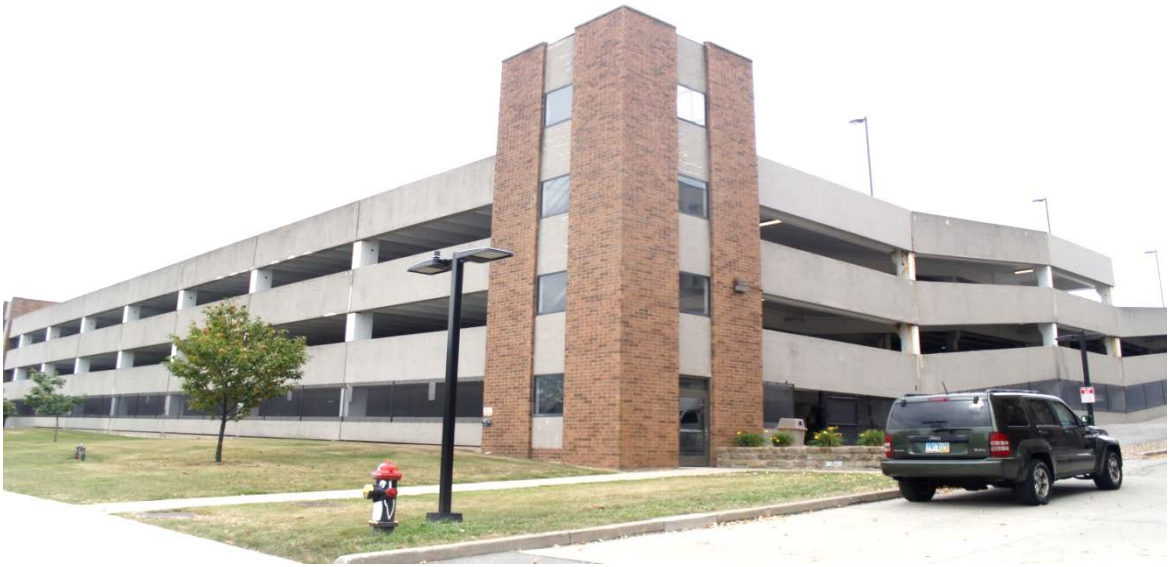
Figure 2-1: A perspective view of the Lincoln Parking Deck from Lincoln Ave.

Parking structures are relatively complex structures in the field of structural design and construction (Berkowskia et al., 2013). According to ACI, a parking structure with at least 40% opening is called an 'open parking structure' (ACI 330R, 2001). The Lincoln Parking Deck, as shown in Fig. 2-1, falls under this category as more than 40% of the entire structure is unenclosed.

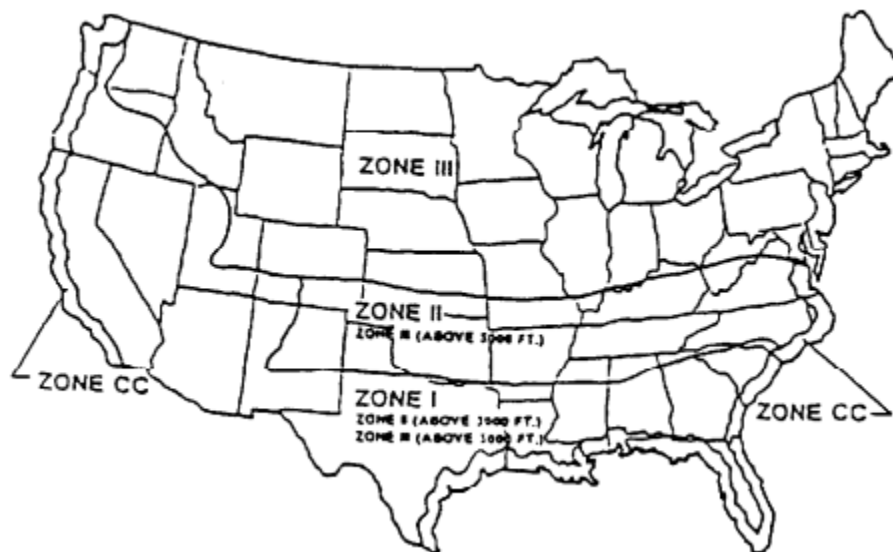
Figure 2-2: Exposure Zones in the United States (ACI 362.1R, 1997).

The structures have been classified into five different zones based on the permeability of concrete, moisture content prior to freezing (no deicing salts are used) and concrete exposed to deicing, brackish water or sea water. ACI 318 (2002) classifies the five exposure zones as shown in Fig. 2-2 based on the temporal conditions (ACI 362.1R, 1997);

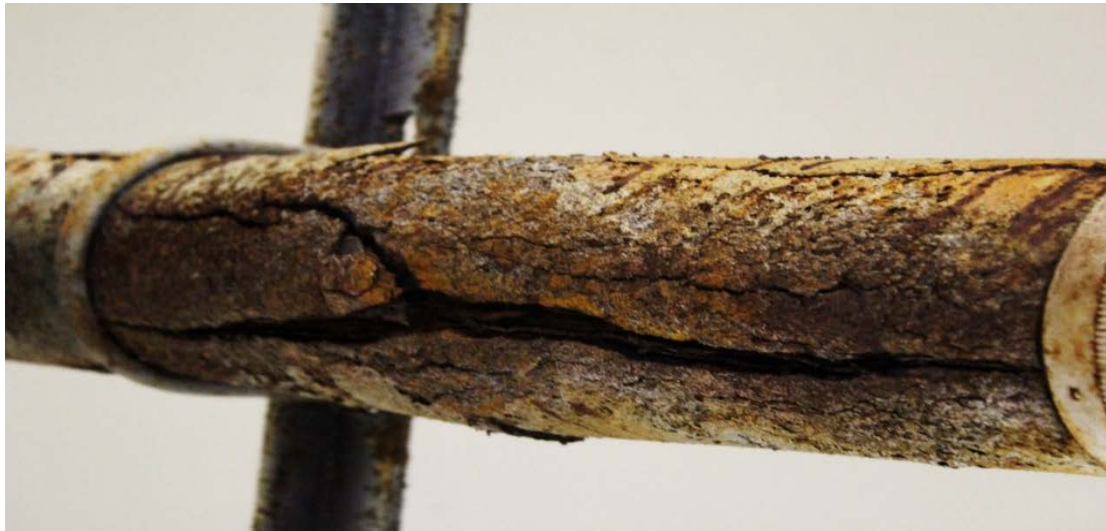
Uniform corrosion usually takes place with the help of chemical agents, such as acids, causing a direct chemical attack on the structure, as shown in Fig. 2-4. From observations, this could be identified as a dulling of the surface of the metal embedded within the concrete. This is also called as localized or general corrosion. This could become a major maintenance issue if proper care is not provided before corrosion becomes critical. The application of chemical-resistant protective coatings could be a possible solution for such corrosions (Farny and Kosmatka, 1997).

Figure 2-4: Uniform corrosion on the pipes in the Lincoln Parking Deck.

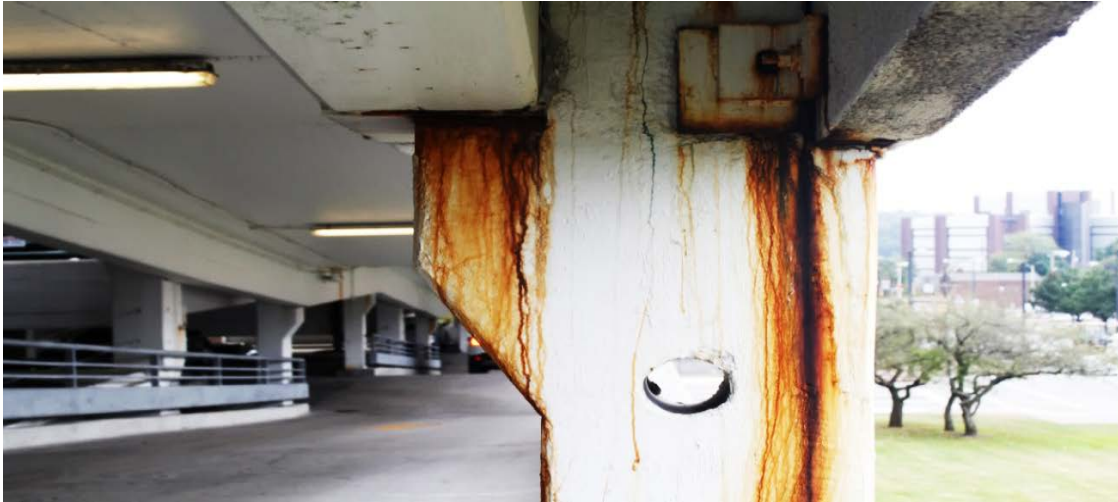
(PCA, 2002). Figure 2-5 shows corrosion formed due to two dissimilar metals since the angles were made of ASTM A-36 steel and the bolts were made from carbon steel.

Figure 2-5: Dissimilar corrosion between deck metal plates and bolts in the Lincoln Parking Deck.

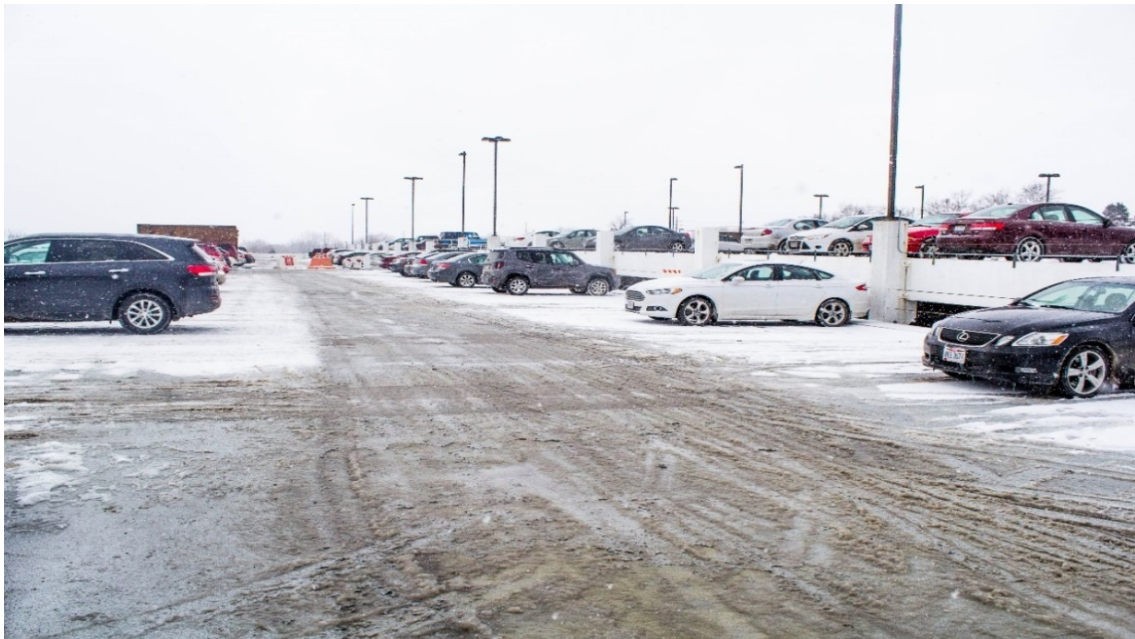
The chemical agents in deicing salts instigate the formation of corrosion in reinforced concrete structures. During winter, the rate of corrosion increases as the structure is exposed to deicing salt from the vehicles. Figure 3-1 represents the roof level of the parking deck filled with snow after a winter storm.

Figure 3-1: Roof of the Lincoln Parking Deck filled with slushy snow.

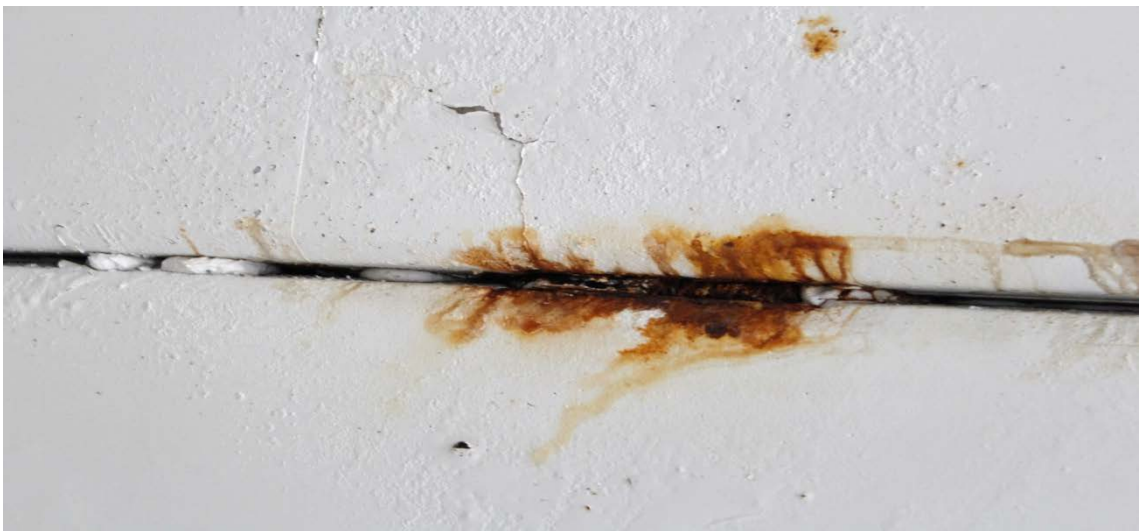
Deicing salt is considered as the main constituent for initiating chlorination. Chloride ions dissolved in water can pass through the cracks or pores by capillary action of concrete and reach the rebar. Corrosion caused due to chloride ingress at the joints of two double T-beams is shown in Fig. 3-2.

Figure 3-2: Corrosion due to chloride ingress at the joint of two double T-beams.

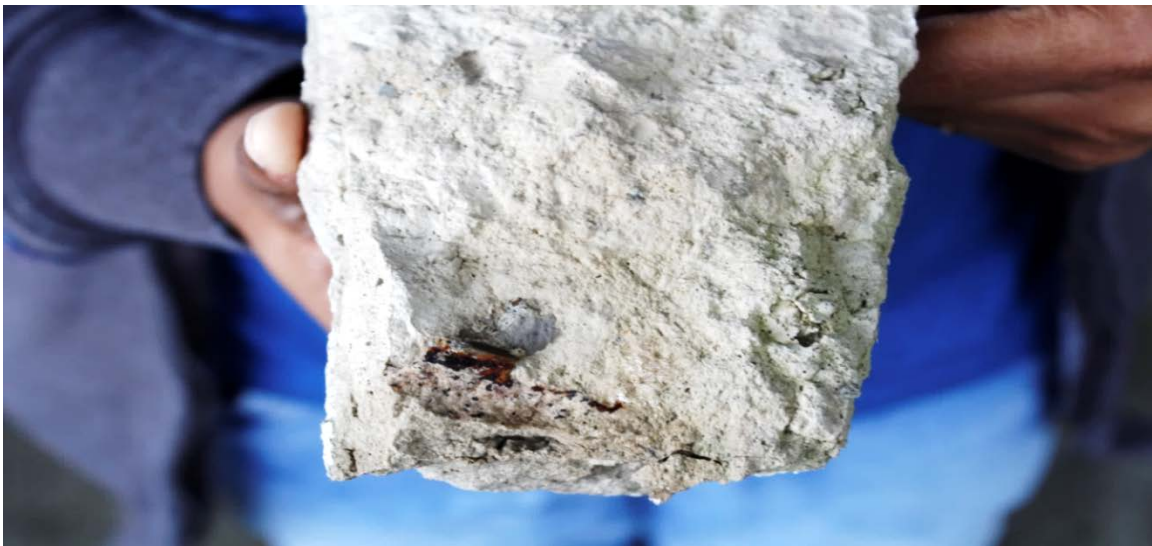
A chemical test is conducted to confirm the presence of carbonation on concrete surfaces. A small amount of Phenolphthalein when applied on the carbonated surface indicates the presence of carbonation. If the surface turns pink, it indicates the absence of carbonation. The presence of carbonation is confirmed if the surface turns colorless from pink (Bertolini et al, 2004). This experiment was performed on the parking deck to study the presence of corrosion due to carbonation. Figure 3-3 depicts the presence of carbonation on Level 1-D obtained from the exposed specimen which had fallen off the walls. This specimen was estimated to be no longer than a few weeks old. Figure 3-4 indicates the absence of carbonation on the unexposed surface of the specimen obtained from the same location.

Figure 3-3: Presence of carbonation detected as the concrete turns colorless.

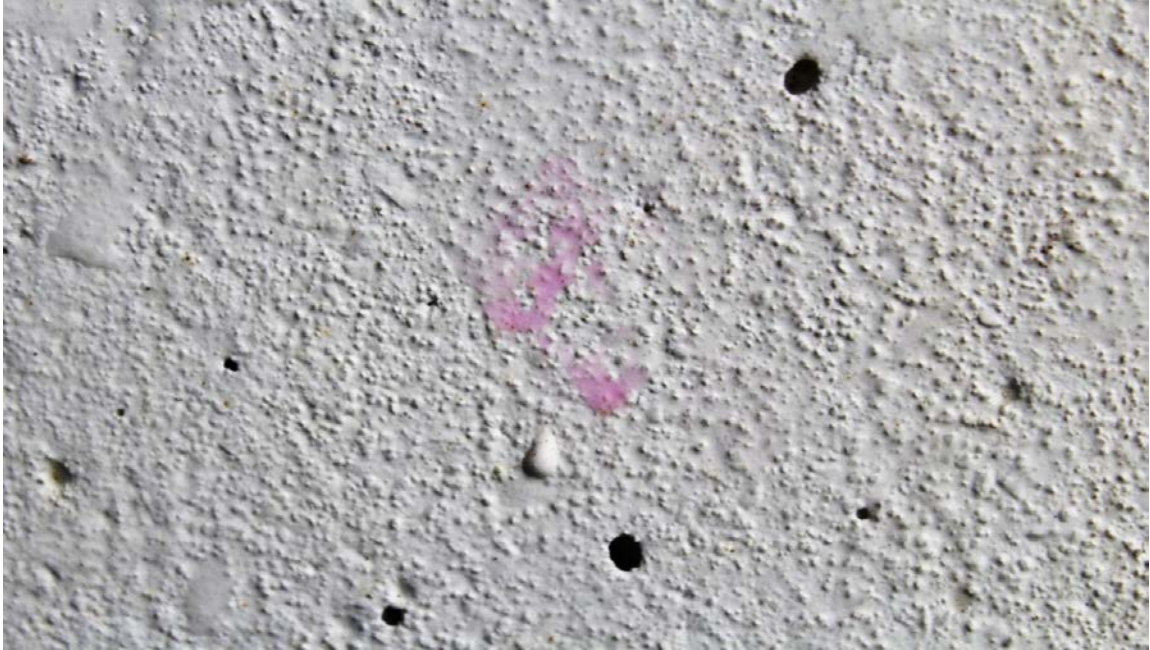
Figure 3-4: Absence of carbonation indicated as the surface becomes pink.

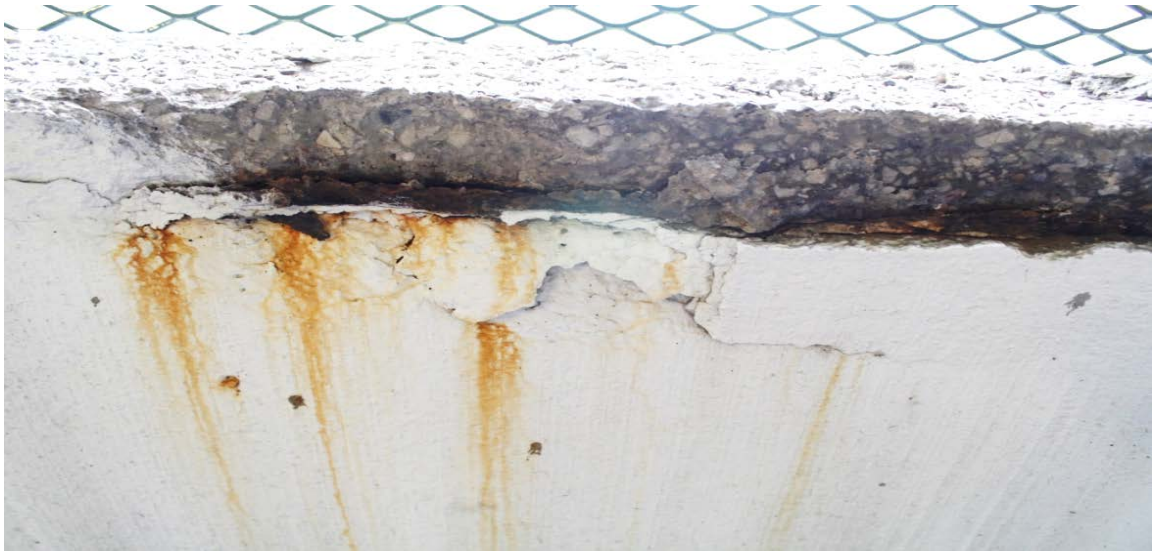
Figure 3-5 shows the formation of corrosion observed on the barrier walls in Level 1-D. Table 3-1 indicates the depth of concrete clear cover provided in the structure according to the details obtained from the structural drawings.

Figure 3-5: Corrosion observed on the barrier wall in Level 1-D.

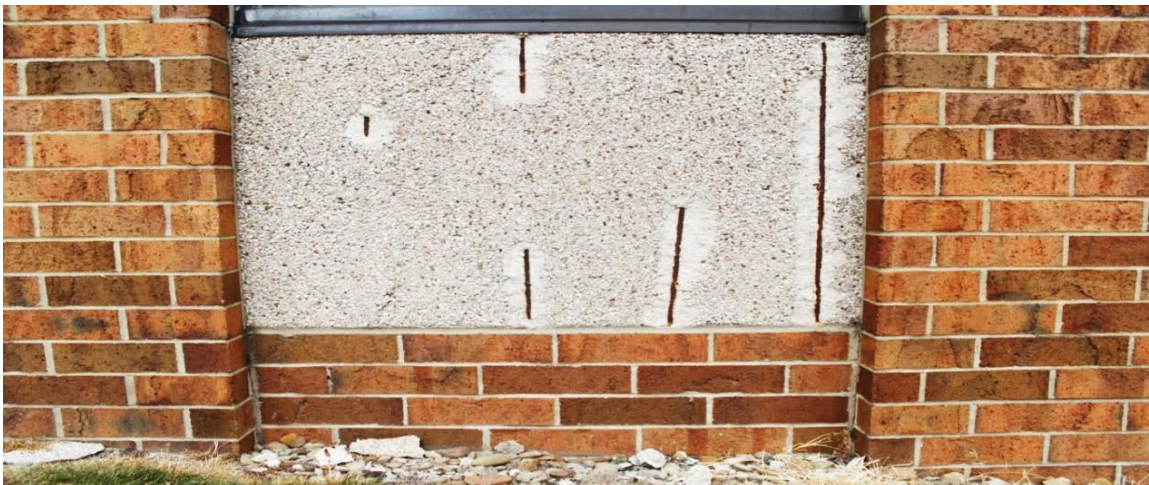
Figure 3-6 represents the image of the exposed steel reinforcements on the walls of the deck with an average clear cover of about 0.6 in. Adequate clear cover should be provided as carbonation or chloride ingress reduces the strength of concrete and reaches the reinforcement bars causing corrosion (Glass et al., 1991).

Figure 3-6: Inadequate concrete cover seen on the outside of the exterior walls.

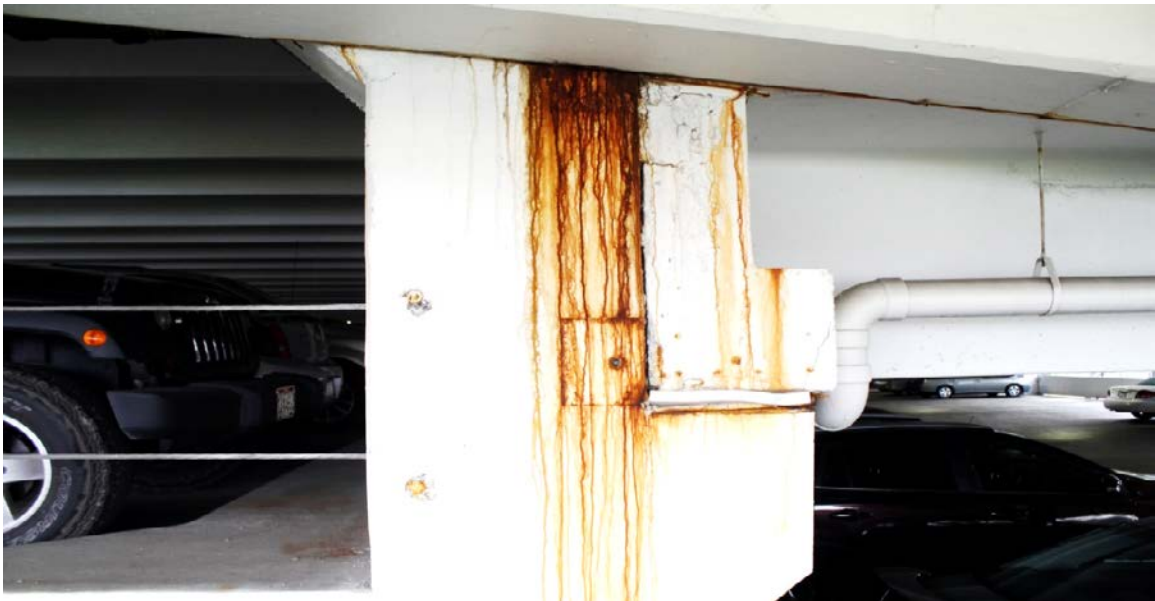
This is one amongst the most ignored category when it comes to the construction of parking decks. Routine maintenance might give early indications on the issues caused due to water leakage. Figure 3-7 shows rust stains on the columns because of water leakage. Neglecting this issue would result in necessary repairs in the future.

Figure 3-7: Corrosion stains caused due to water leakage.

Three major signs of a water leakage in a concrete structure are rust stains on the walls, efflorescence and metal rusting from parts that are not covered (Western Specialty Contractors, 2015).

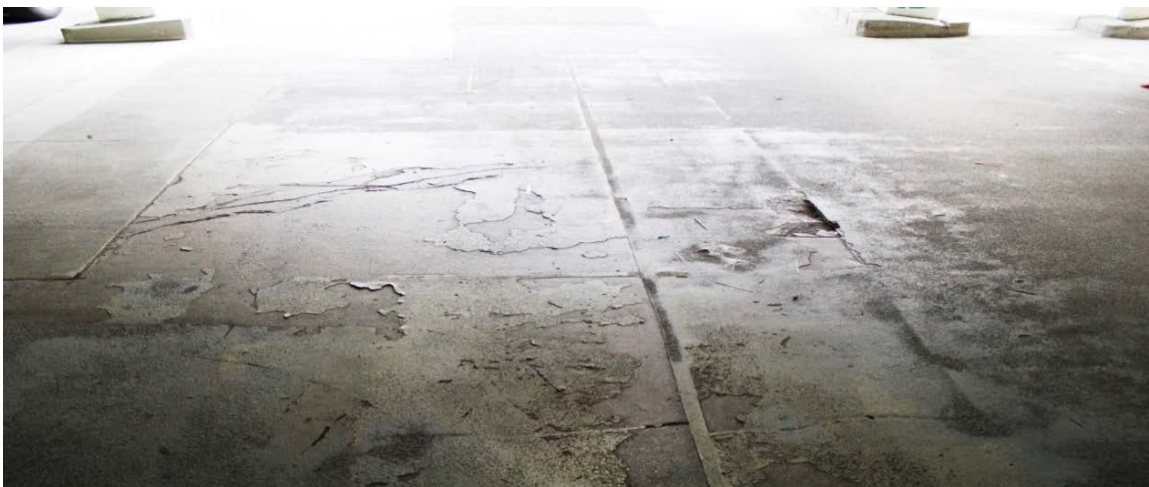
Upon inspection, the amount of vehicular traffic on the parking deck has caused considerable amount of wear to the structure. During winter, the abrasive nature of the tire chains and snow studded tires has resulted in the loss of concrete from the surface. Figure 3-8 shows the surface of the deck which has undergone wear because of vehicular movements.

Figure 3-8: Wear and tear caused from tires of the vehicles.

When the metals present on studded snow tires come in contact with the surface it leads to flailing or scuffing. The compressive strength of concrete is mostly sufficient to resist abrasion but also highly dependent on the aggregate abrasion properties. Higher the compressive strength, higher is the abrasion resistance of the concrete (PCA, 2002).

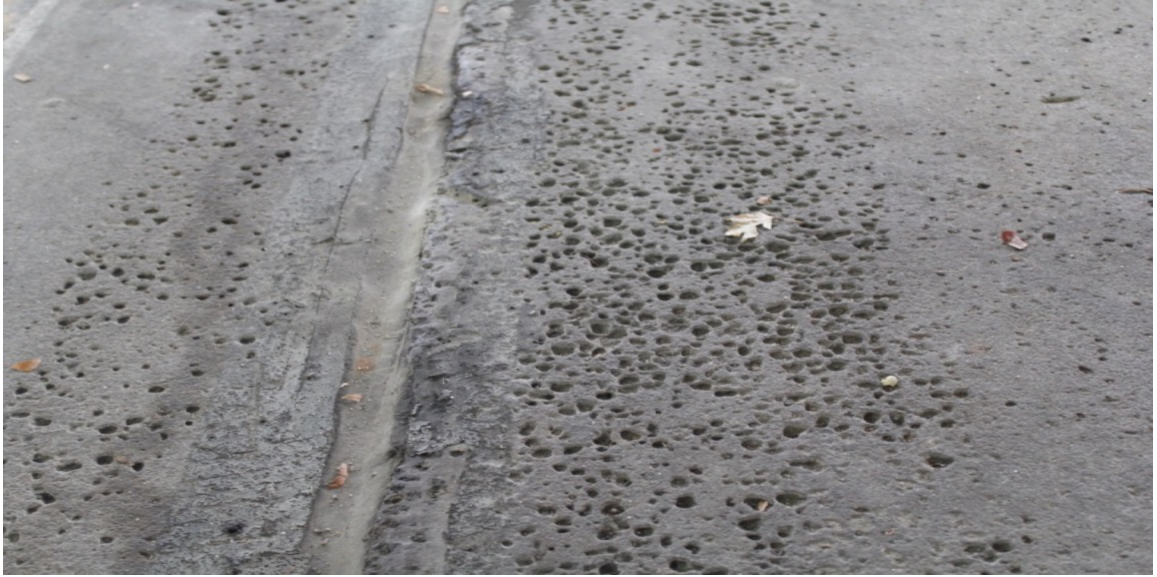
Surface defects occur due to poor materials and improper construction practices. The most commonly found defects on the surface of the structures are formed due to the entrapment of air bubbles present within the concrete, known as surface air voids or bug holes. Low workability, excessive fine aggregate content, uncontrolled use of form releasing agent or use of vibrators with high amplitude could also be responsible for the formation of surface defects. The main reason for air voids is lack of consolidation. The typical width of a bug hole ranges between 15mm and 25 mm (PCA, 2002). In Fig. 3-9, the minimum width of a bug hole was found to be about 2mm and the maximum was around 26mm.

Figure 3-9: Bug holes found on the slabs.

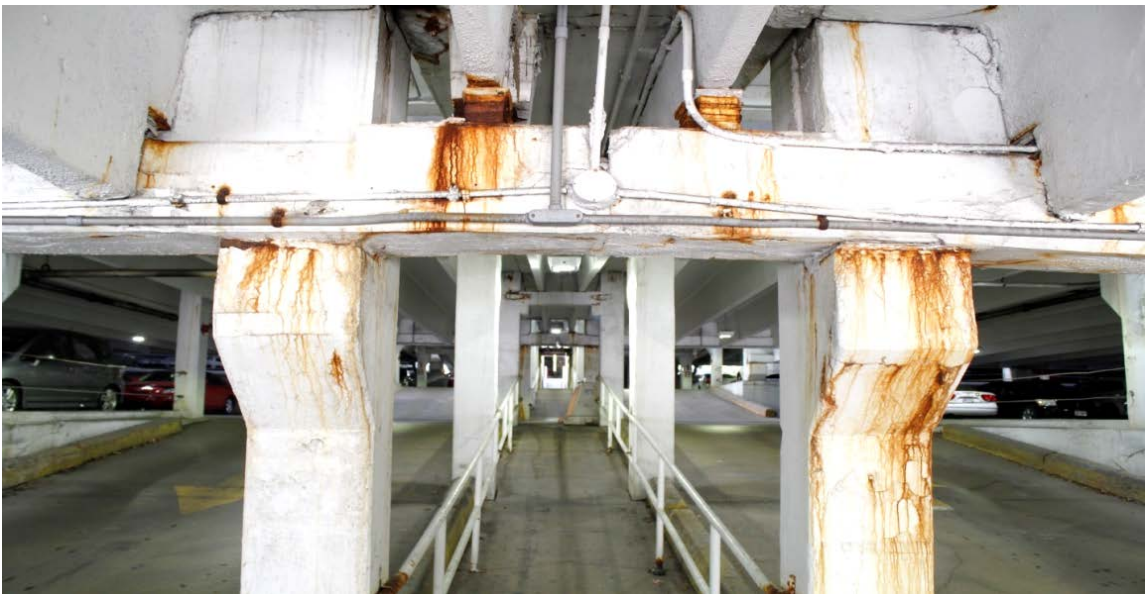
This step was important in documenting the areas of corrosion on the structure. A series of photographs were taken to record the path of corrosion at various locations. These photographs were used to conduct a detailed study into the types of corrosion mentioned in Section 2.4. The bright brownish colored stains on the columns (as seen in Fig. 4-1) and exposed reinforcement bars due to lack of concrete clear cover were a few amongst the many identified corrosion spots during the visual investigation.

Figure 4-1: Corrosion stains on the columns at Lincoln Parking Deck.

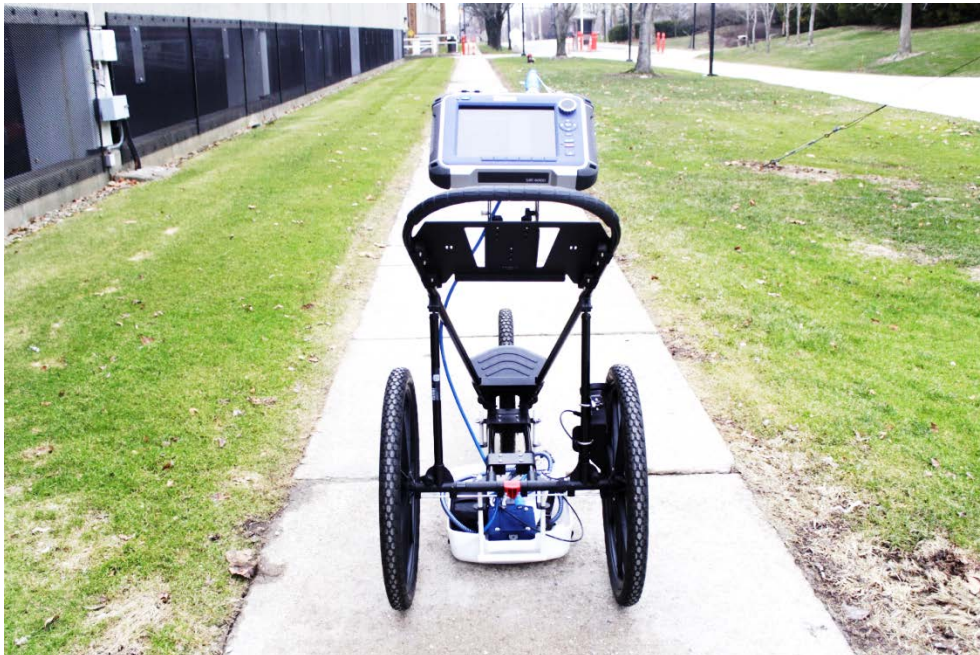
Ground Penetrating RADAR (Radio Detection And Ranging) is one of the latest available methods to detect corrosion in embedded reinforcing steel, mainly delamination. GPR utilizes Ultra-Wide Band (UWB) energy, which provides a wide range of frequencies. The GPR has low power emissions compared to other electromagnetic devices, typically about 1% of the energy emitted from a cellphone. A typical GPR is shown in Fig. 4-2. The GPR functions by propagating a wide range of electromagnetic frequencies through the depth of the specimen for both metallic (steel) and non-metallic components (pipes) (SIR 4000 Manual, 2016).

Figure 4-2: A perspective view of the GPR SIR 4000.

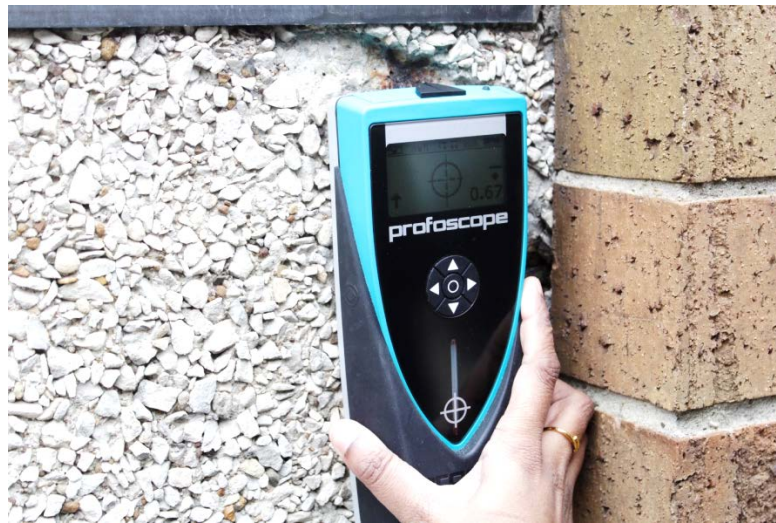
technology. The electric current present within the rebar is detected by the Profoscope via eddy currents induced by a magnetic field in the opposite direction of the current (Proceq, 2009). The change in voltage is correlated to rebar size and the strength of the current is correlated to cover depth. The Profoscope was also used to determine the depth of concrete clear cover and reinforcements in several areas. The instrument had to be calibrated before the experiment. This was done using the knob on the upper side of the instrument. Figure 4-3 depicts the Profoscope being used to determine the depth of concrete clear cover on the exterior walls of the parking deck.

Figure 4-3: The Profoscope being used to determine the depth of concrete clear cover on the wall.

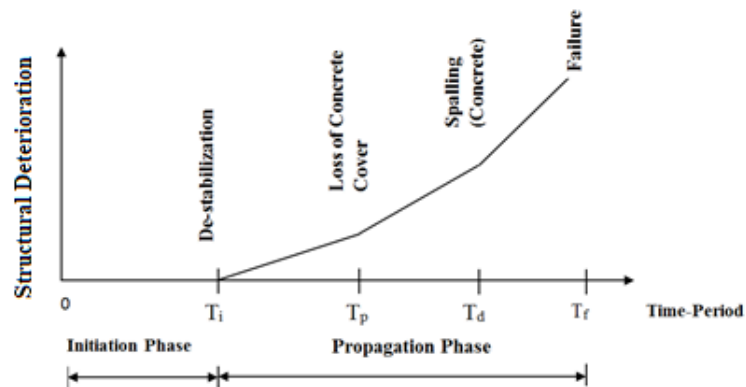
The second phase is the propagation phase. The propagation phase is typically divided into three sub categories. They are as follows: the approximate time since the inception of corrosion ( $T_i$ ); the approximate time for visible crack formation, which is simply known as the propagation period ( $T_p$ ); and the approximate time for the cracks to expand, leading to further deterioration of concrete ( $T_d$ ); after which the structure fails. All these factors are combined to predict the functional service life ( $T_f$ ) of the reinforced concrete structure (Duracrete, 2000; Hájková et al., 2016; Hartt et al., 2004). These phases are explained in more detail in the next Section 4.2.1 onwards.

Figure 4-4: Graphical representation of the deterioration phases (Duracrete, 2000).

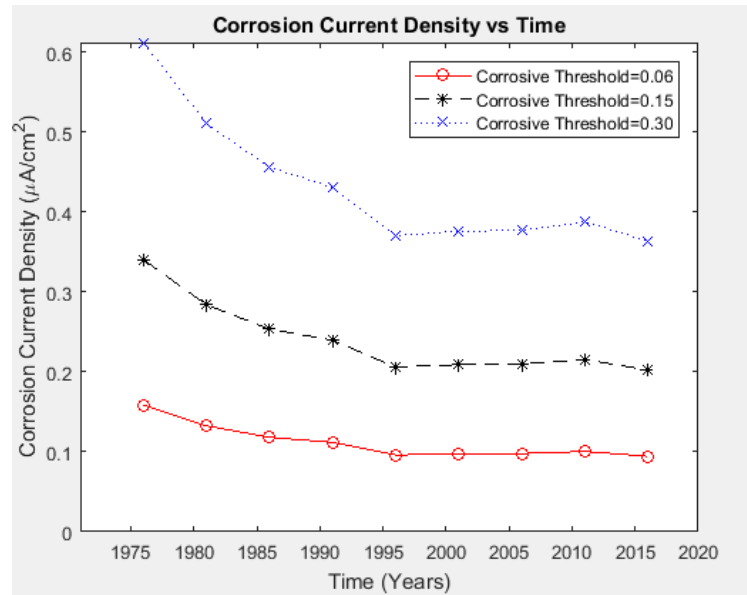
The general trend in Fig. 4-5 indicates that as the maximum chloride ion content increase, corrosion current density increases showing the initiation of chloride-induced corrosion. Based on the assumed values, the highest corrosion current density was seen in 2011 as the average temperature in 2011 was recorded as 75° F (297.039 K) when compared to the other years.

Figure 4-5: Corrosion current density ( $\mu\text{A}/\text{cm}^2$ ) vs. time (years).

The results in Fig. 4-5 indicate the rate of current density which was initially higher, slowly started decreasing after 1975, after which the change in corrosion current density stabilized. This is due to the steel remaining in its passive state as de-passivation of the reinforcement had not taken place yet.

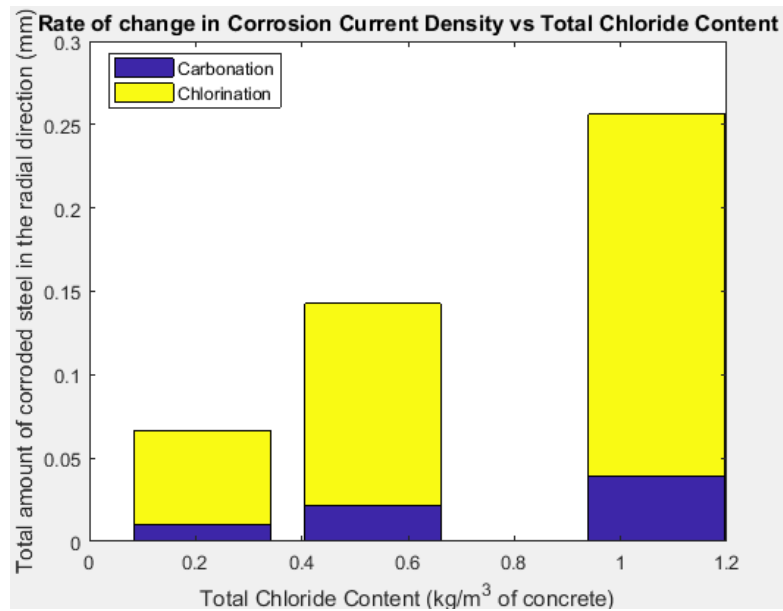
Figure 4-6: Rate of change in corrosion current density ( $\mu\text{A}/\text{year}$ ) vs. total chloride content ( $\text{kg}/\text{m}^3$  of concrete).

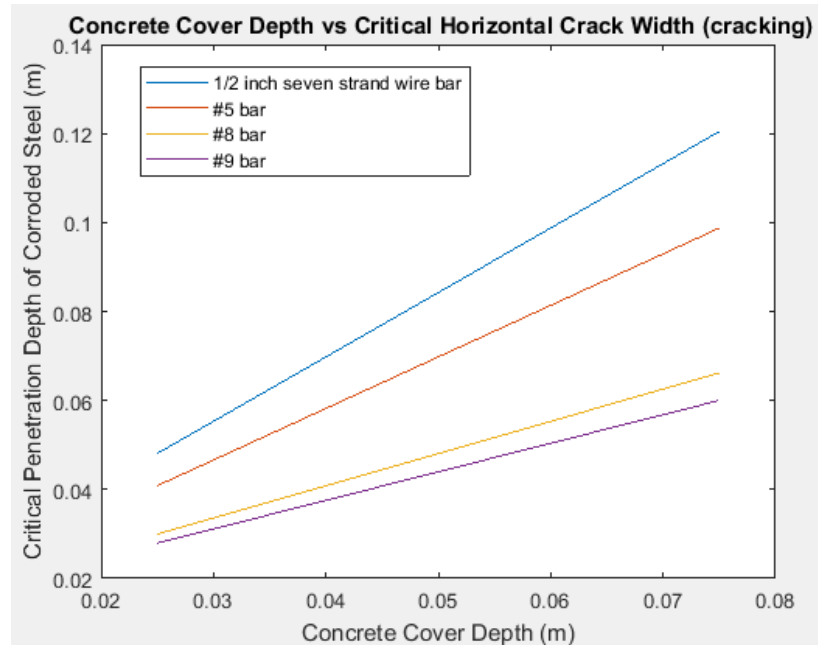
Based on the results obtained from the corrosion model shown in Fig. 4-7, it was observed that the critical horizontal crack width of corroded steel in concrete increases with the increase in the depth of concrete clear cover. Although, the purpose of concrete clear cover demands it to stop the ingress of chlorides into the concrete, it often contradicts this statement. As the thickness of the concrete clear cover increases, occurrence of cracks on the surface is more likely (Berkowskia et al., 2013).

Figure 4-7: Concrete cover depth (m) vs. critical horizontal crack width in the clear cover (cracking),  $x_{corr,cr}$  (m).

It was also observed that the values of critical horizontal crack width for ½ in. diameter seven-wire strand are higher when compared to other reinforcements. Thus, for ½ in. diameter seven-wire strand, the critical horizontal crack width of corroded steel in concrete ( $x_{corr,cr}$ ) is obtained as 1.89 in. (0.0481 m) with a concrete clear cover depth of 1 in. (0.0254 m) and 4.7 in. (0.1205 m) with a concrete clear cover depth of 3 in. (0.0762 m). The results indicate a 59.78% increase in the depth of corrosion in steel for cracking in the horizontal direction as the concrete clear cover increases from 1 in. to 3 in.

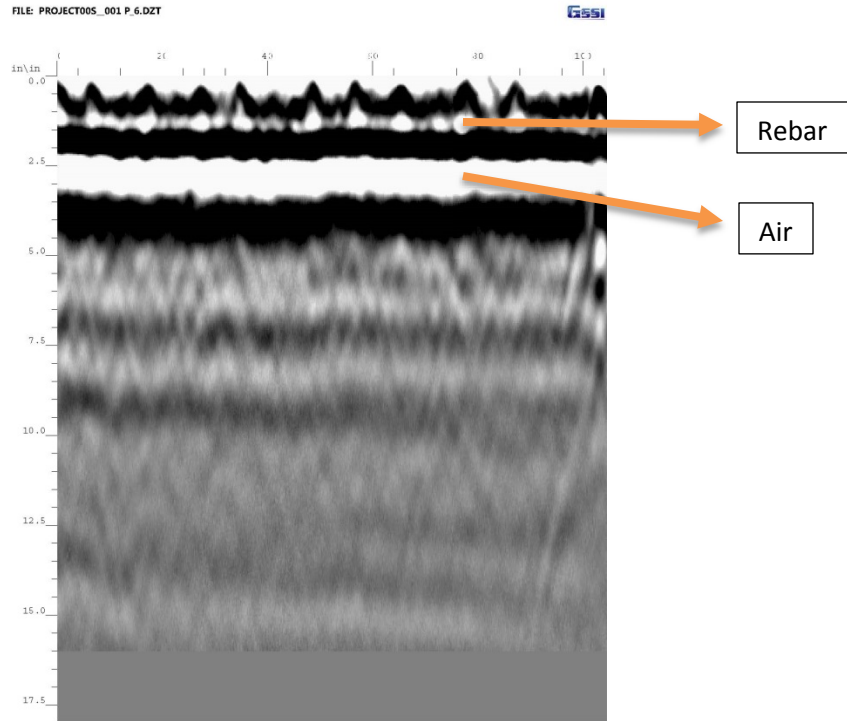
Figure 4-11 shows the scanned portion of the slab from Level 4A with the diameter of the reinforcement being measured 0.5 in. In Fig. 4-11, the depth of the reinforcement is seen at 1.5 in. from the top. The white area indicates the presence of air and the sharp black lines are the reflections obtained from the reinforcements.

Figure 4-11: Section of the slab from Level 4A in Lincoln Parking Deck from RADAN.
