LOW-DENSITY CONCRETE IMPACT ATTENUATORS
(Freeze-Thaw Protection and Installation Techniques)

Submitted in Partial Fulfillment of the Requirements
for the Degree of
Masters of Science
in the
Civil Engineering
Program

YOUNGSTOWN STATE UNIVERSITY

March, 1977

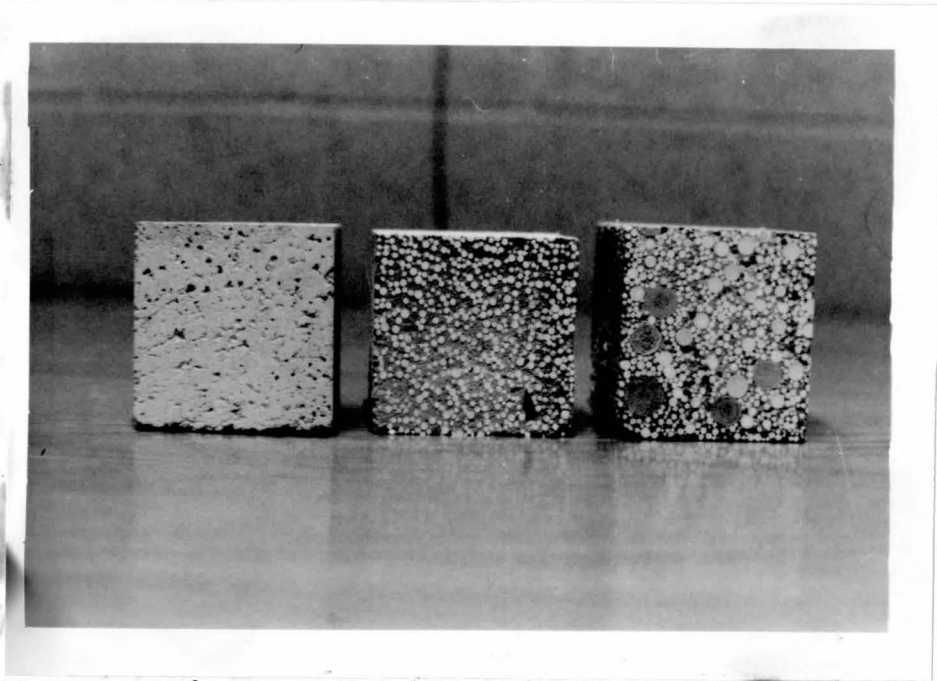
FIGURE 2.1
PERLITE, DYCON, D4

Figure 2.1 shows a cross section of the three basic types of concrete: perlite, Dycon, and D4.

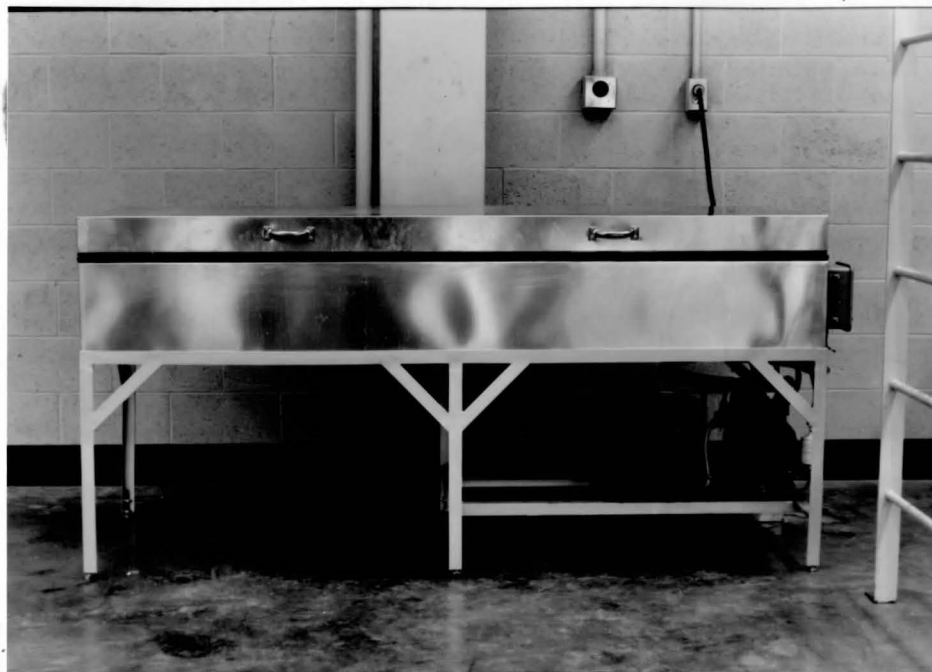
FIGURE 5.1
THE FREEZE-THAW APPARATUS

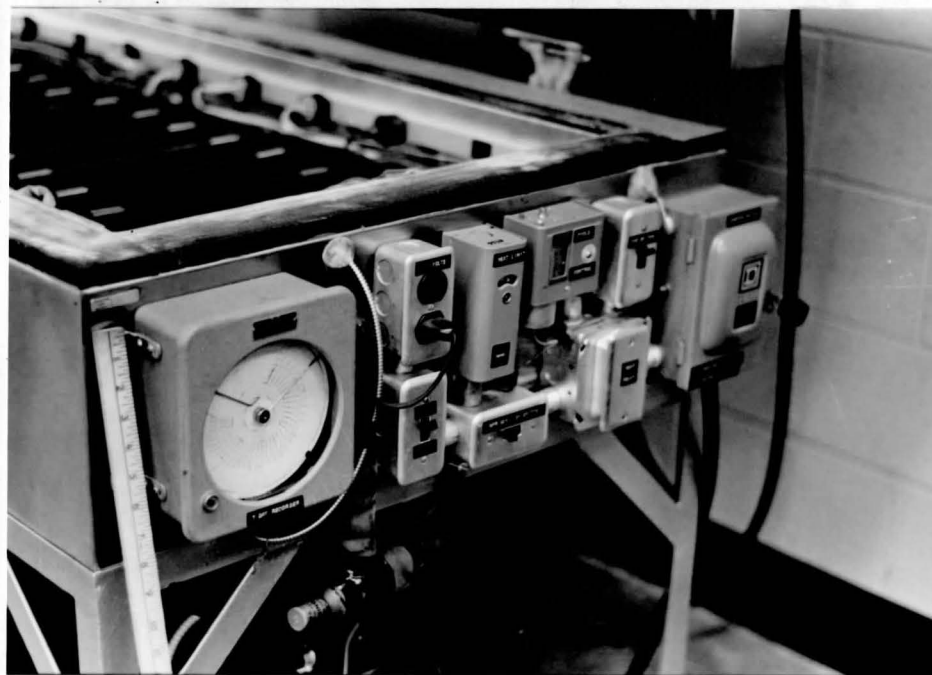
FIGURE 5.2
THE AUTOMATIC TEMPERATURE CONTROL SYSTEM
FOR THE FREEZE-THAW APPARATUS

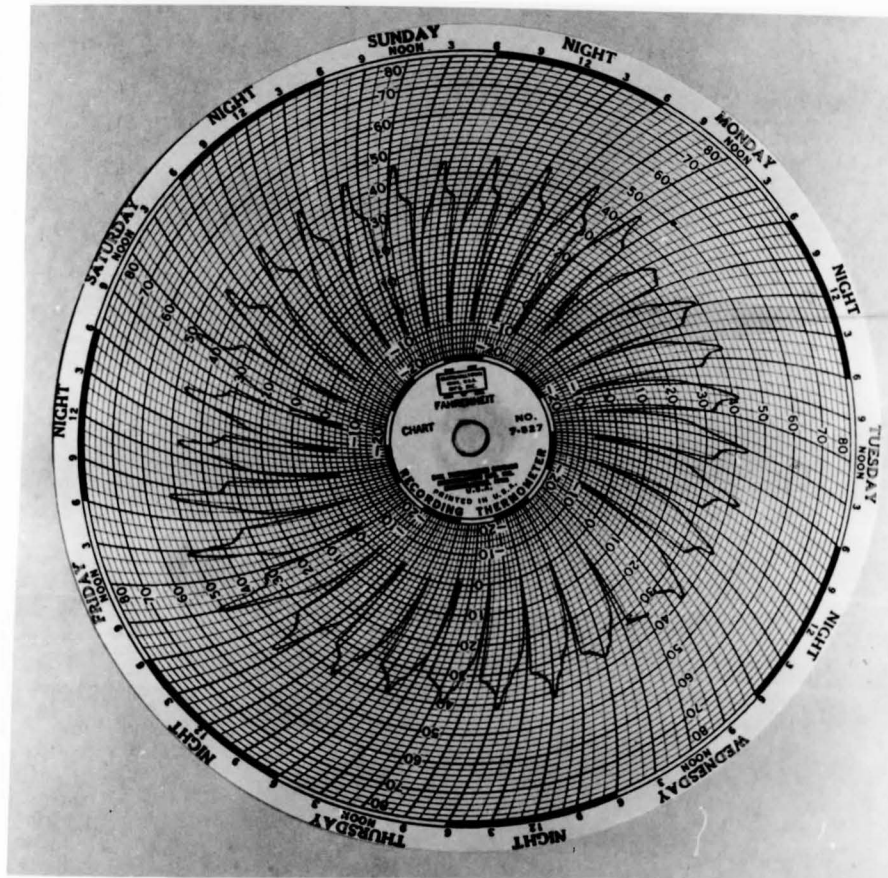
FIGURE 5.3
TYPICAL SEVEN DAY TEMPERATURE RECORD

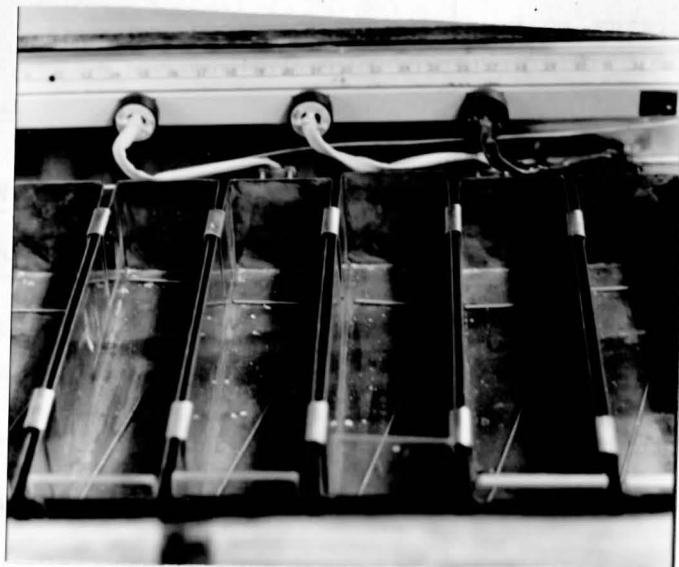
FIGURE 5.4
COPPER SPECIMEN CHAMBERS
IN THE FREEZE-THAW APPARATUS

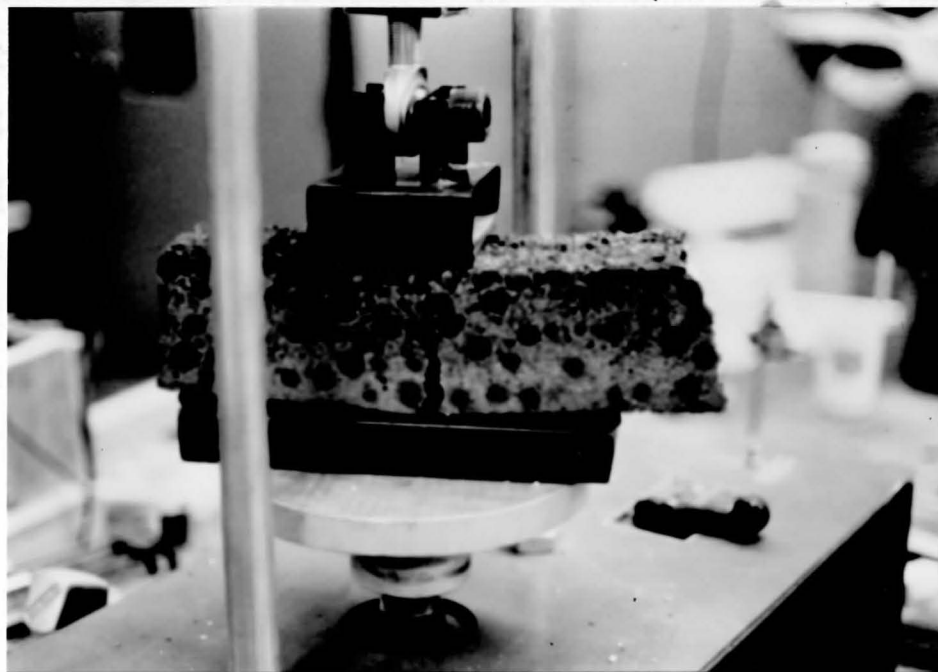
FIGURE 5.5
MODULUS OF RUPTURE APPARATUS
WITH SPECIMEN IN PLACE

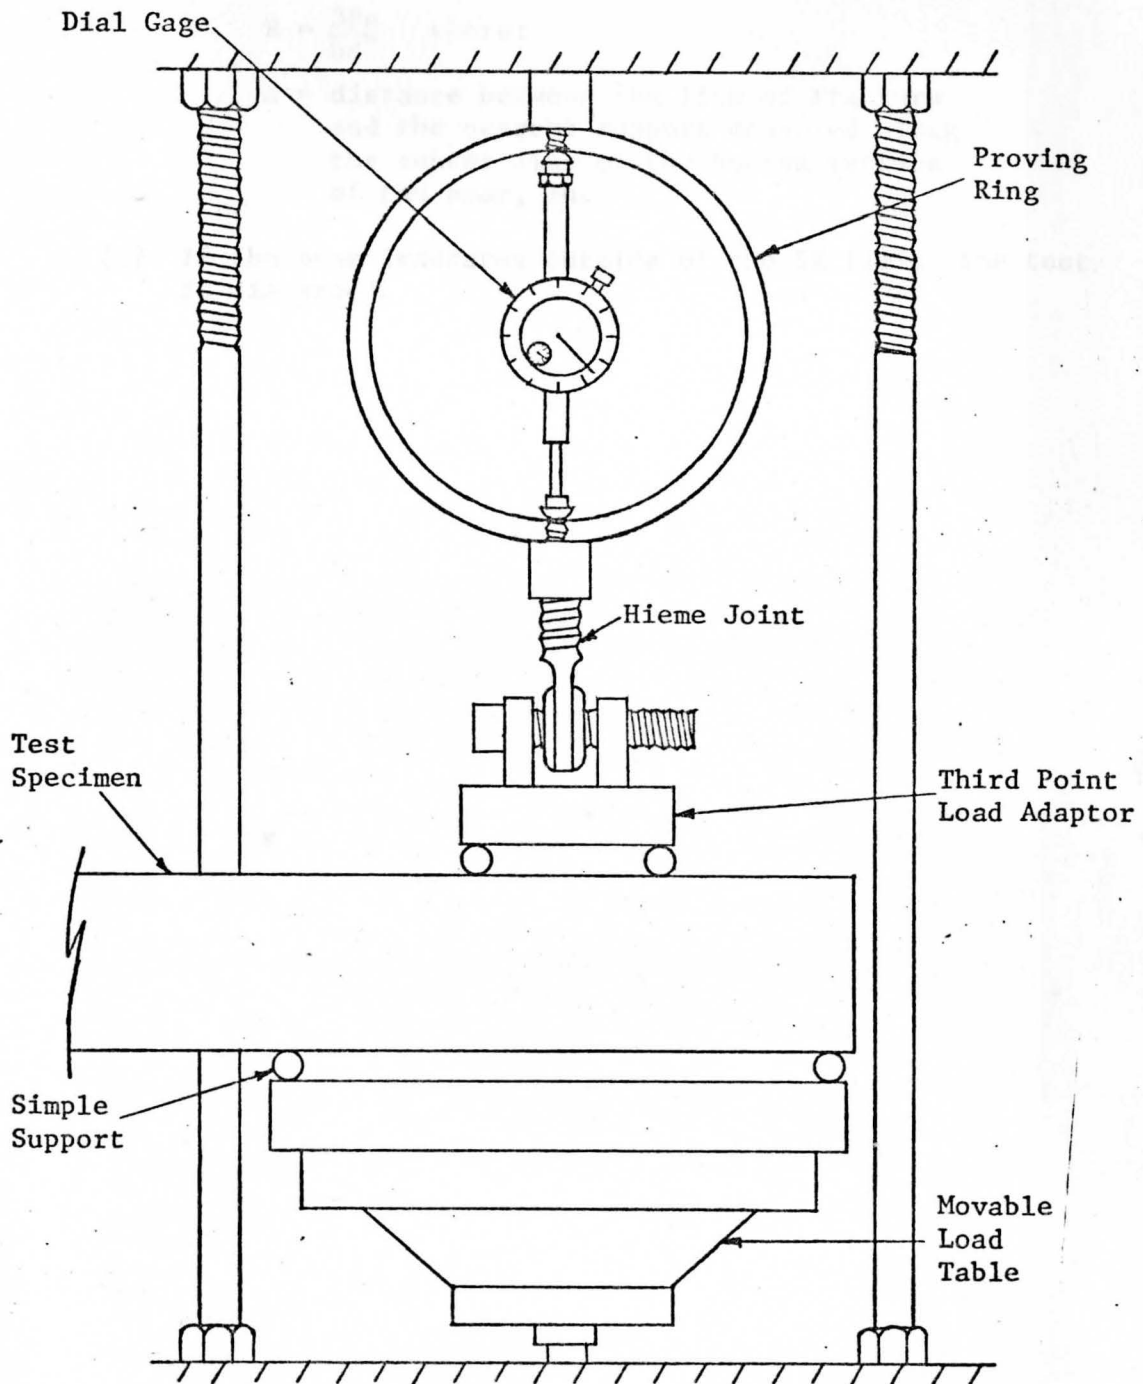
FIGURE 5.6
MODULUS OF RUPTURE APPARATUS

method. The use of this test procedure was thought, therefore, to yield erroneous results. It was decided, therefore, that the third-point modulus of rupture test (ASTM C78-64) would be used for determining the strength loss due to freeze-thaw cycling. Because of the size of the specimens to be tested (3" x 3" x 15") and the low flexural strength of low-density concrete, conventional universal testing machines were found to be far too insensitive. A special apparatus was, therefore, contrived. A Soiltest AP-170A Stability Compression Machine (see Figure 5.5) was utilized for this purpose. The machine was modified (in accordance with ASTM C78-64) by fabricating both support and applied load apparatus. Figure 5.6 is a diagrammatic view of this modified apparatus. The load was applied by slowly rotating a hand crank which in turn moved the specimen upward against the loading points. Applied load was determined from the deflection of the proving ring at the top of the apparatus. The load was applied until the concrete fractured. This rupture was noted by a severe drop in the applied load while the crank was still being rotated. According to ASTM C78-64, the modulus of rupture is calculated in the following manner:

- (a) If the fracture occurs within the middle third of the span length, i.e., between the two loading points, the modulus of rupture is calculated by:

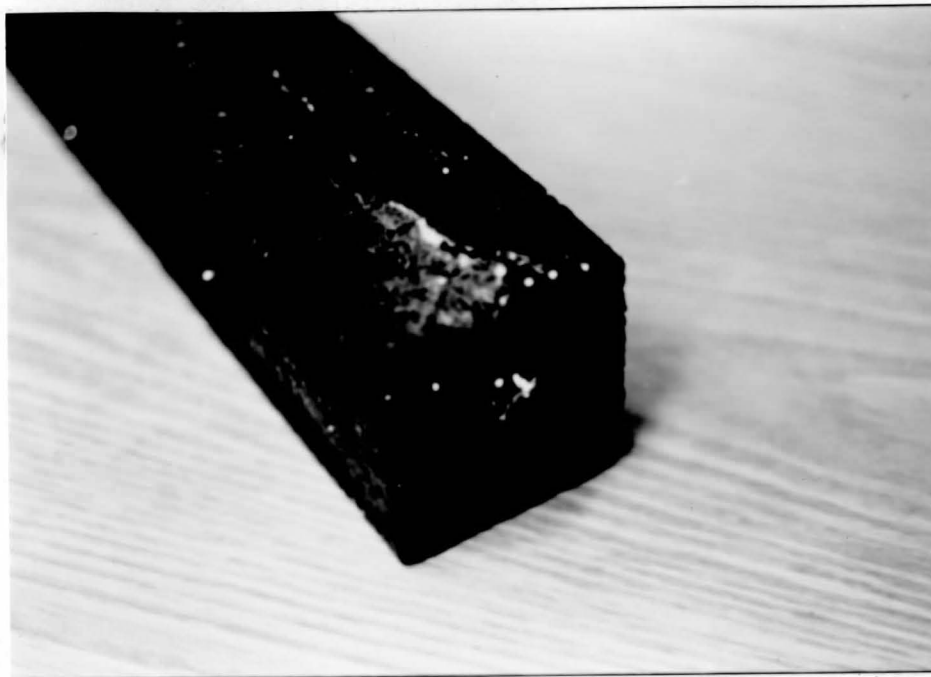
FIGURE 6.1
SPLITTING OF BITUMASTIC 300-M
ON P4 AFTER 100 CYCLES

of water around the crack and its subsequent freezing. Splitting of the coatings may also have been caused by thermal shock due to the accelerated freeze-thaw rate. A common household dish which has been in a freezer for a period of time will crack if held over a flame immediately after removal from the freezer. The rate at which the coated specimens were cycled may have been such so as to cause a similar sudden rupture in the brittle coating. Another possible cause of splitting may have been the build-up of ice in a particular area of the specimen. Intrusion of water through a pinhole or flaw in the coating creates high stresses in the coating upon freezing which in turn could have produced rupture. Figures 6.1 through 6.3 illustrate some of the severe splitting encountered during the testing.

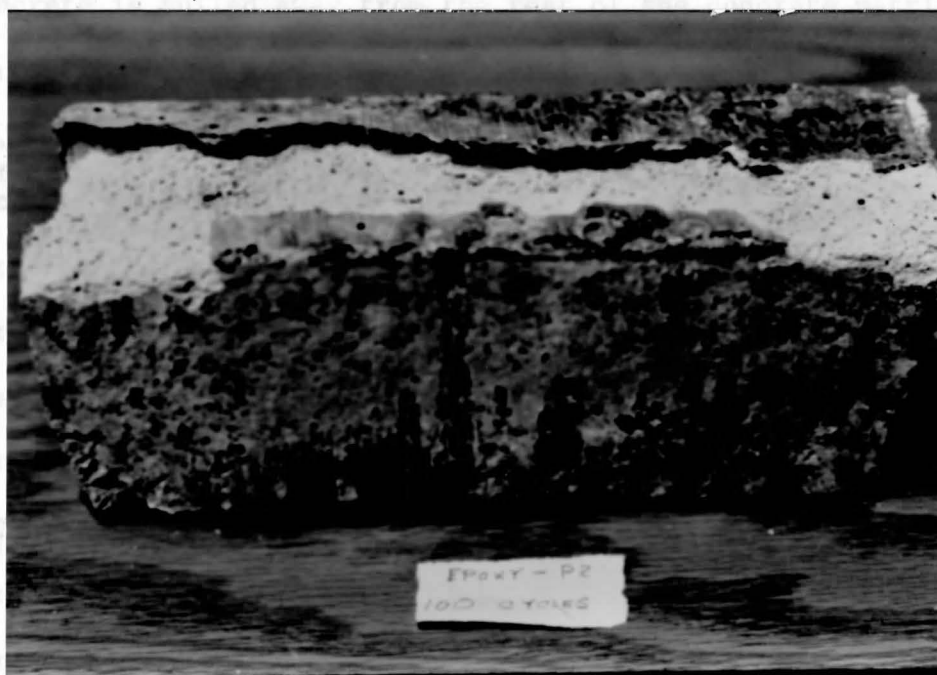
FIGURE 6.2
SPLITTING OF EPOXY RESIN 1391 ON P2
AFTER 100 CYCLES (A PORTION OF THE
COATING HAS BEEN REMOVED TO SHOW THE
DISINTEGRATION OF THE UNDERLYING CONCRETE)

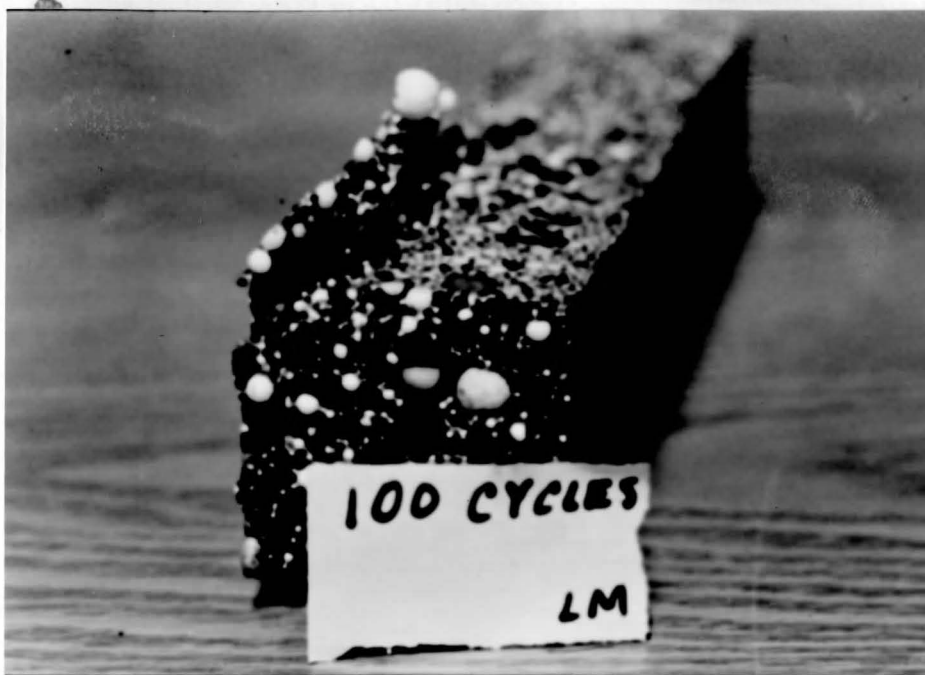
FIGURE 6.3
SPLITTING OF LO-MOD
ON D4 AFTER 100 CYCLES

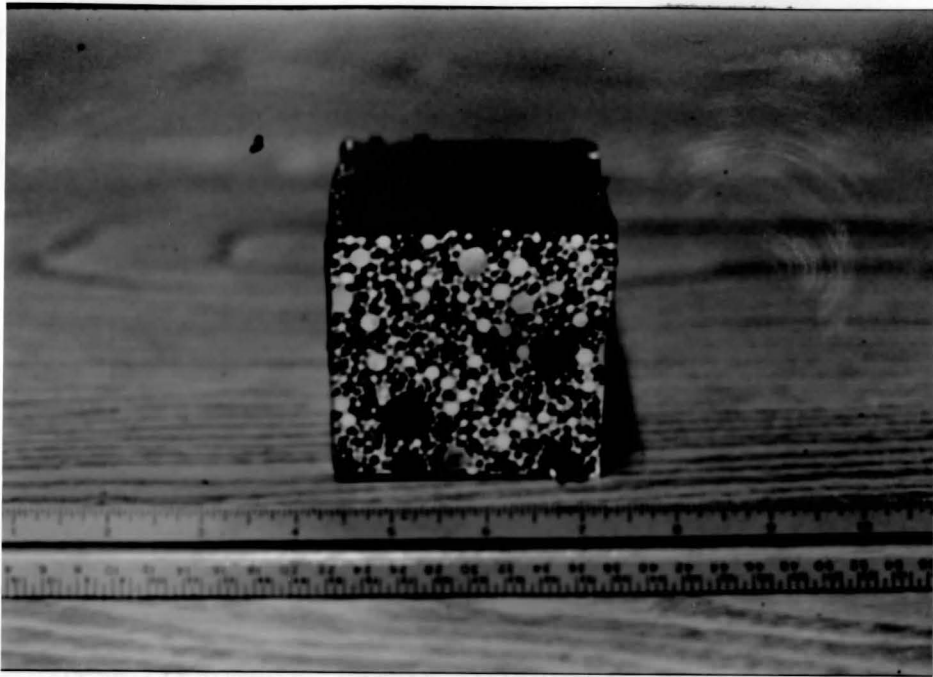
FIGURE 6.4
HEAVING OF AQUA-BASE ON D4

of concrete is pulled away from the rest of the concrete matrix. In either case, room is made for the accumulation of more water and hence, further deterioration. In the case of a strong, non-elastic coating underlied by a growing ice mass, the concrete gel structure is destroyed since only limited yielding of the coating is permitted. This deterioration is evidenced by a spongy structure below the coating rather than a noticeable bulge in the coating. Examples of heaving can be seen in Figures 6.4 and 6.5.

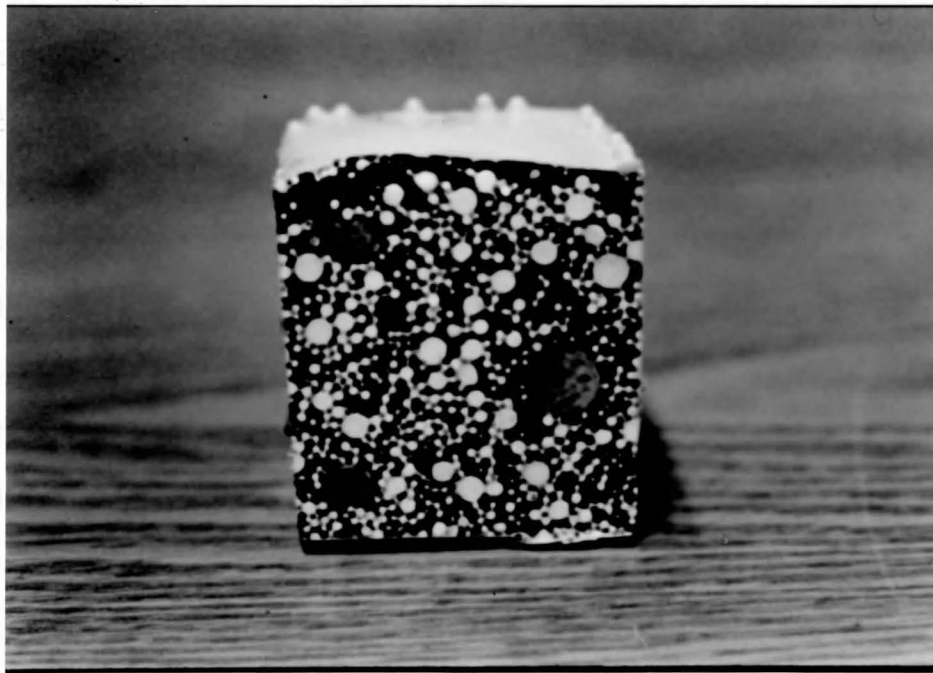
FIGURE 6.5
HEAVING OF AQUA-TOP ON D4

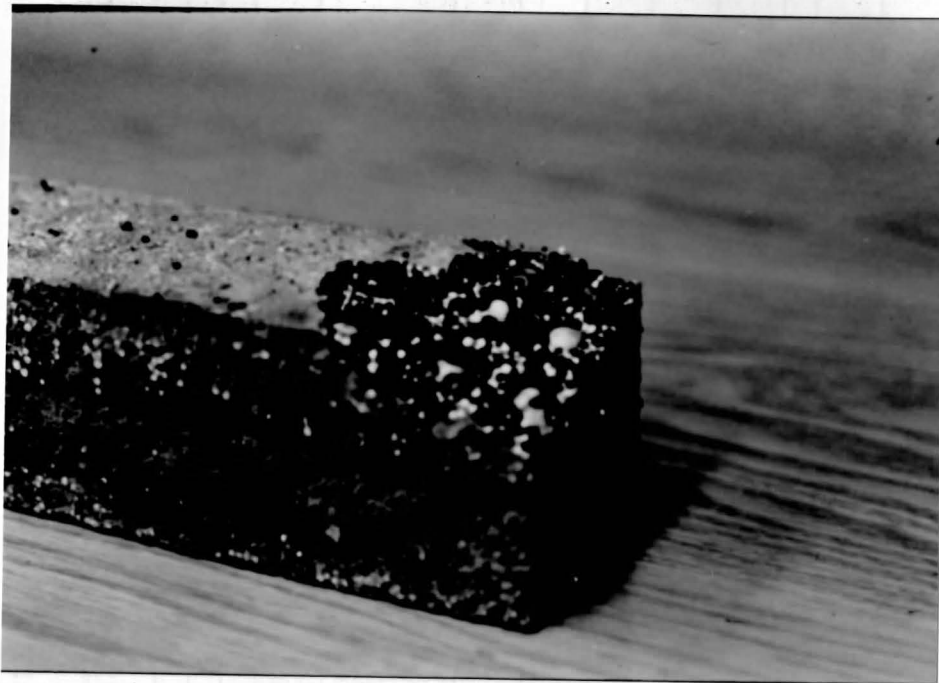
FIGURE 6.6
SPALLING OF LINSEED OIL ON D4

point at which the specimens began to spall completely, i.e., large layers of concrete separated from the specimen (see Figure 6.6). Water absorption was usually extremely high and sometimes exceeded that of uncoated specimens. This can be explained by the fact that these types of treatments do not prevent water from intruding into the concrete, but create a layer of dense treatment saturation which may, to a certain degree, trap the water within the specimen (see Figure 6.7).

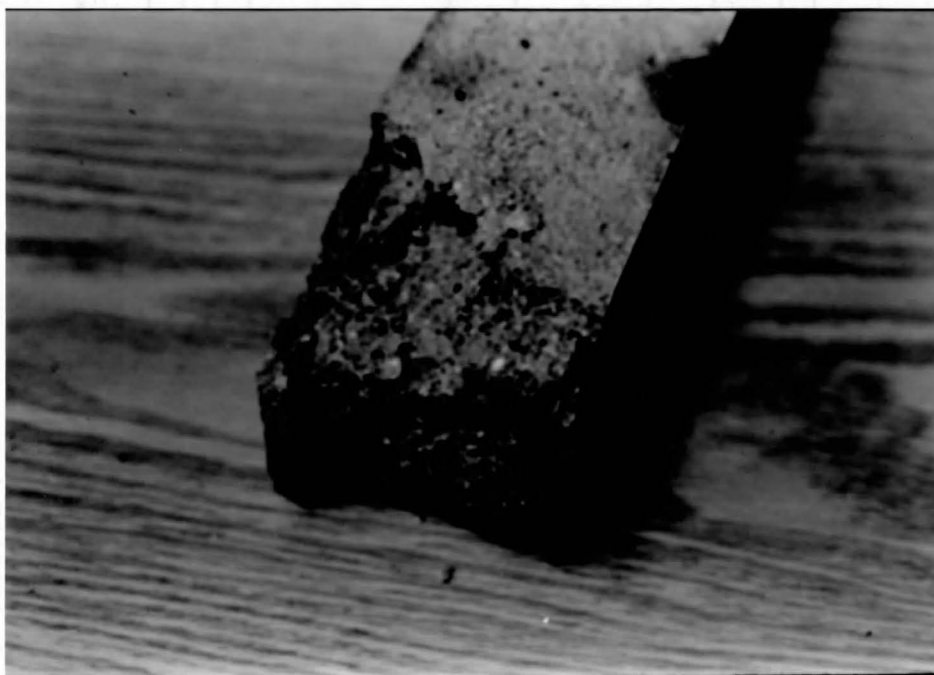
FIGURE 6.7
SPALLING OF LINSEED OIL ON P2
(NOTE LAYERED EFFECT)

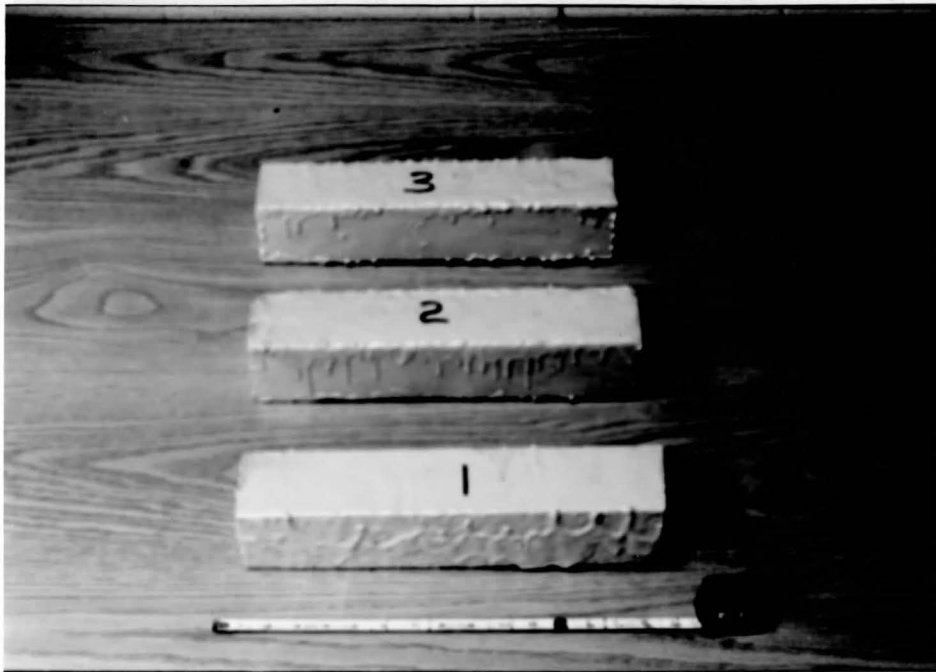
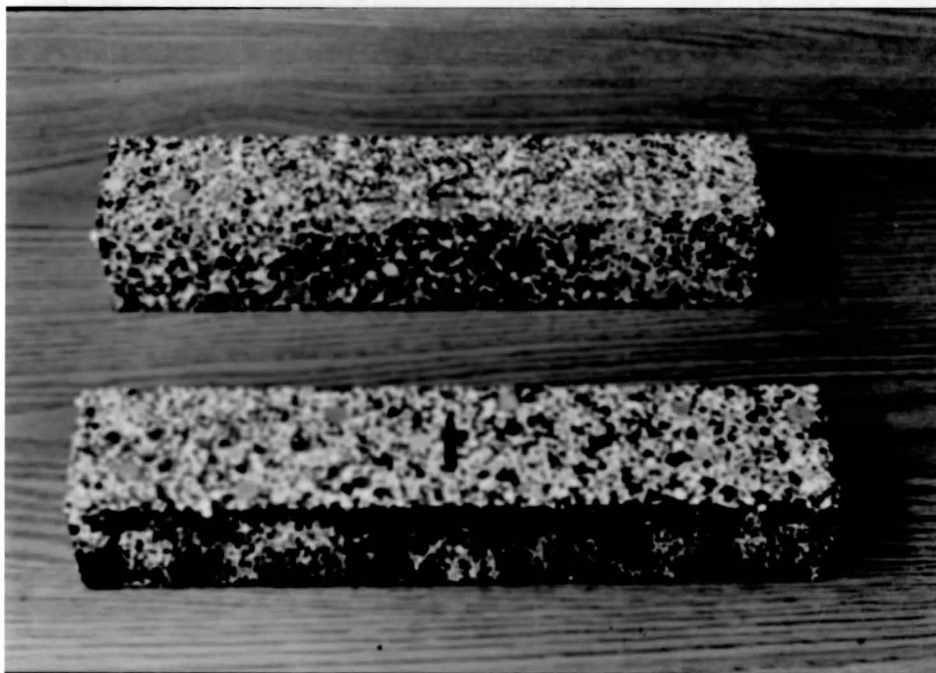
FIGURE 6.8
COMCOAT ON D4 (a) AND
UNCOATED D4 (b) AFTER 25 CYCLES

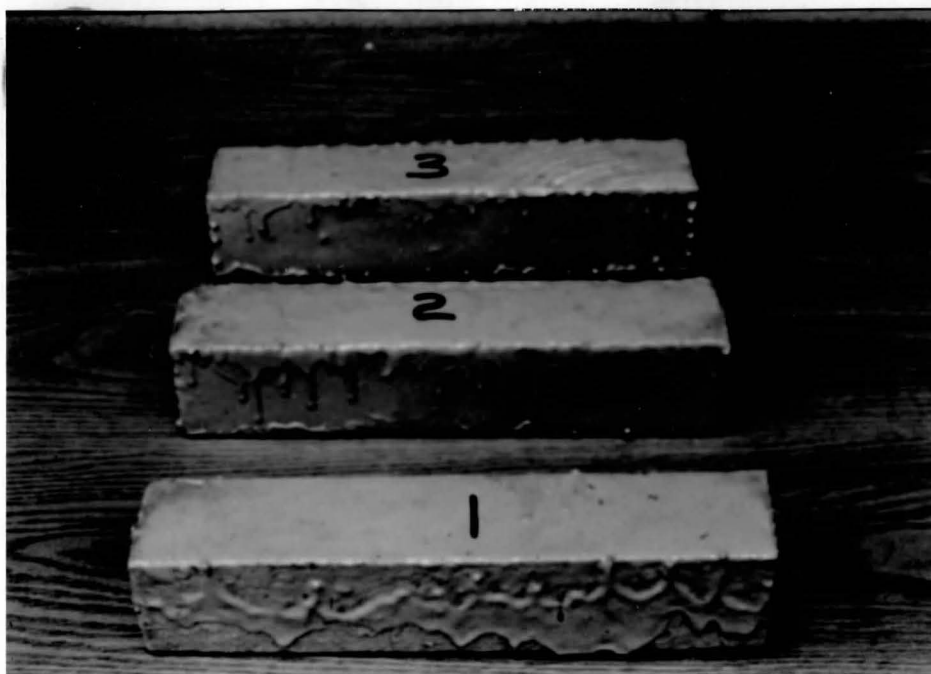
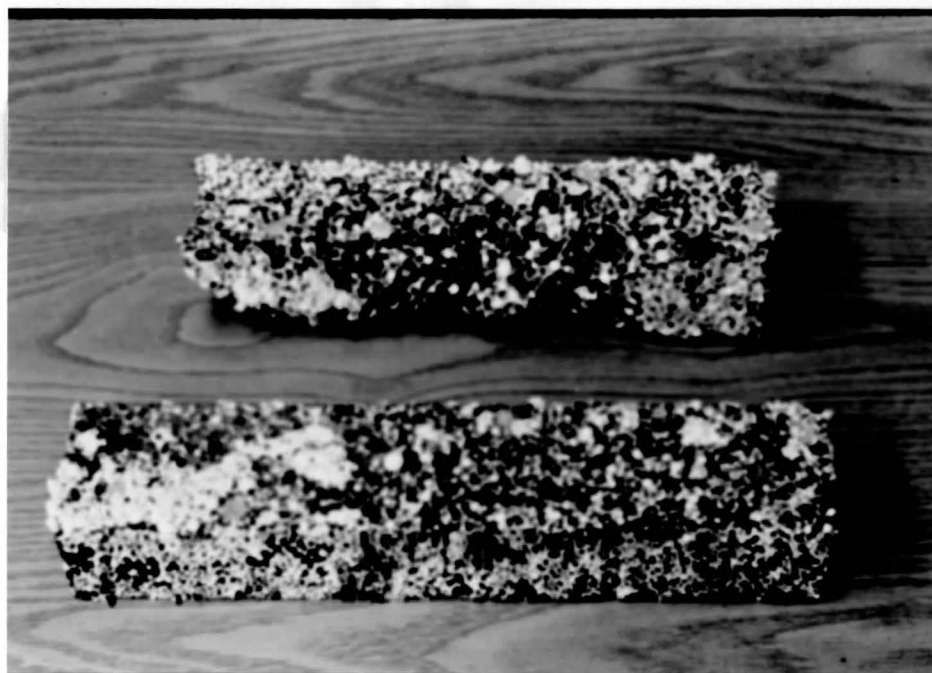
FIGURE 6.9
COMCOAT ON D4 (a) AND
UNCOATED D4 (b) AFTER 50 CYCLES

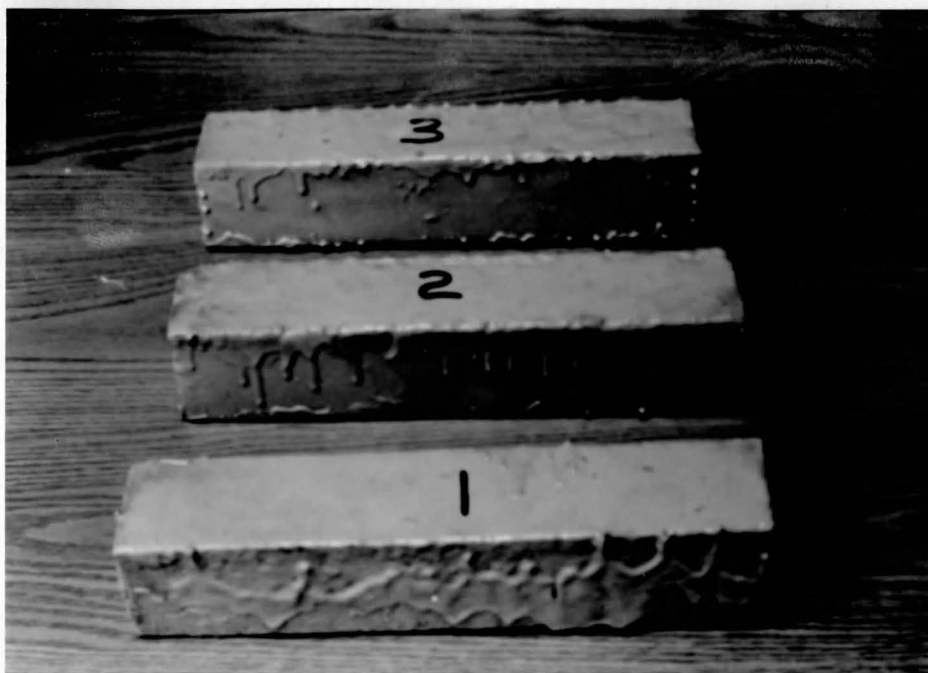
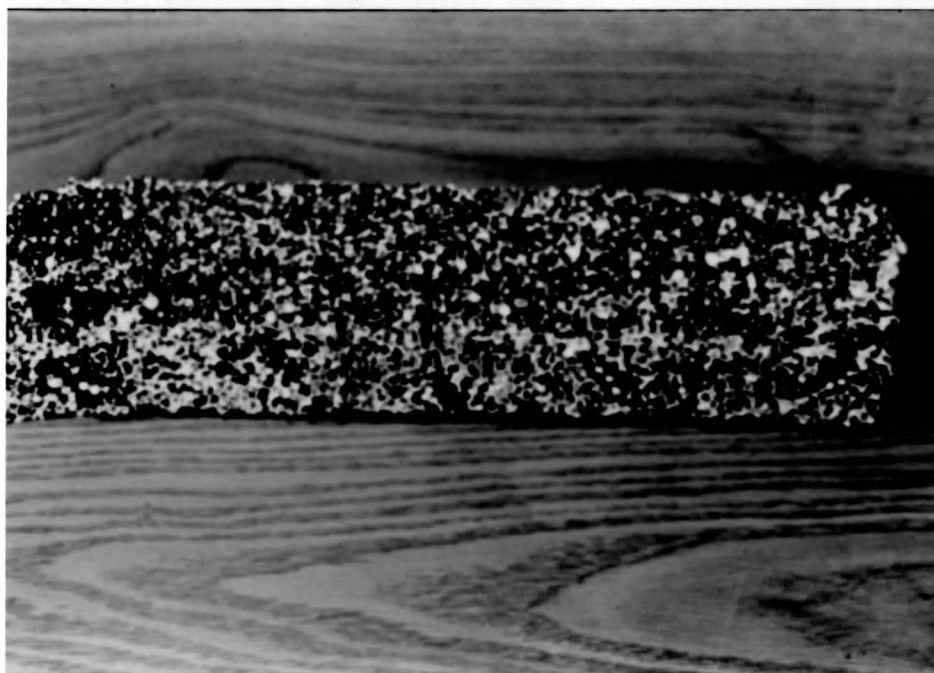
FIGURE 6.10
COMCOAT ON D4 (a) AND
UNCOATED D4 (b) AFTER 75 CYCLES

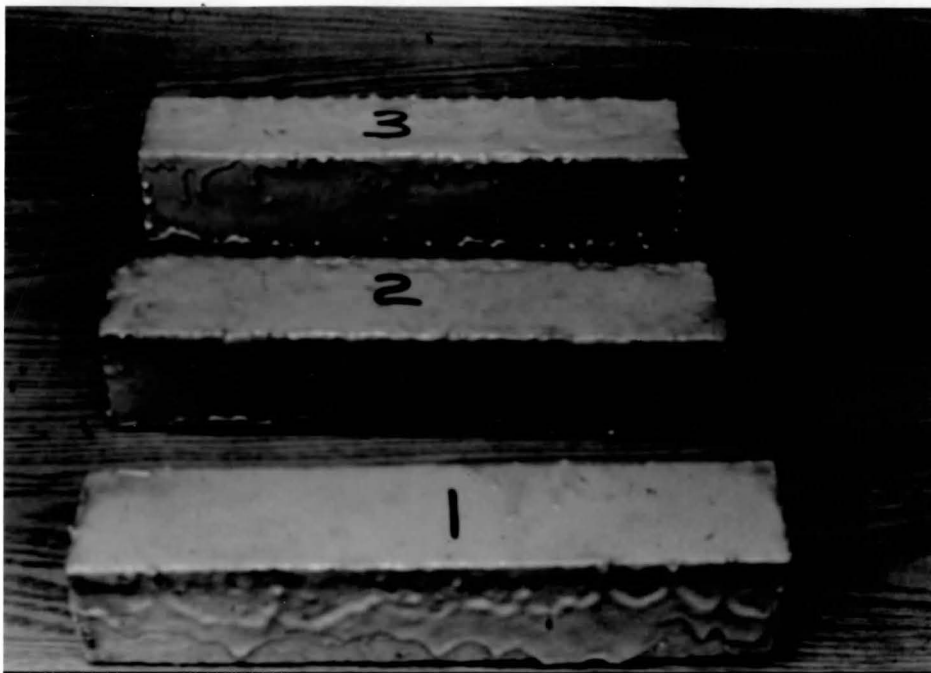
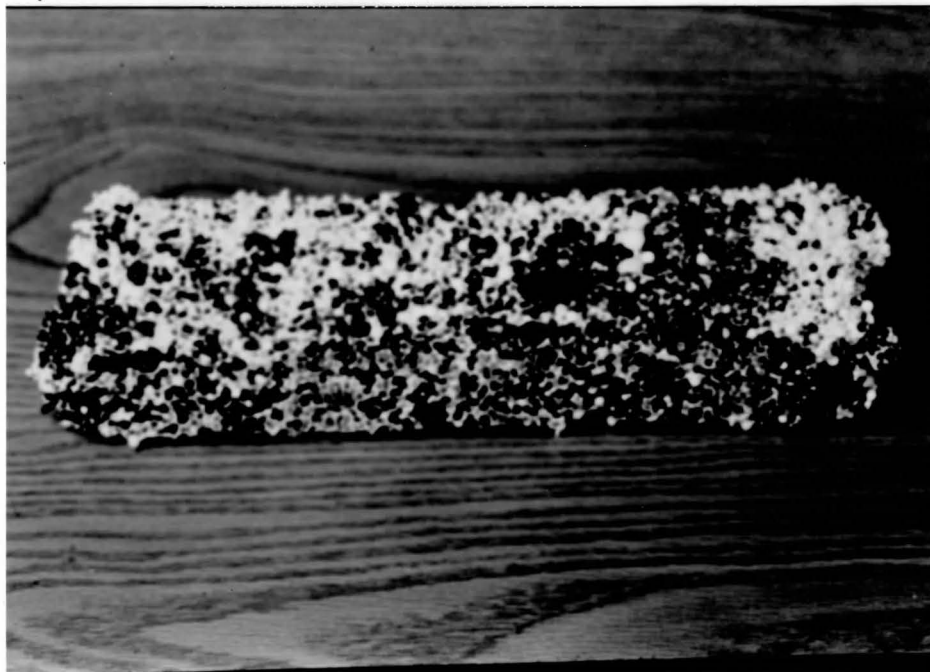
FIGURE 6.11
COMCOAT ON D4 (a) AND
UNCOATED D4 (b) AFTER 100 CYCLES

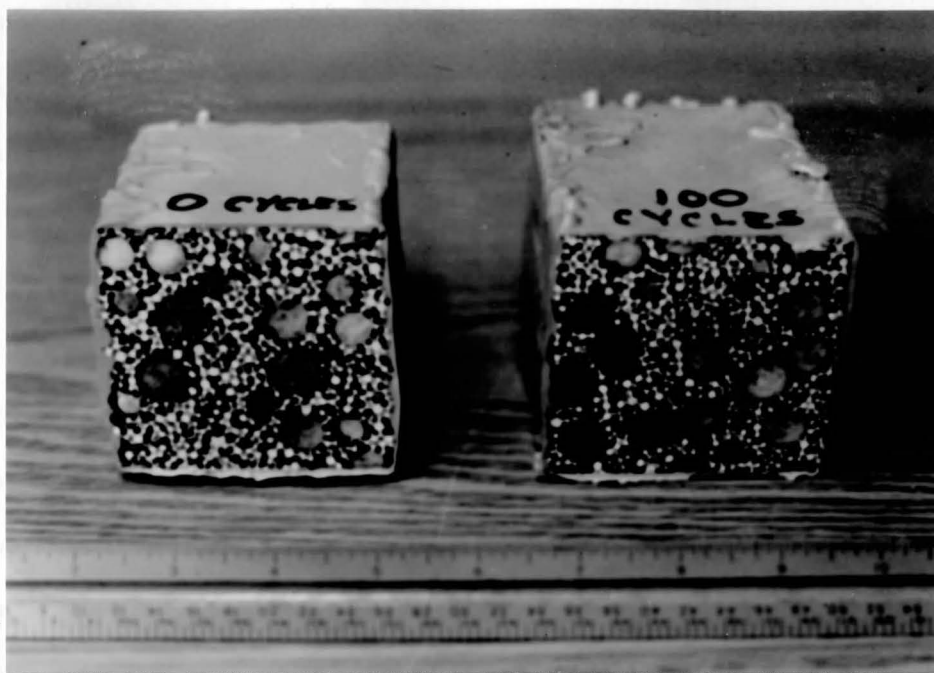
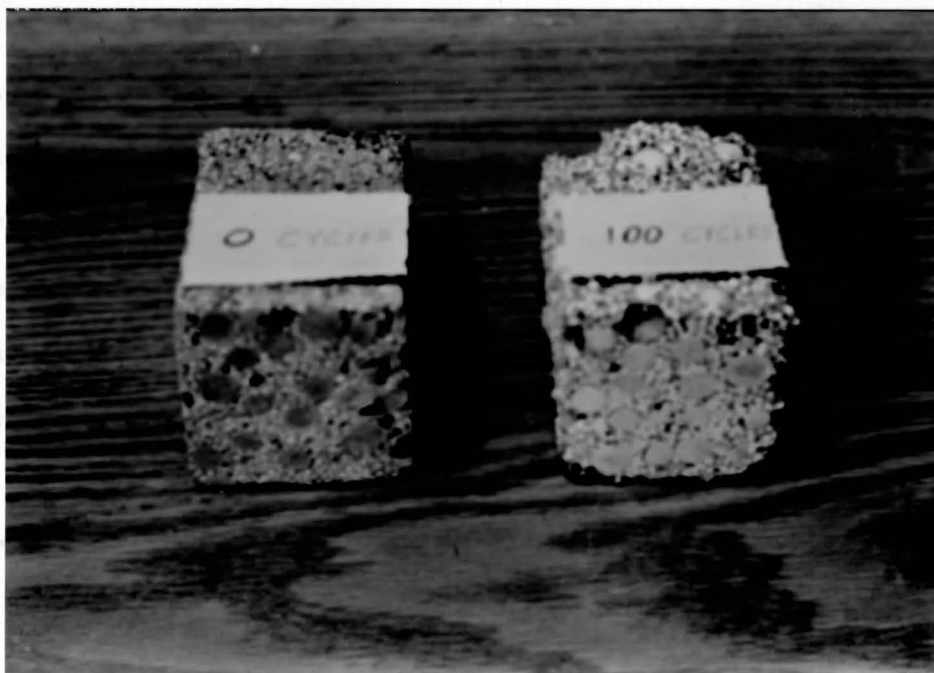
FIGURE 6.12
TYPICAL CROSS-SECTION OF
CYCLED AND UNCYCLED COMCOAT ON P4 (a) AND
CYCLED AND UNCYCLED UNCOATED P4 (b)

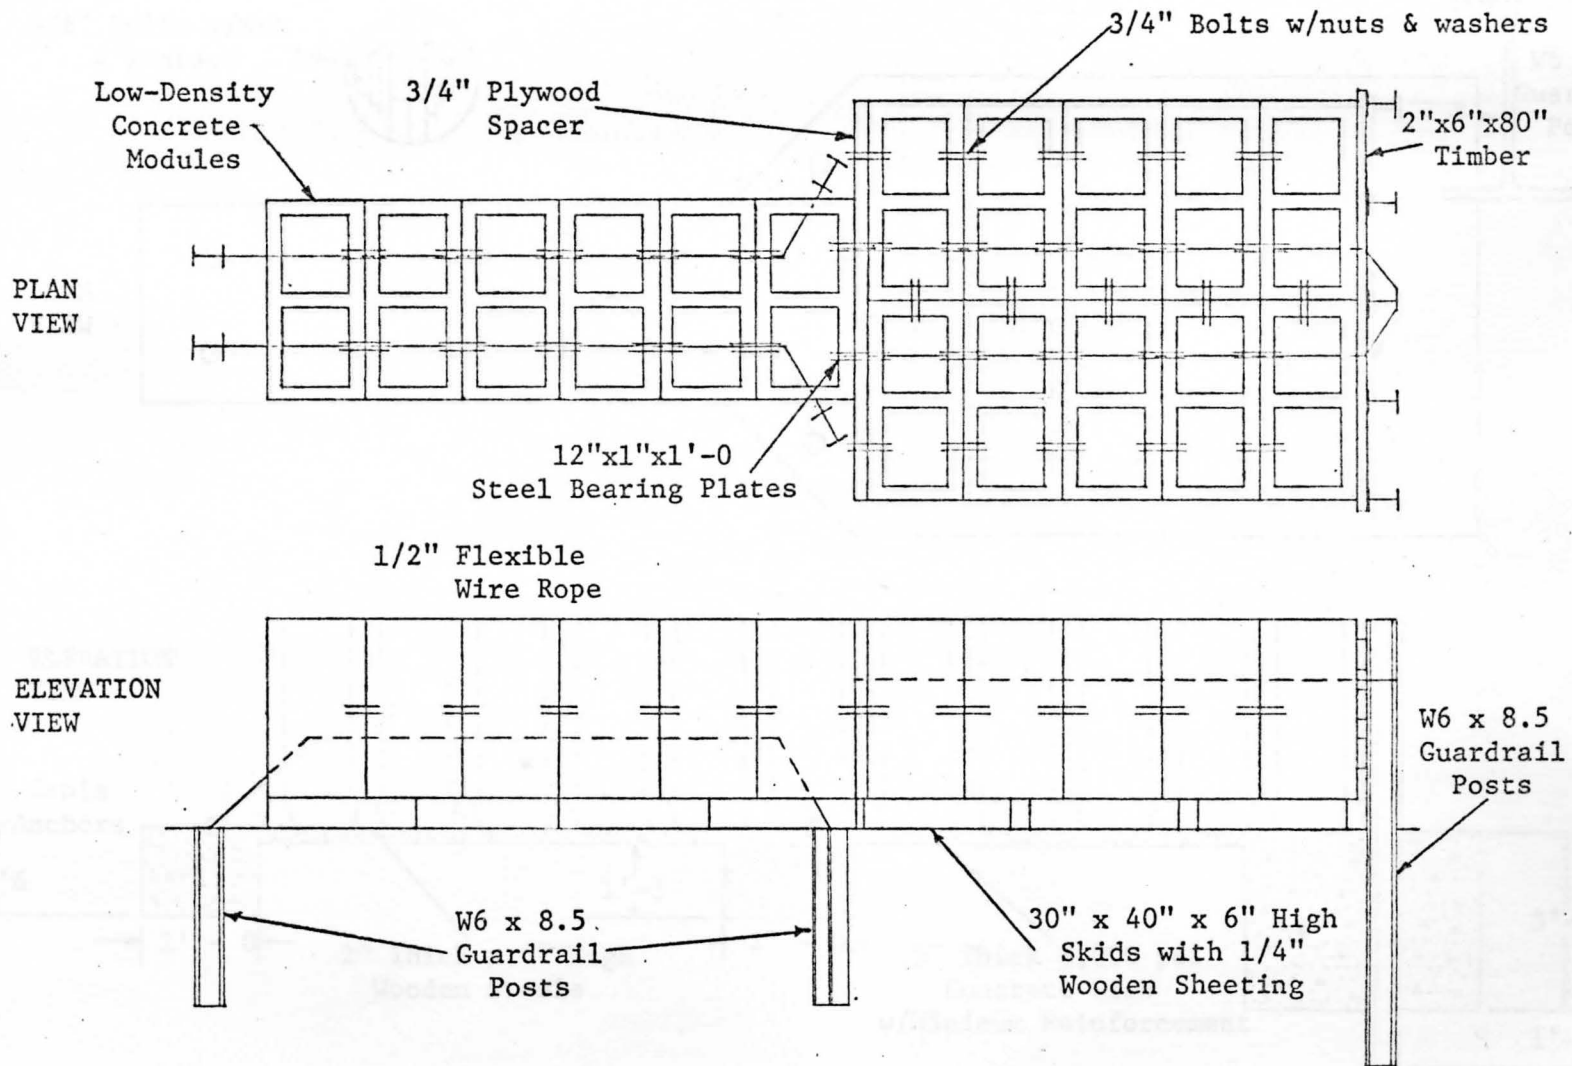
FIGURE 7.1
TEMPORARY ATTENUATOR INSTALLATION

There are two proposed installation plans recommended. Figure 7.1 shows the temporary installation and although the name temporary implies a short lifespan, this configuration is recommended for sites of relatively low accident occurrence or in areas where attenuator usage may ultimately be discontinued. In other words, this installation is intended for use in areas where replacement of the attenuator is expected to be infrequent. The cost of this installation was kept to a minimum.
