A HYDROLOGIC MONITORING PROGRAM FOR YELLOW CREEK WATERSHED

Submitted in Partial Fulfillment of the Requirements

Civil and Environmental Engineering

YOUNGSTOWN STATE UNIVERSITY

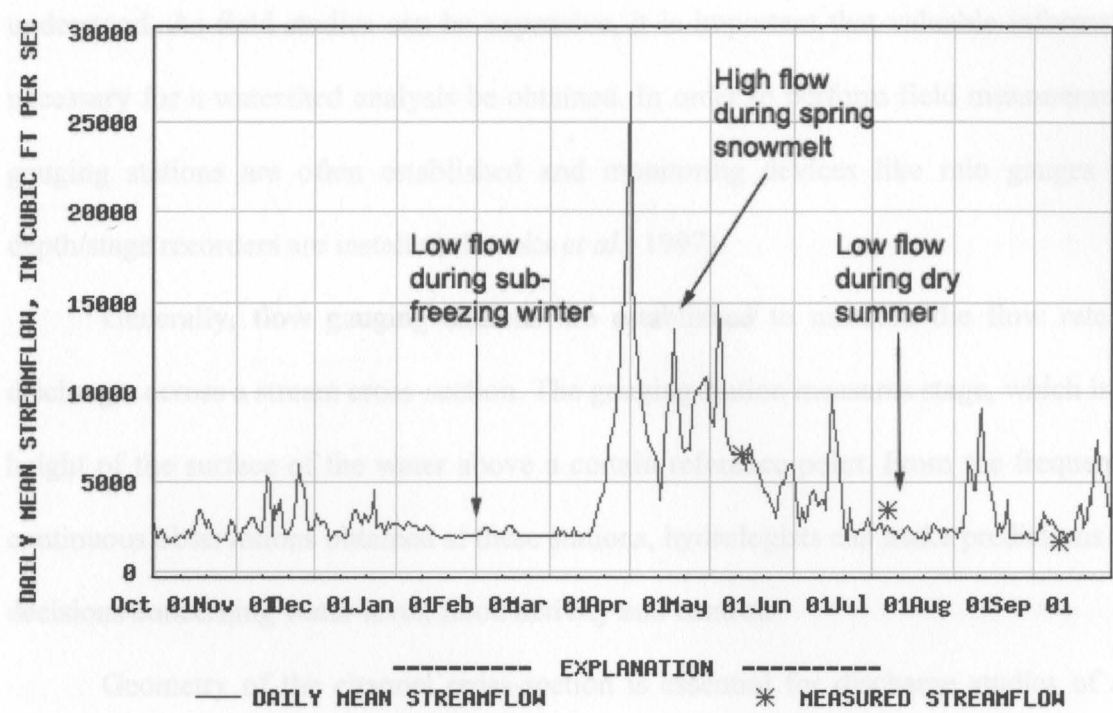
Figure 2.2 A Typical Annual Hydrograph (Bowdoin, 2001)

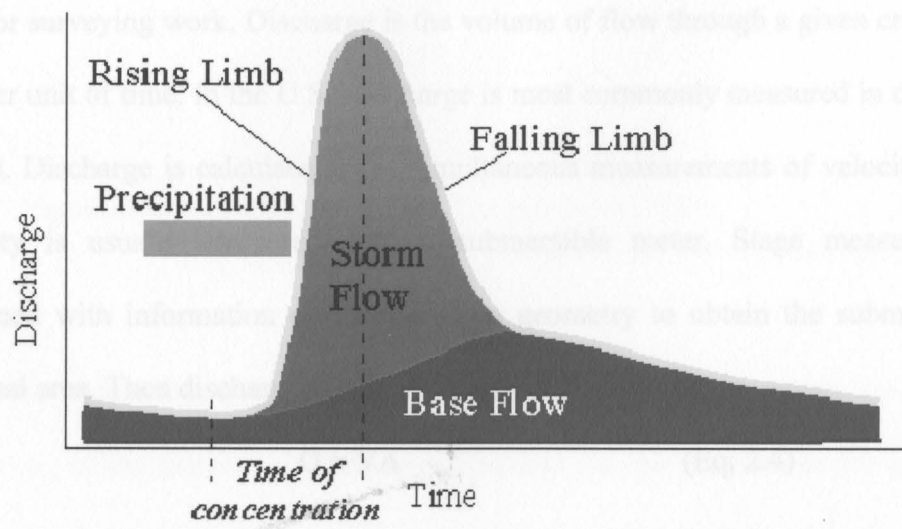
Figure 2.3 A Typical Storm Hydrograph (Van Es, 1997).

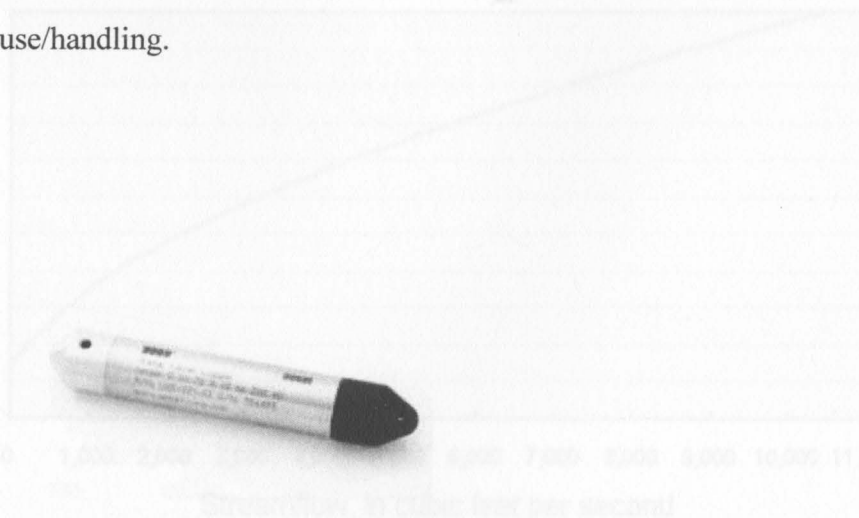
Figure 2.5 A 30 ft “U20-001” HOBOTRON pressure sensor.

As water levels in the stream change rapidly during rain events, manual monitoring of the gauging stations is inadequate. So, for continuous depth recording a device called pressure sensor or water level logger (Figure 2.5) is used. The pressure

sensors or water level loggers record water level, and possibly temperature, in streams, lakes, and freshwater wetlands. Different types of pressure sensors have different ranges for measuring water depths. For example, a pressure sensor of range 0 to 9 m (0 to 30 ft) was used for the depth recordings in this study. Water depth varies with the change in pressure or water density acting on a pressure sensor. Launching and data readout of a pressure sensor is done using software provided by the manufacturer. Barometric compensation should be done to compensate for changes in atmospheric pressure. Stormy weather can produce barometric pressure sensor differences in the range of 25 mb during a single day, resulting an error of 2.5% in water level for a 30 ft range sensor (<http://www.globalw.com/support/barocomp.html>). However, if a stream is only 3 ft. deep, then 25 mb is equivalent to about 25% error. Barometric pressure data can be collected on site using a recording barometer, or from a local weather station. Accuracy of a pressure sensor is affected by several factors such as over pressure, lightening strikes and improper use/handling.

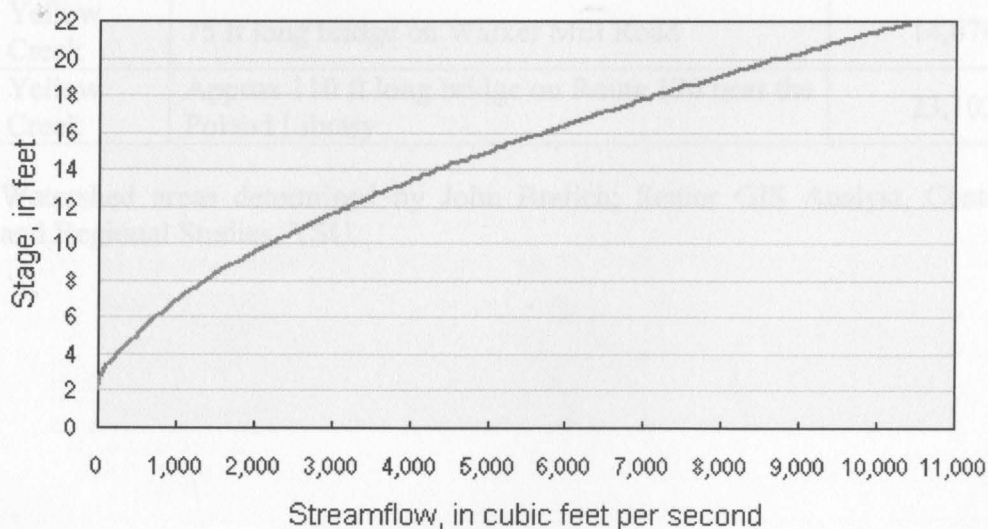
Figure 2.6 Typical Rating Curve. (<http://ga.water.usgs.gov/edu/measureflow.html>)

A rating table or curve is a relationship between stage and corresponding measurements of discharge. Generally, a rating curve is plotted with stream flow on the horizontal axis and stage on the vertical axis as shown in Figure 2.6. Once the rating curve is developed, then it is used to convert records of water level into flow rates. The rating curve should be checked periodically to ensure that the relationship between the discharge and gage height has remained constant. Since rating curves are sometimes developed with a small number of stage/discharge measurements, and measurements of high flows are rare, significant errors in rating curves at high flows are possible. Sometimes we observe different discharge for the same recorded stage; this can be because of scouring of the stream bed or deposition of sediment in the stream (Chow *et al.*, 1988).

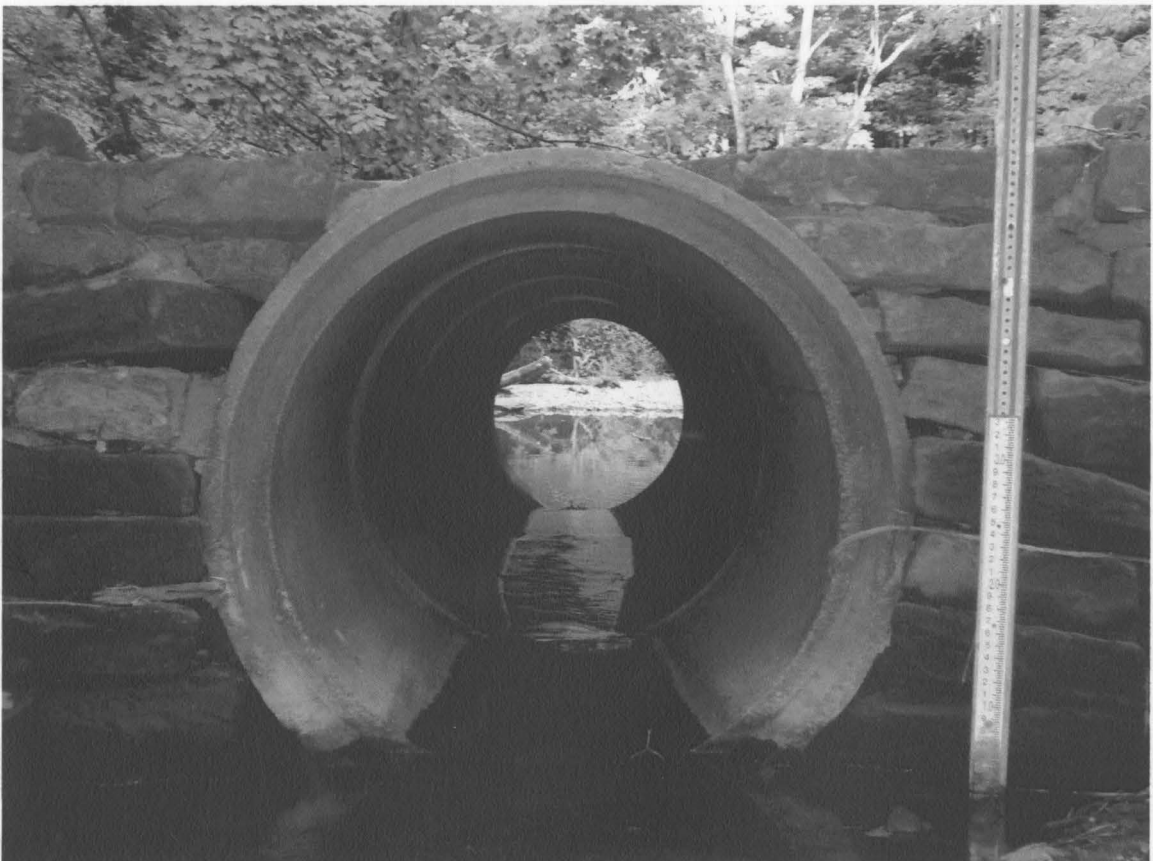
Figure 3.2 Photograph of Gauging Station at Drake's Run (Site #1).

At Site #1, Drake's Run flows through a culvert and the gauging station was established at the upstream end of the culvert (Figure 3.2). Gauging stations on Burgess Run (Site #2), Yellow Creek at Walker Mill Rd. (Site #4), and Yellow Creek at State Route 170 Bridge (Site #5) were established on the downstream sides of the bridges. At Site #3 (Yellow Creek below Lake Evans dam), the gauging station was established on the upstream side of the bridge. Photographs of gauging stations for Sites #2 through #5 are shown in Appendix A, Figures A-1 through A-4, respectively.

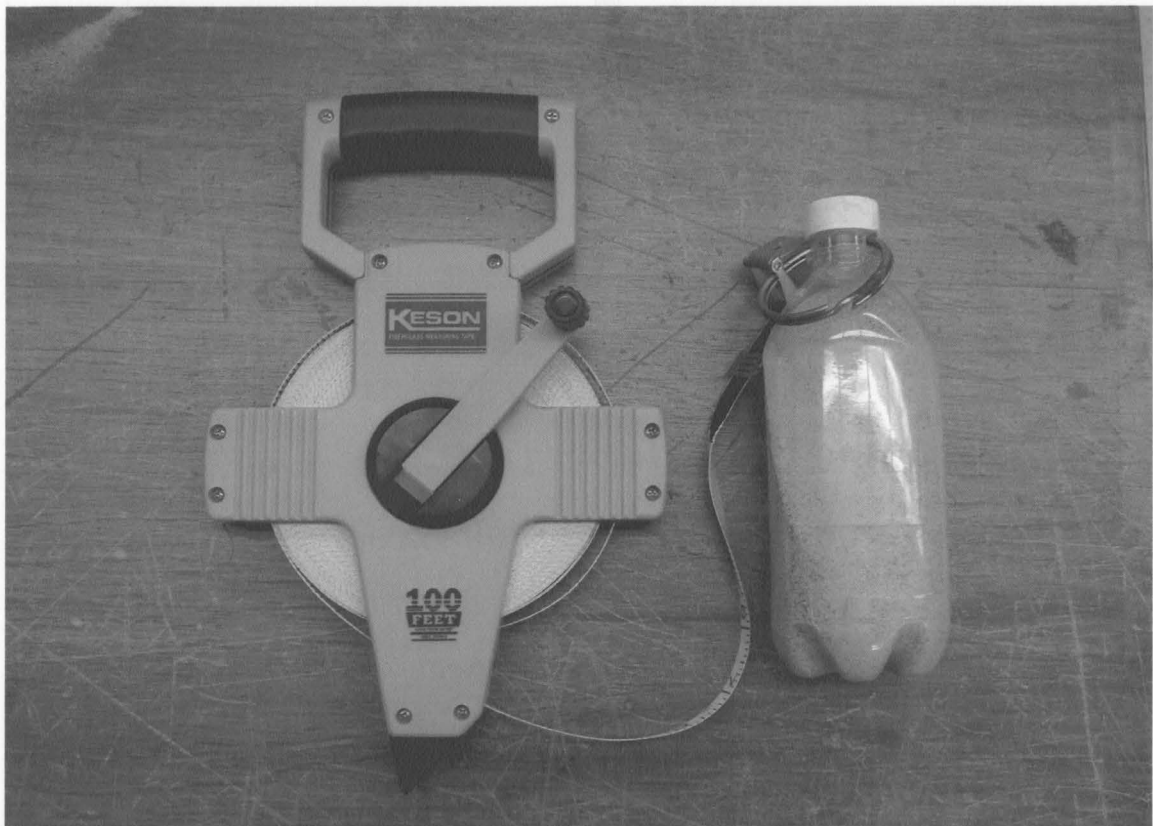
Figure 3.3 A 100 ft Surveyor's Tape Attached to 0.78 ft Bottle Filled With Sand.

establish a baseline along the railing of the bridge at Sites #2, #4, and #5. After a baseline was established, 5 ft intervals were marked along the baseline. A surveyor's level and a Philadelphia rod were used to measure the relative elevation of the bridge deck at the 5 ft intervals marked. The height (elevation) of the instrument was assumed to be 1000 ft at all stations. The height of the railing was measured from the bridge deck at each interval. Then distances to the ground, water surface, and/or stream bottom were measured from the top of railing at marked intervals. Distances to the ground and water surface were measured using a fiberglass tape graduated to 0.01 ft with a weight attached. The weight was a plastic bottle filled with sand, which added 0.78 ft to the length of the tape (Figure 3.3). Depth of water was measured with the scale on the velocity meter pole (Figure 3.4).

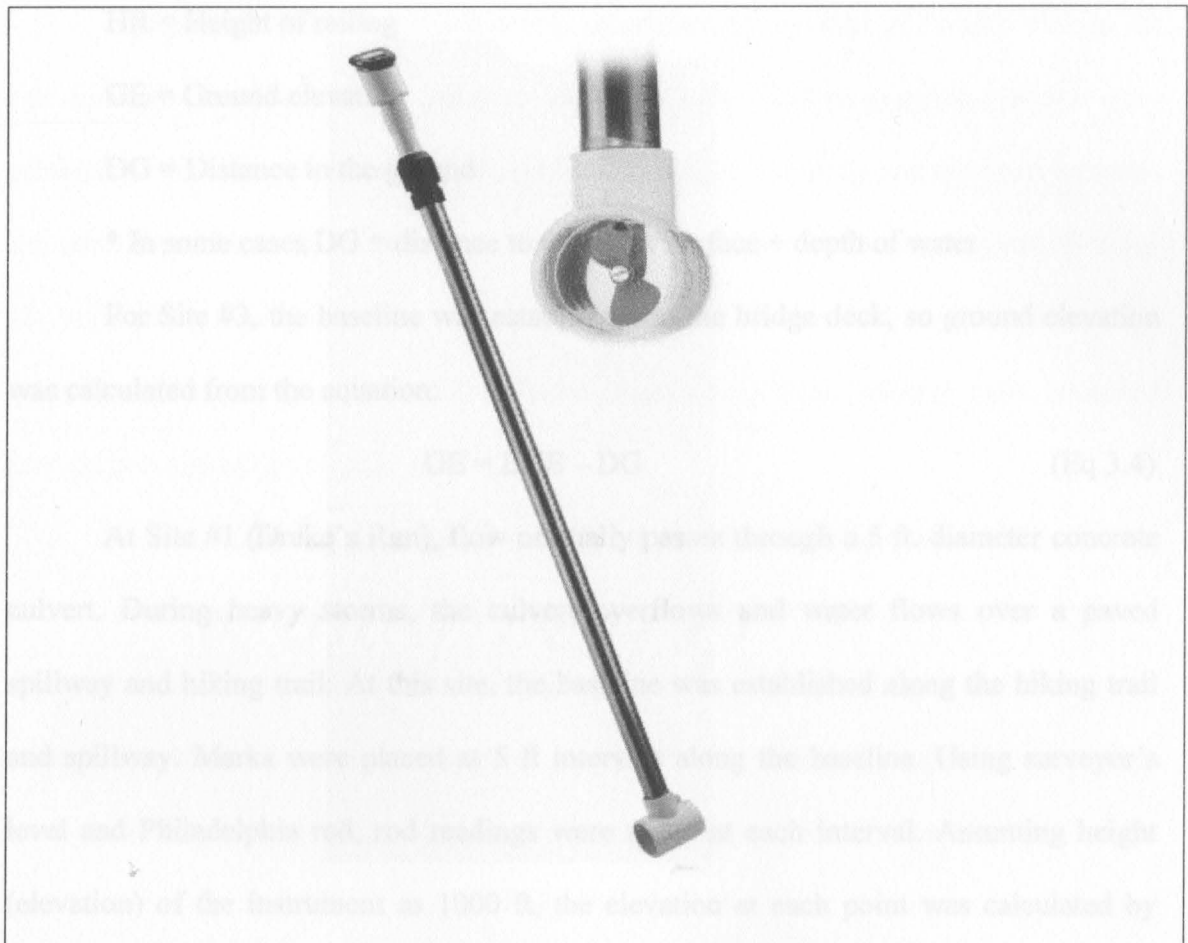
Figure 3.4 Global Water Flow Probe.

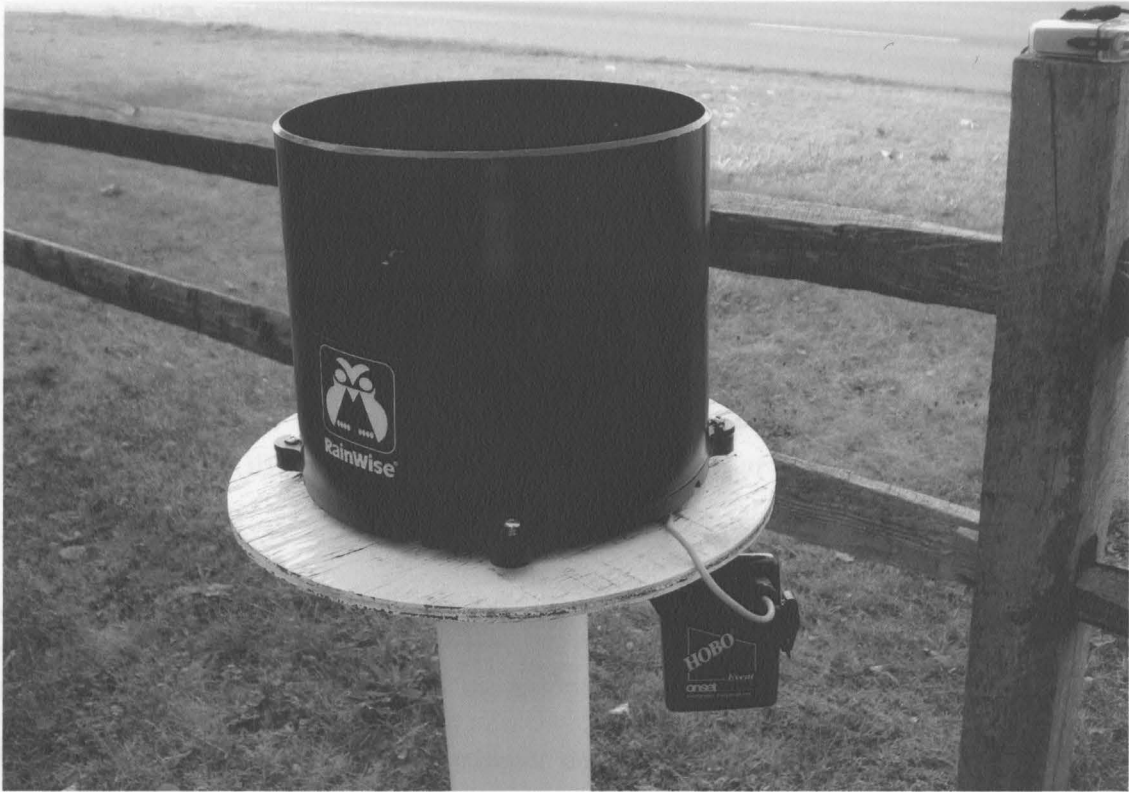
Figure 3.7 Photograph of Rain Gauge connected with a HOBO H7 Event Logger.

Once rain gauges were connected with data loggers (Figure 3.7), the loggers were “launched” using an interface cable and BoxCar Pro 4.3 software. The HOBO H7 event data logger has a red LED that blinks every two seconds while it is logging. After the loggers were properly launched, the rain gauges were installed at their respective locations. A HOBO Shuttle was used for the retrieval of data from the loggers to avoid the risk of bringing the loggers back from the field or taking a computer into the field.

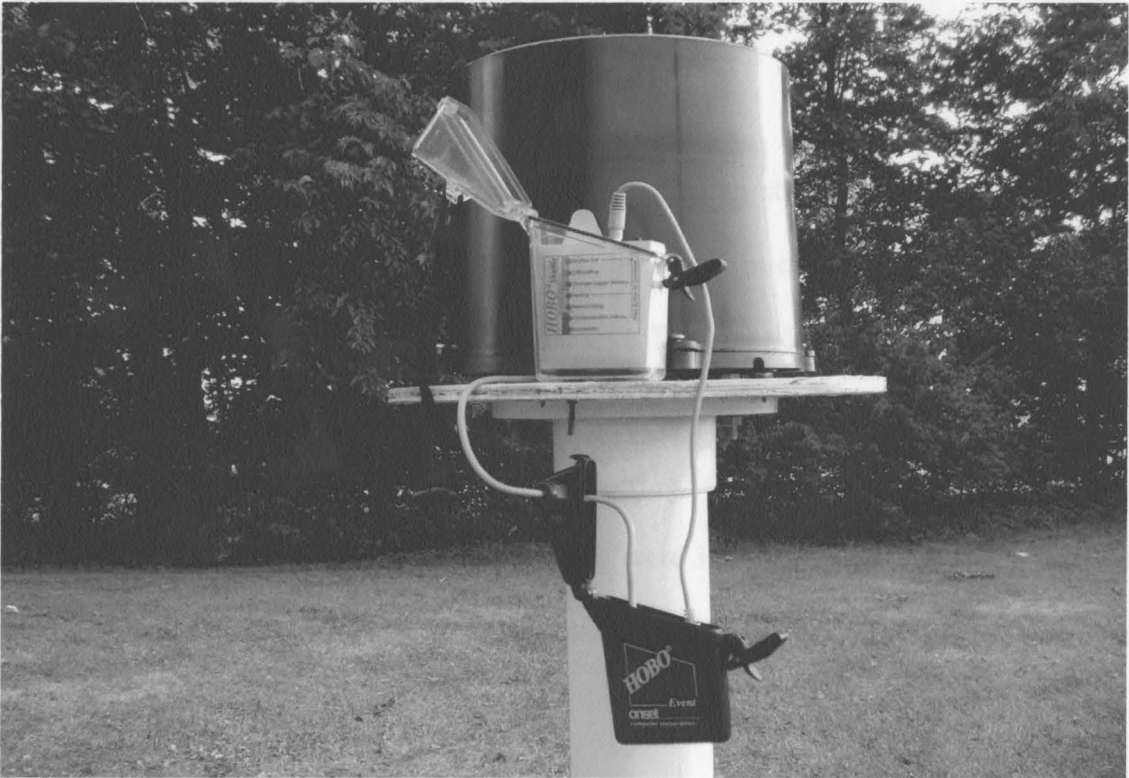
Figure 3.8 Photograph of HOBO Shuttle connected to HOBO H7 Event logger.

The data from the data logger was automatically downloaded by connecting a HOBO Shuttle to the data logger with a 1 ft long cable provided with the shuttle (Figure 3.8). Then, the HOBO shuttle was connected to a computer using an interface cable and the readout was done with BoxCar Pro 4.3 software. Once the data were downloaded from the shuttle, the shuttle was automatically relaunched and the shuttle clock synchronized with the PC clock. The HOBO Shuttle has 468 kb of memory, which is enough for 13 full 32 kb data loggers.

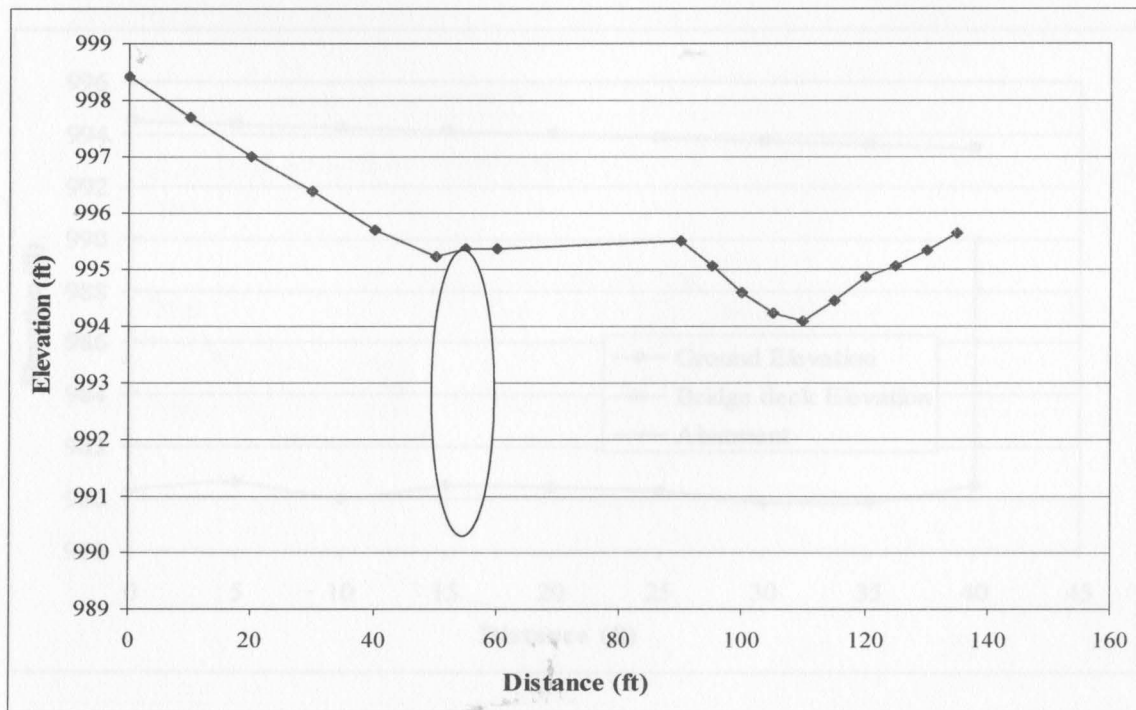
Figure 4.1 Plot of Culvert Pipe and Overflow Channel at Site #1, Drake's Run, looking Downstream.

A plot showing the cross-section of the overflow channel and position of the 5 ft. diameter culvert at Site #1 is shown in Figure 4.1. Plots of channel cross-sections for Sites #2 through #5 are presented in Figures 4.2 through 4.5, respectively. The surveying data of the channel cross-sections for Sites #1 through #5 are summarized in Appendix B, Table B-1 through B-5, respectively.

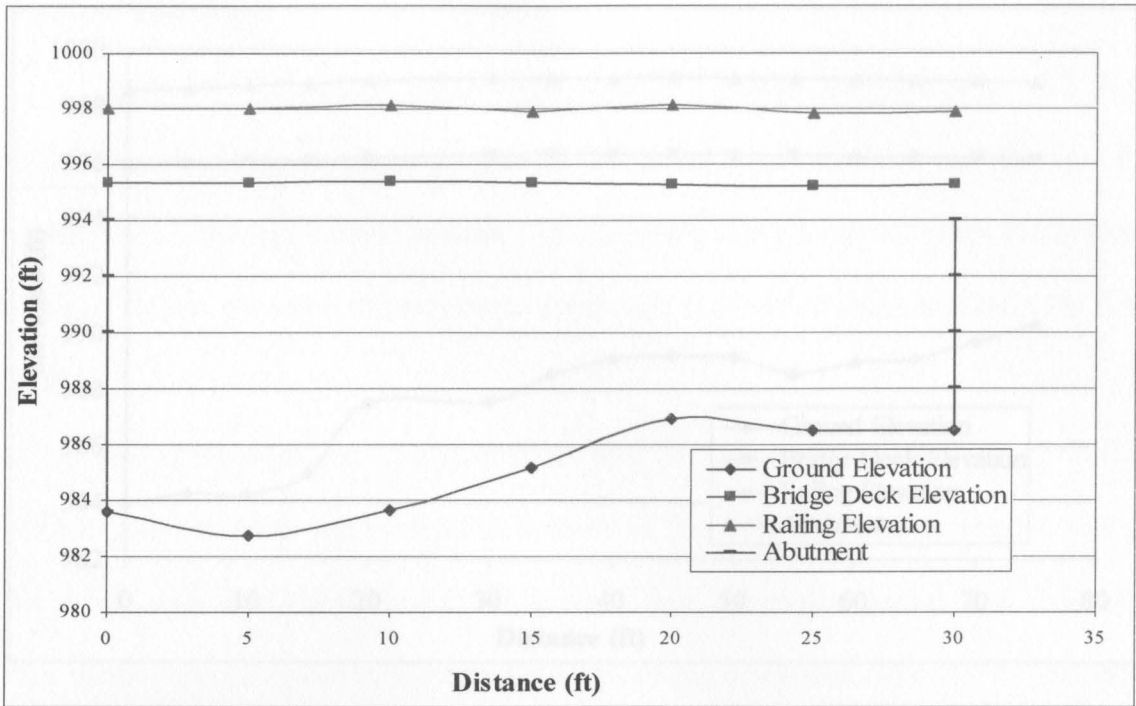
Figure 4.2 Plot of Stream Cross-Section at Site #2, Burgess Run at Walker Mill Rd, Looking Downstream.

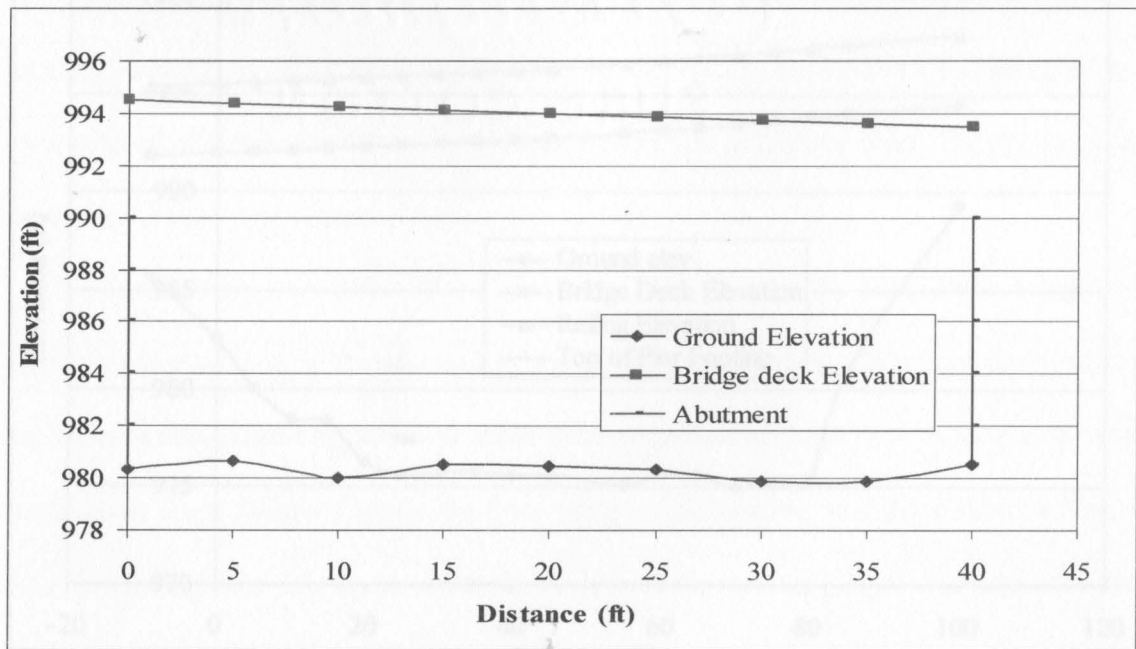
Figure 4.3 Plot of Stream Cross-Section at Site #3, Yellow Creek below Lake Evans Dam, Looking Upstream.

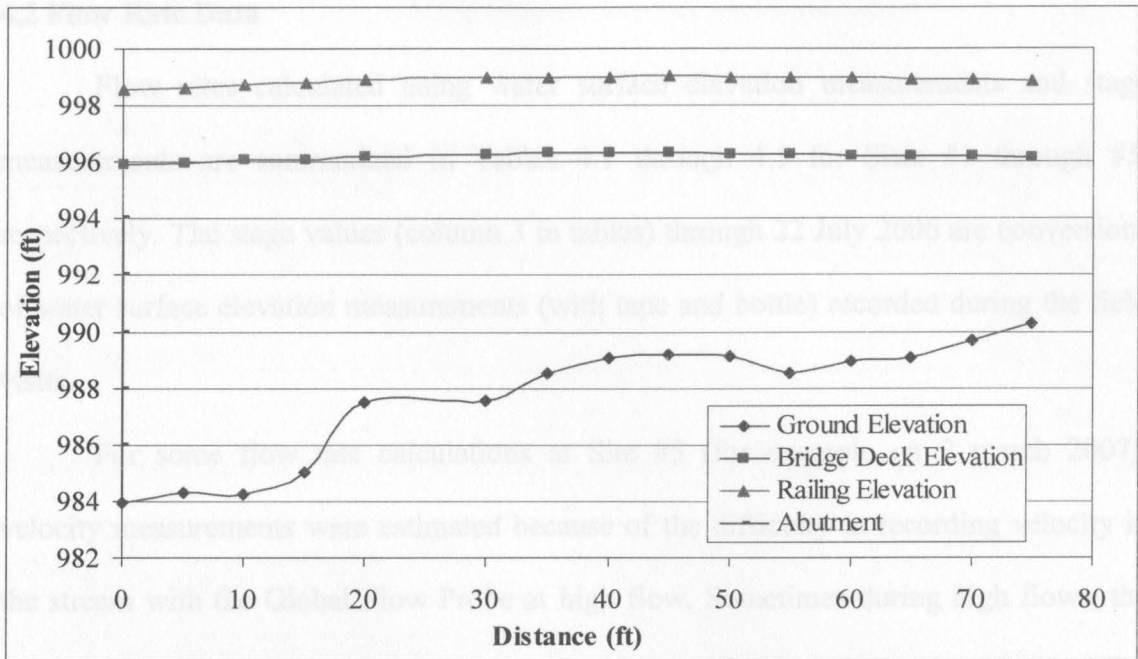
Figure 4.4 Plot of Stream Cross-Section at Site #4, Yellow Creek at Walker Mill Rd., Looking Downstream.

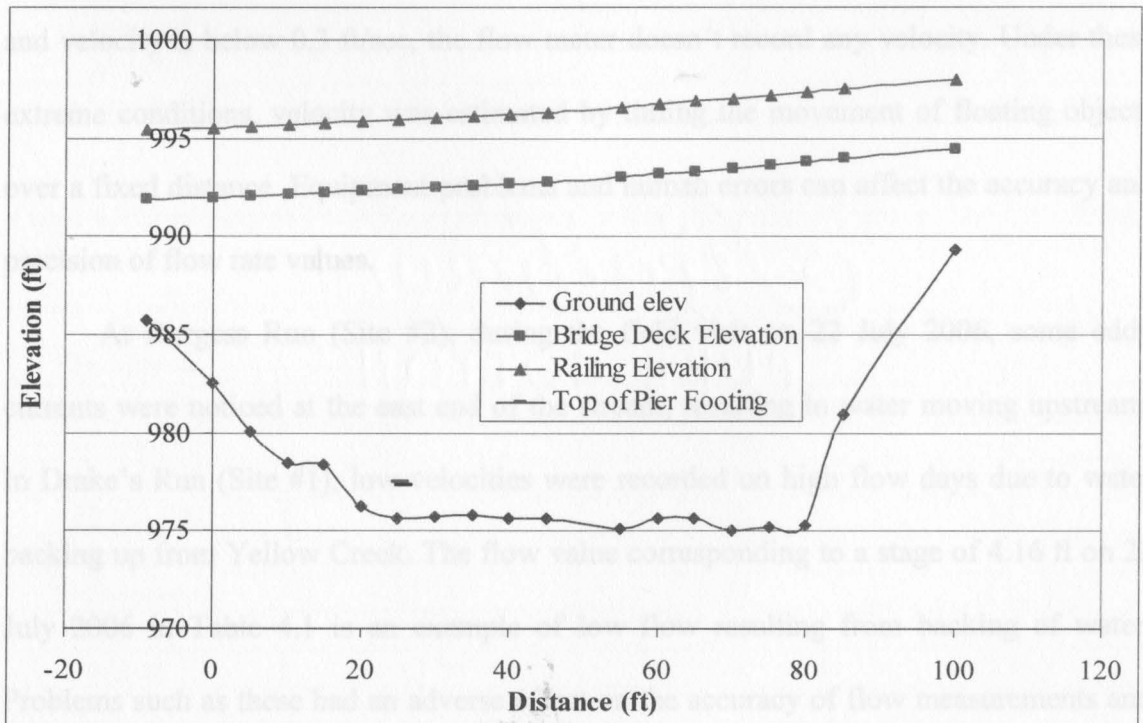
Figure 4.5 Plot of Stream Cross-Section at Site #5, Yellow Creek at State Route 170, Looking Downstream.

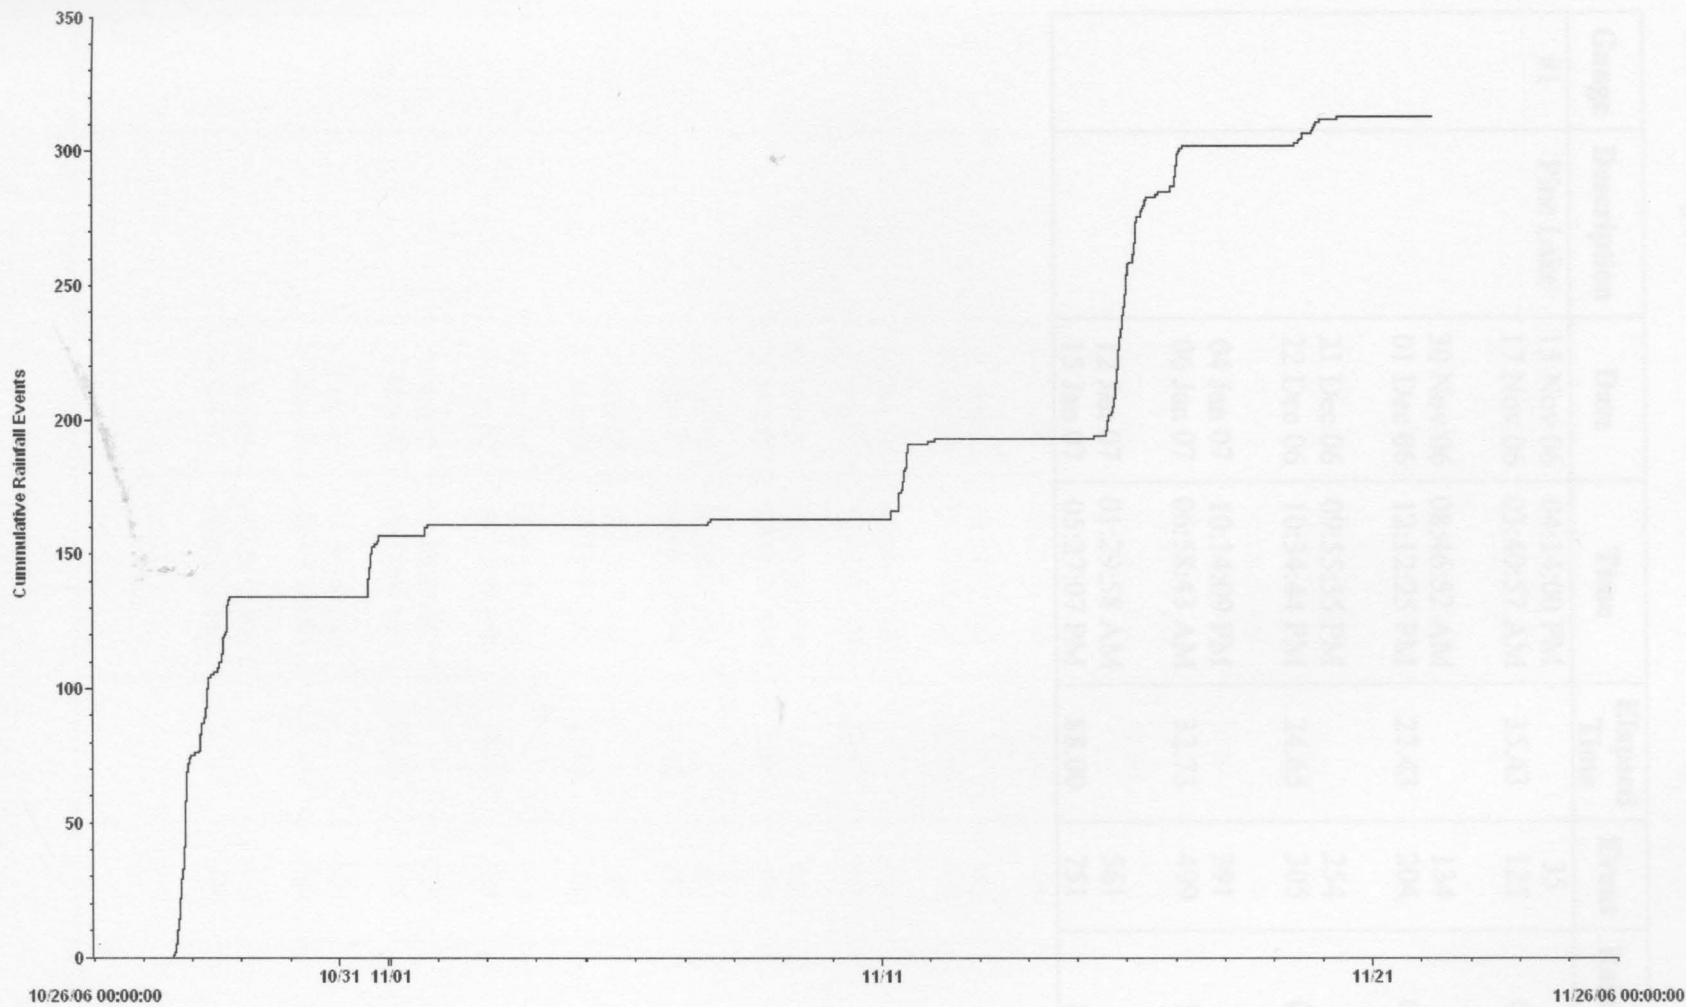
Figure 4.11 Rainfall Graph for Rain Gauge #2.

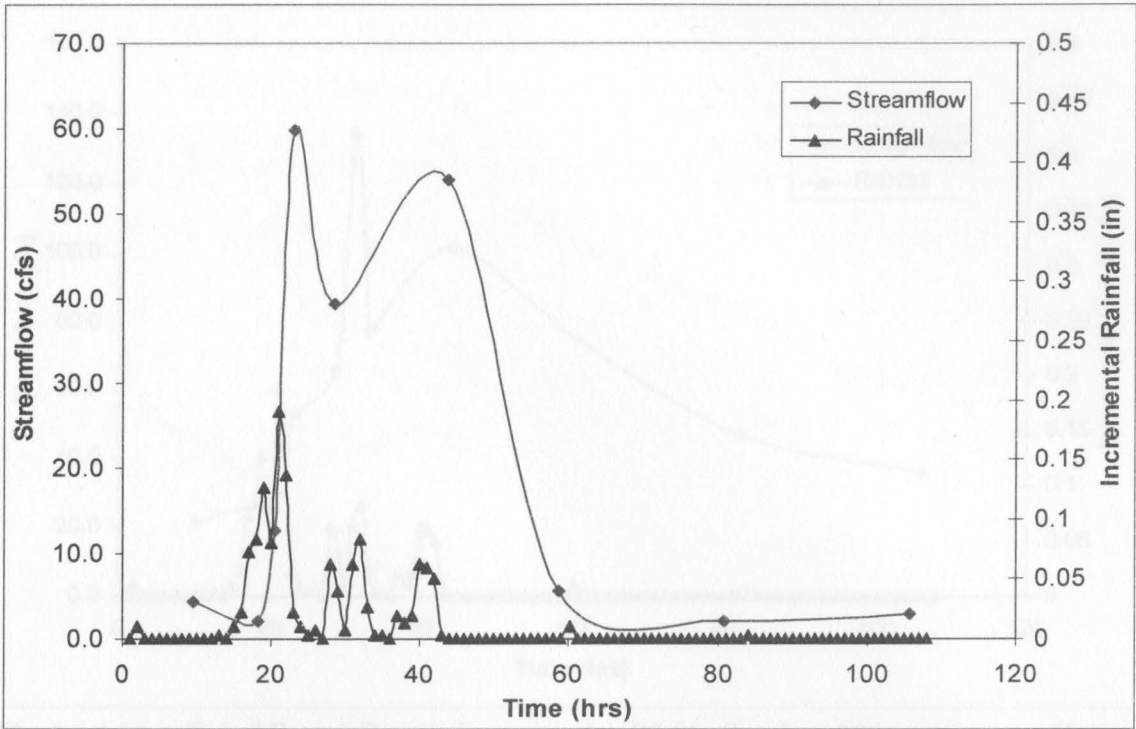
Figure 4.14 Rainfall and Streamflow for the 27-28 October 2006 Storm on Yellow Creek Watershed at Site #1, Drakes Run.

Based on land use, the runoff coefficient for Burgess Run would be expected to be lower than for Drake's Run. Drake's Run watershed is mostly urban land (residential and commercial), while Burgess Run watershed is mostly agricultural and wooded land. Runoff coefficients of 0.5-0.7 are typical of urbanized areas like Drake's Run. More rural areas like the Burgess Run watershed would typically show runoff coefficients in the range of 0.2-0.4.

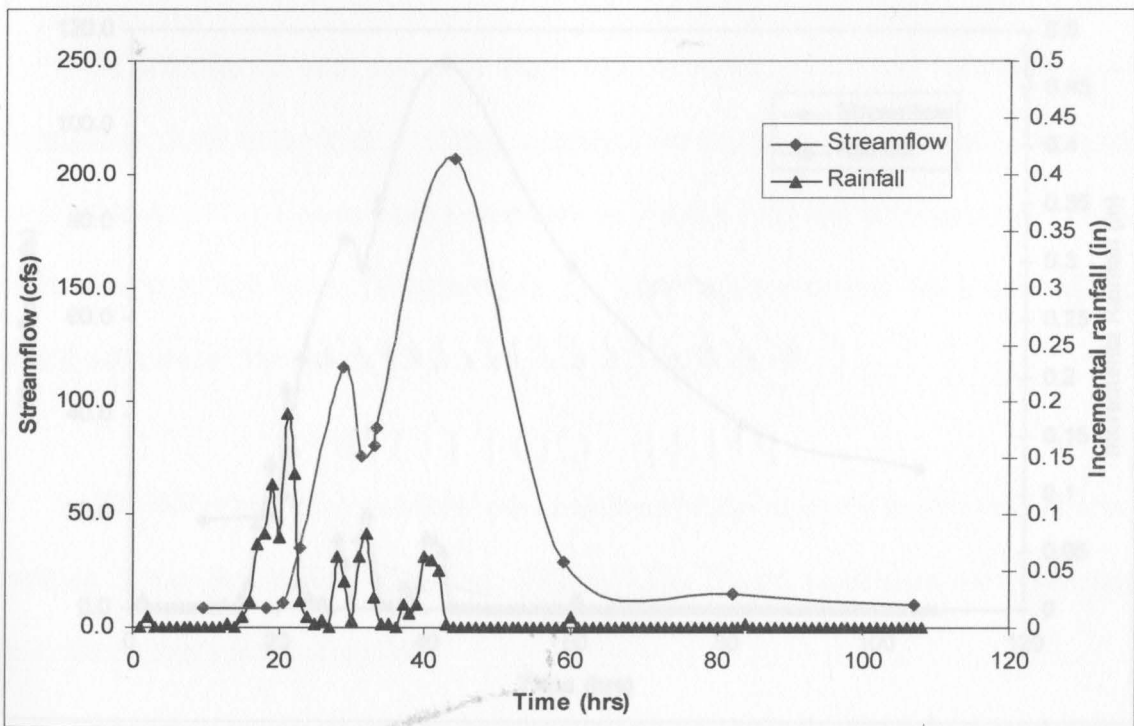
Figure 4.15 Rainfall and Streamflow for the 27-28 October 2006 Storm on Yellow Creek Watershed at Site #2, Burgess Run at Walker Mill Rd.

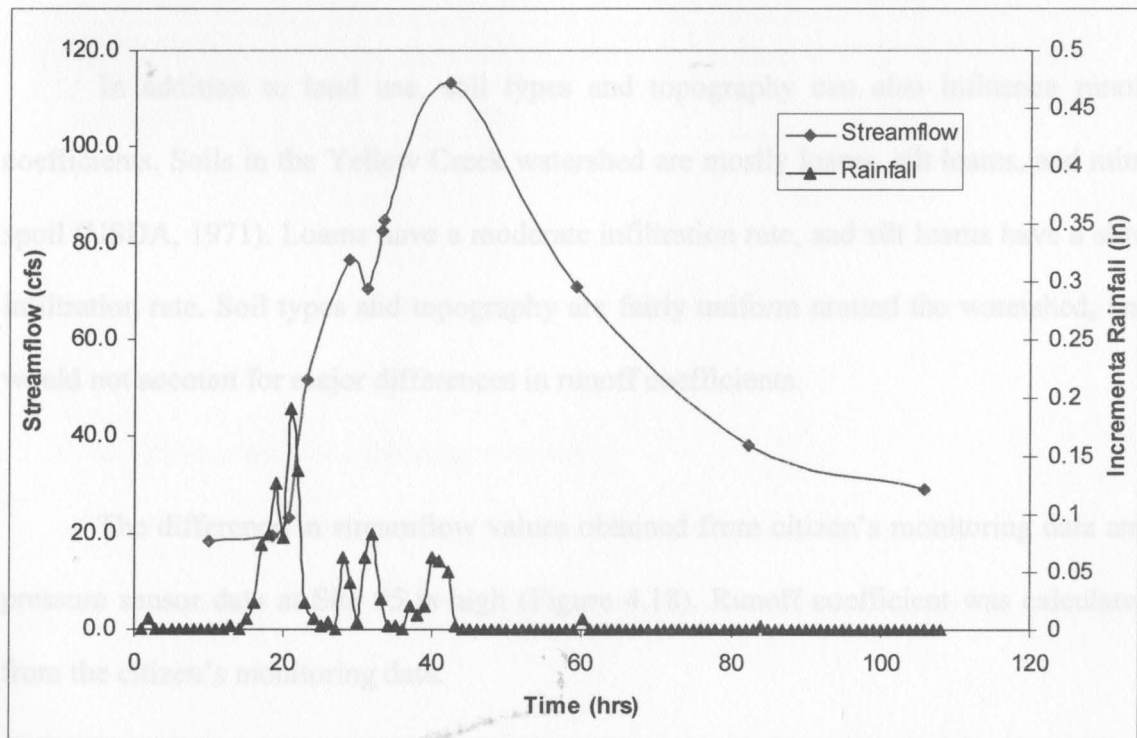
Figure 4.17 Rainfall and Streamflow for the 27-28 October 2006 Storm on Yellow Creek Watershed at Site #4, Yellow Creek at Walker Mill Rd.

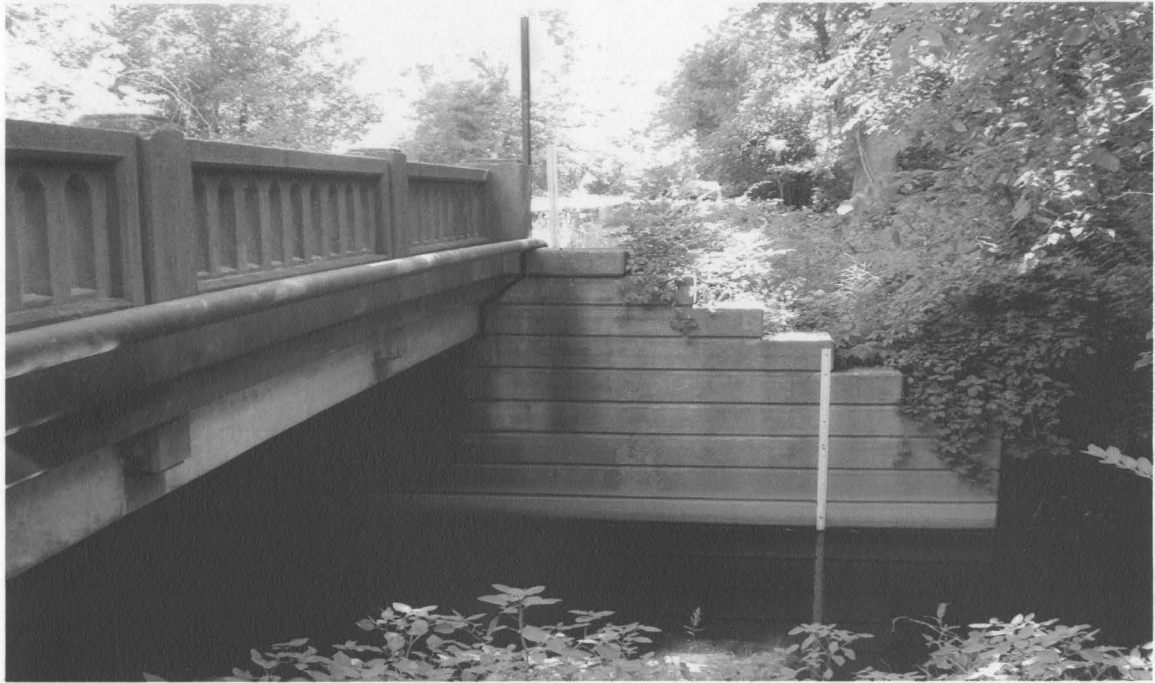
Figure A-1 Photograph of Gauging Station at Burgess Run (Site #2).

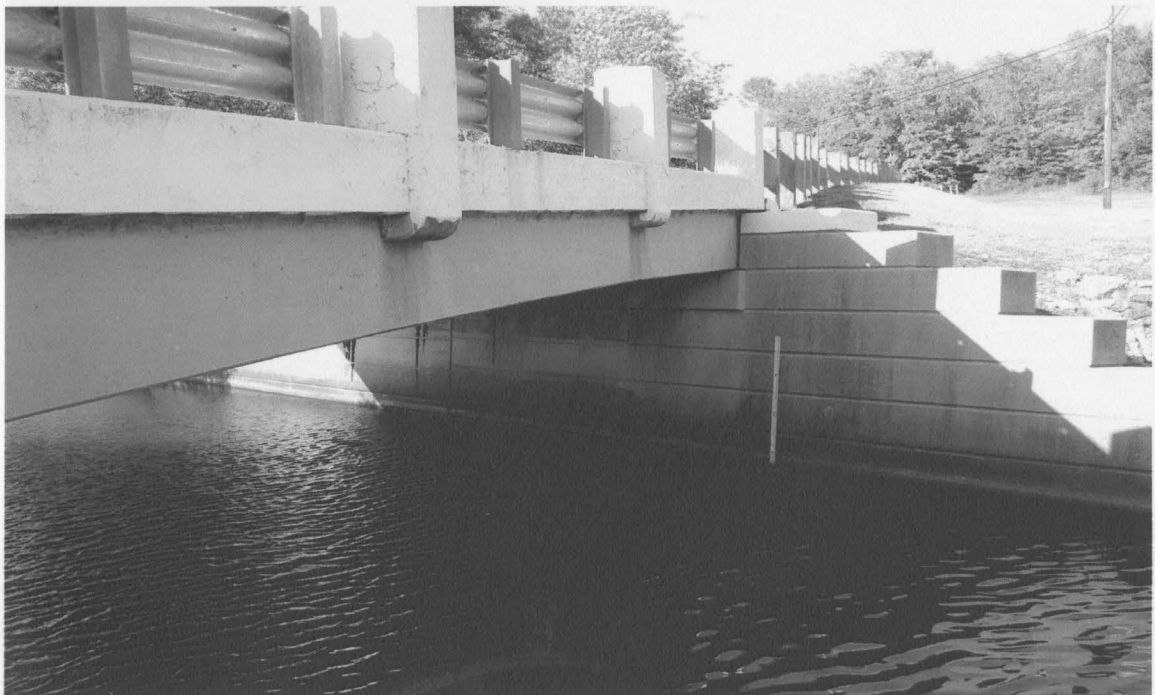
Figure A-2 Photograph of Gauging Station at Yellow Creek near Lake Evans (Site #3).

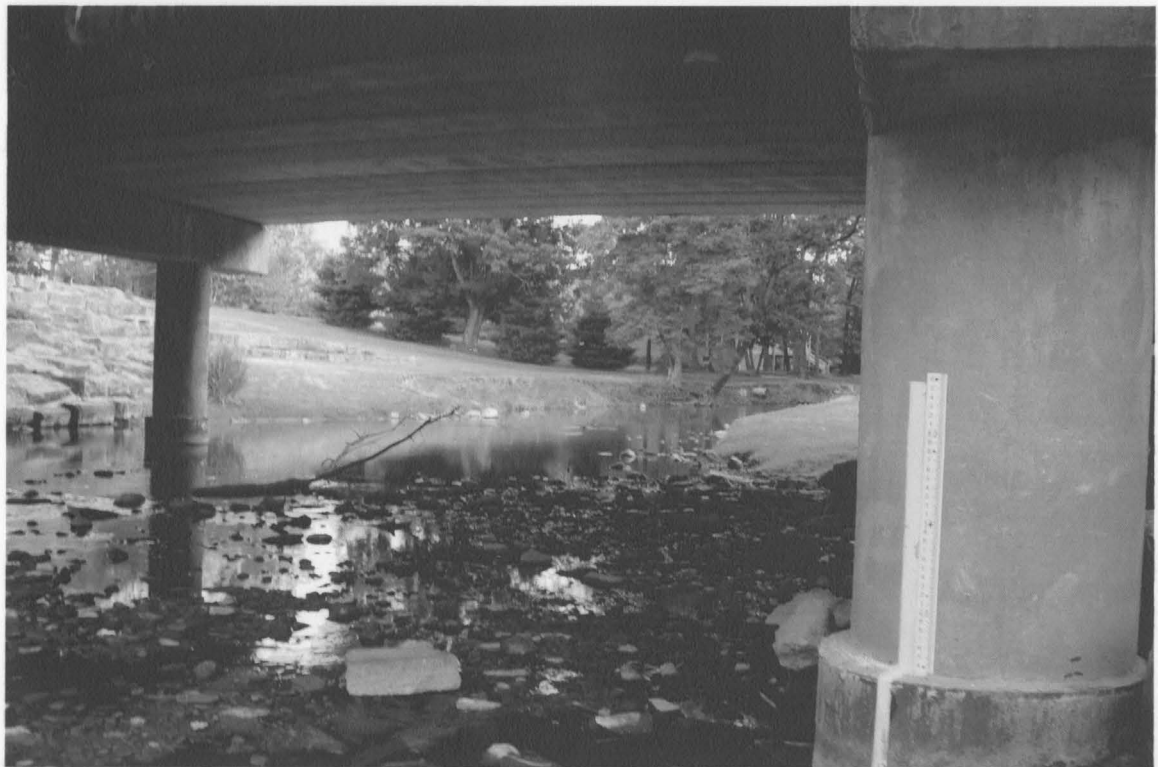
Figure A-4 Photograph of Gauging Station at Route 170 Bridge (Site #5).
