The Corrosion and Tensile Characteristics of Hot-Wire Deposited 316L Stainless-Steel: An  
Analysis of Four Printing Methods

Brandon Lee Koenig

Master of Science in Engineering

YOUNGSTOWN STATE UNIVERSITY

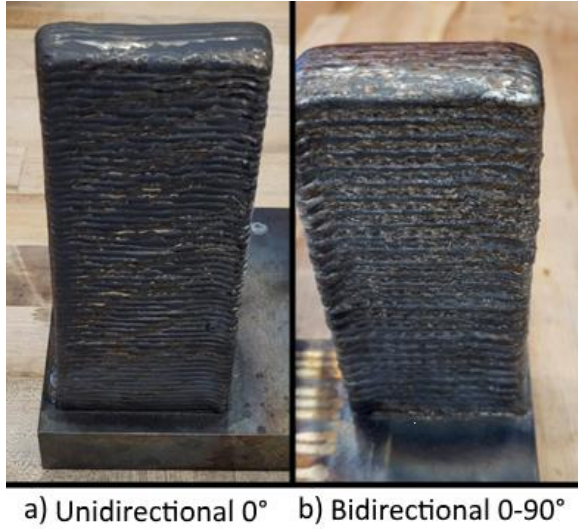
**Figure 4:** a) Unidirectional vs b) Bidirectional Build-Orientations Before Wire EDM

All samples were extracted from cuboids printed in the Z-direction such that each layer was coplanar to the “C” and “T” dimensions referenced from Figure 3. That is, the cuboids were printed standing up-right as shown in Figure 4, which shows a comparison of the build of the unidirectional vs bidirectional build-orientations. Figure 5 further explains the build-direction which can be thought of as being inside of the cuboids shown in Figure 4.

Unidirectional indicates that each layer is printed such that the print-head in reference to the stage are only depositing material moving in one direction, that is, point “A” to point “B” for every row, never point “B” to point “A”. Bidirectional indicates that the direction of material deposition alternates with each bead step-over, that is point “A” to “B” for one row, and point “B” to “A” for the following row. Within the same layer, the relative movement of print-head to stage does not change until the layer is complete. This alternating print-direction in each layer can be seen by comparing Figure 4A’s unidirectional 0° sample versus bidirectional 0-90°.

All samples were extracted from printed-blocks similar to Figure 4 using EDM wire-cutting. Each of the samples shown in Table 3 were machined to the dimensions listed but started as 3D-printed cuboids shown Figure 4.

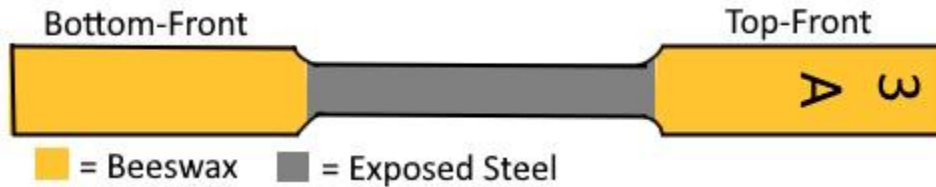
**Figure 7:** Example Tensile Sample with Label and Beeswax-Coverage prior to Corrosion

thinner portion. Differences in exposed surface area from one coating to the next could allow for more or less weight-loss that is unaccounted for in the comparison of one sample to the next. See Figure 7 below for how the beeswax and label were applied to the samples.

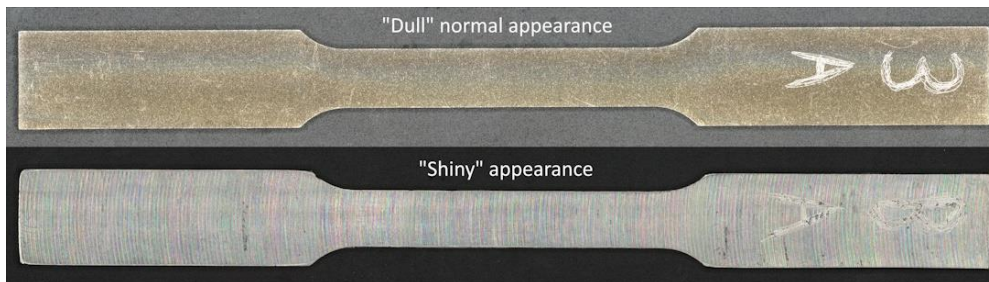
**Figure 10:** Comparison of Dull Sample Versus Shiny

One may notice a disproportionate amount of control samples in each group. This was caused by two separate issues. The first issue resulted from the use of remaining samples – some builds had more samples than other builds, so where more than six samples were available, the remaining number became controls. In addition, some samples had a drastically different appearance on the surface compared to the rest of the samples. All samples that were set to be corroded for either 21 days or 43.5 days had a similar appearance at the beginning of the experiment. By not mixing the different appearance samples into corrosion testing, results that were affected by surface differences would not create a bias in results. This was done to ensure that every group had at least two samples per corrosion category that would be less likely to differ significantly during corrosion. Figure 10 shows a comparison of a typical looking sample compared to one that was designated as a control sample by appearance only.

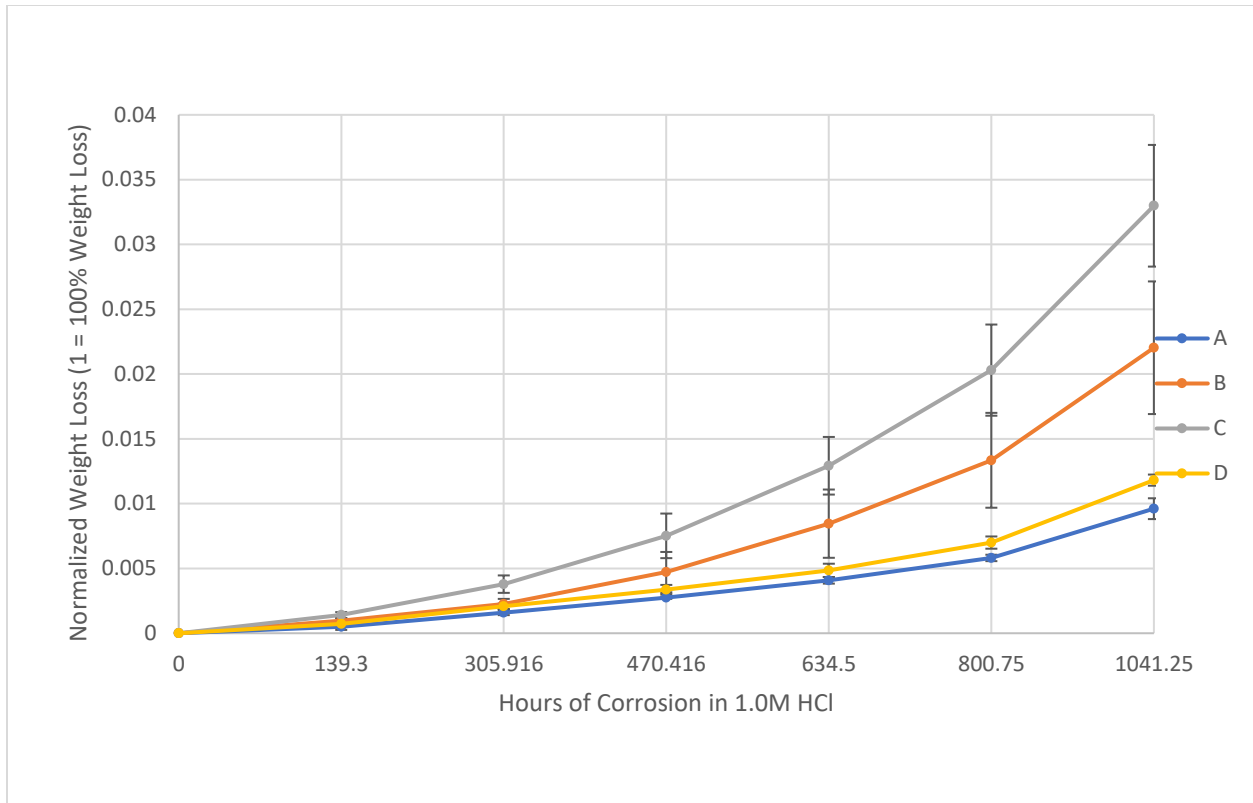
**Figure 18:** Normalized and Averaged Mass Data by Sample Type with Error Bars Showing  $\pm$  One Standard Deviation

In order to better compare each of the sample groups (i.e. A, B, C, and D), the average weight-loss per sample type was plotted on the same chart, as shown in Figure 18, so that it is easier to comprehend the data. Error bars representing  $\pm$  one standard deviation is displayed on each average mass corresponding to the appropriate corrosion duration.

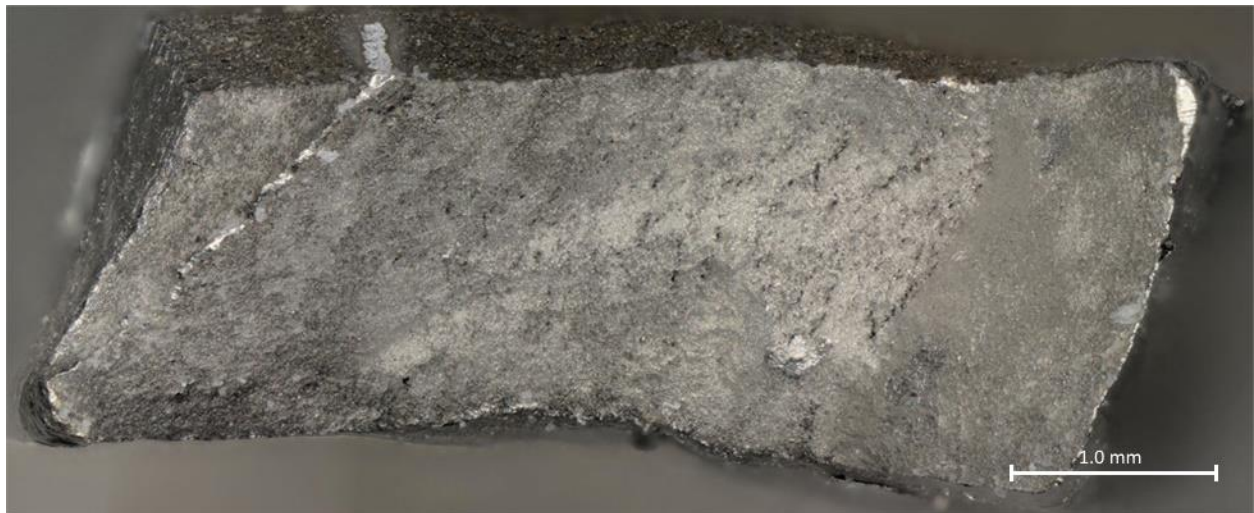
**Figure 58:** Top-Half Fracture of Control Sample TA Taken at 100x Magnification

The center of TA shows signs of some internal stress with the visible cracks. There is a large gouge-like region in the top-left of the image that is not homogeneous with the rest of the cross-section. There are no signs of pitting corrosion. Some distortion occurred during elongation. The fracture was ductile as per Figure 29.

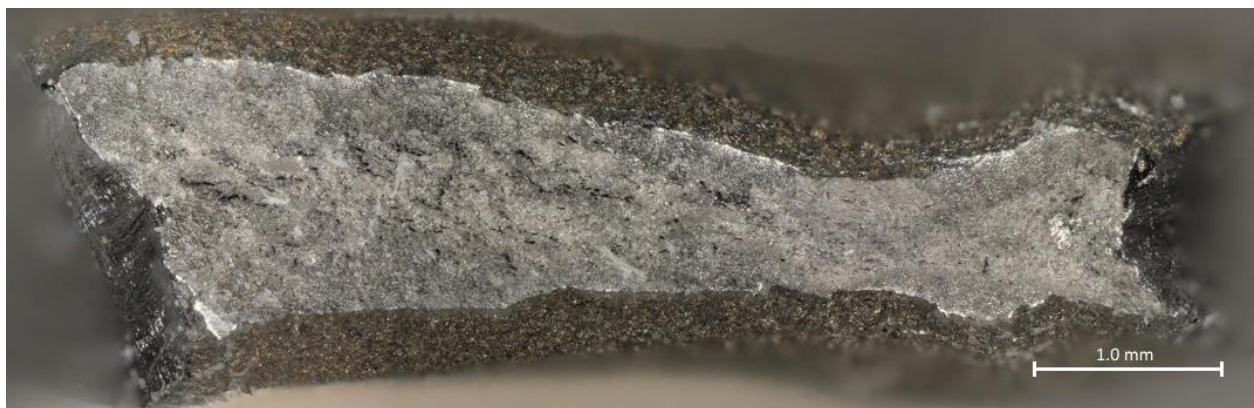
**Figure 59:** Top-Half Fracture of Control Sample 3A Taken at 100x Magnification

3A shows a significant amount of distortion before breaking. There are no obvious signs of corrosion. Some internal cracking is visible. 3A experienced a ductile fracture as per Figure 25 and can be seen by the narrowing of the edges.

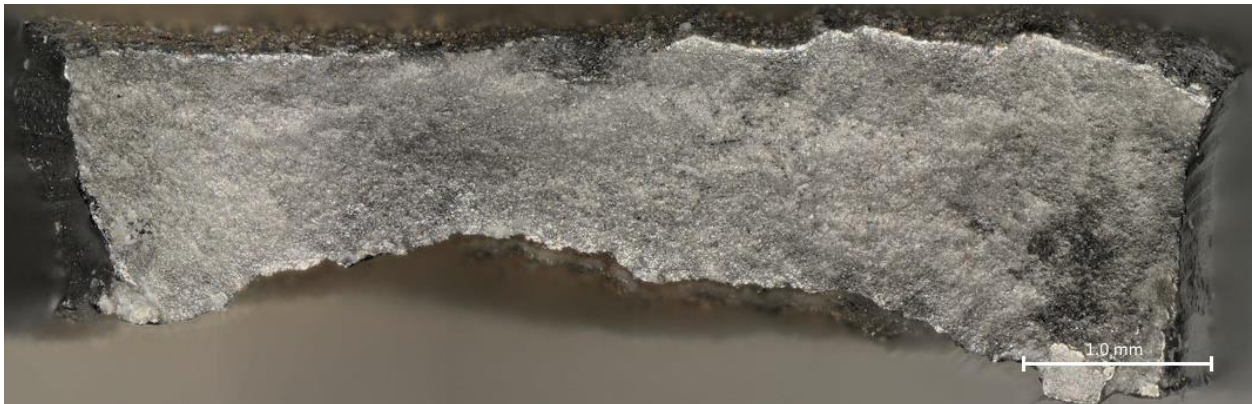
**Figure 61:** Top-Half Fracture of Control Sample 7A Taken at 100x Magnification

7A shows distortion in the fracture. No cracks or sign of corrosion pitting is evident. 7A broke in a manner consistent with a ductile fracture as evidenced by Figure 27.

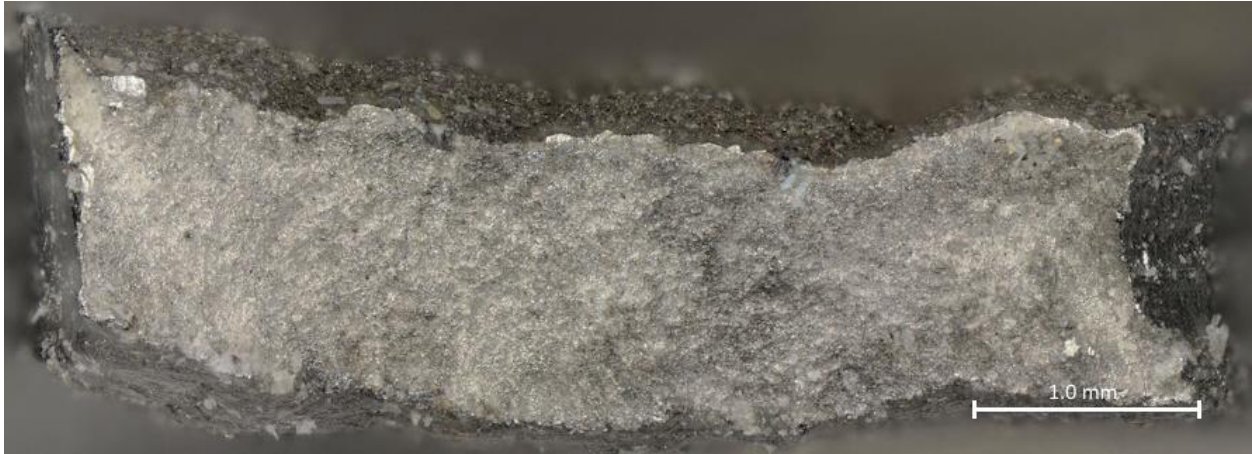
**Figure 62:** Top-Half Fracture of Control Sample BA Taken at 100x Magnification

BA shows distortion in the cross-section. The break shows homogeneous material; no signs of corrosion or pitting. The fracture of BA is best described as ductile using Figure 28 as reference.

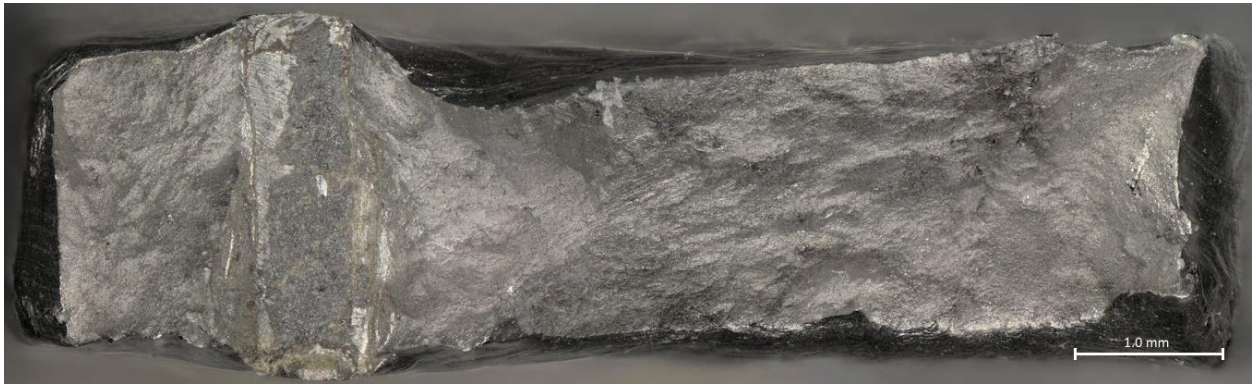
**Figure 63:** Top-Half Fracture of Control Sample 5B Taken at 100x Magnification

5B exhibits some distortion in the cross section. Attention can be drawn to the cylindrical void present in the left-side of the image. There were several of these surface imperfections present in 5B, this one served as a stress-point for failure to occur at under load. The fracture of 5B was mostly ductile, although some brittle nature was observed as per Figure 30. See Figure 64 for an optical view of 5B's back with the void circled in red.

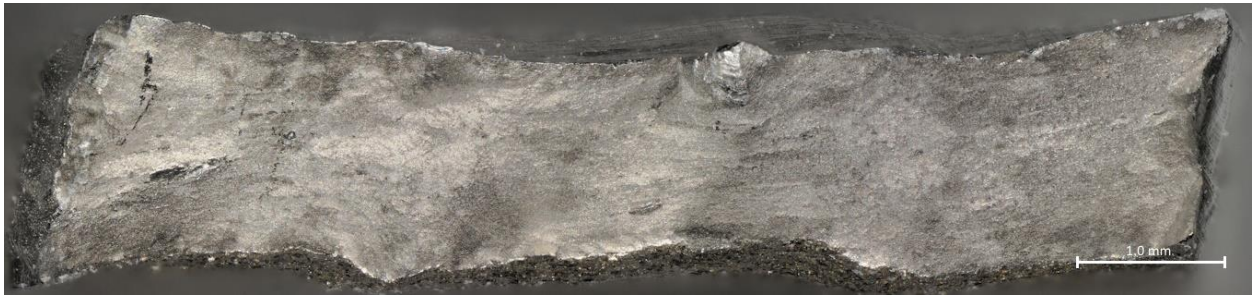
**Figure 65:** Top-Half Fracture of Control Sample 10B Taken at 100x Magnification

10B shows some distortion in the cross-section. There are signs of cracking internally on the left-side of Figure 65. A surface imperfection can be seen towards the top-middle of the image. 10B broke in a ductile manner according to Figure 31.

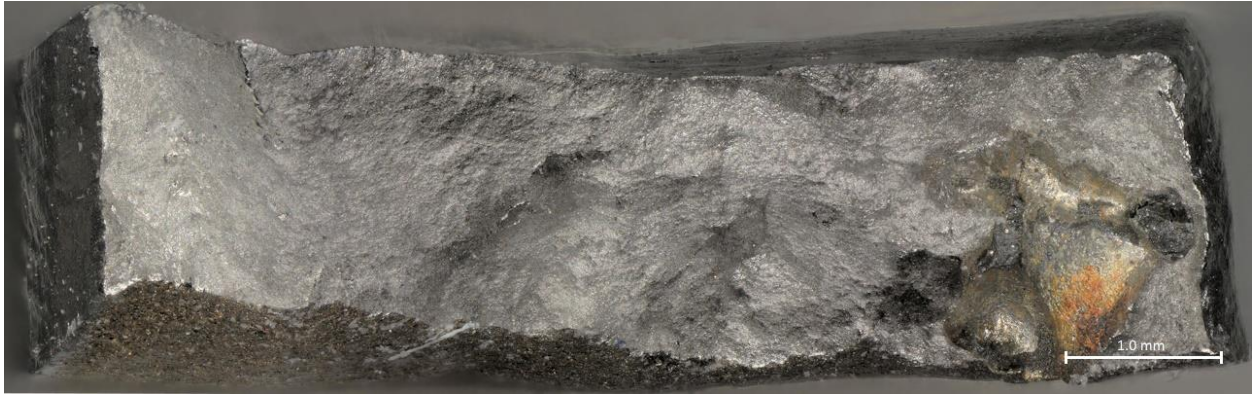
**Figure 66:** Top-Half Fracture of Control Sample 11C Taken at a Magnification of 100x

11C shows some distortion in the cross-section. Two main features are prevalent in the fracture of 11C: The topographical elevation difference between the left and the right sides and

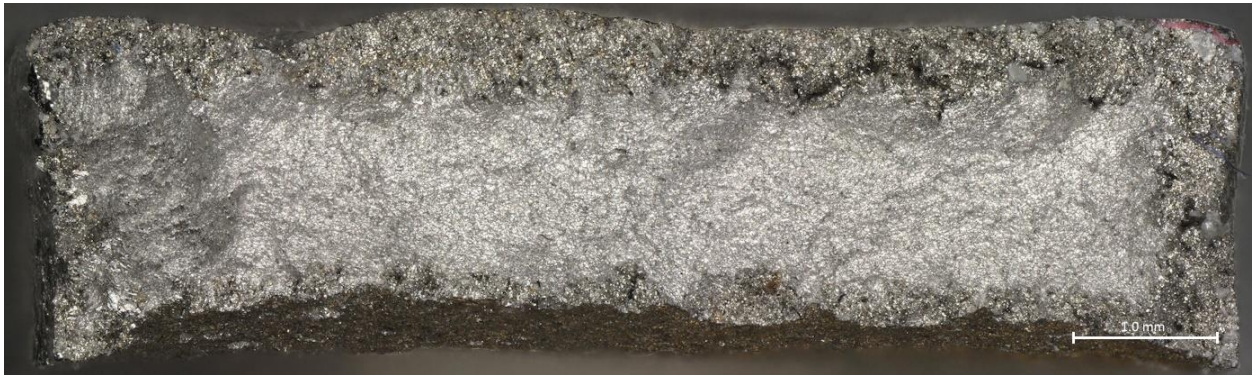
**Figure 68:** Top-Half Fracture of Control Sample 1D Taken at a Magnification of 100x

1D shows some distortion at the fracture location. Interestingly, there is substantial evidence of pitting corrosion towards the borders of the sample. The fracture of 1D is mostly

ductile as per Figure 33's fracture point. This is visible on the back-side of the sample prior to being tensile tested. The corrosion is seen as a duller, darker gray, coming in from the edges, with visible dark-spots present. When corrosion ends, the metal becomes lighter and shiny, with minimal to no dark inclusions. In this image, one can see the corrosion features going around the entire sample, although there is more surface penetrate on the top of the image. Since this is a control, this bit of corrosion is due to the accidental exposure for 16.7 hours. See both an optical view of 1D's back as well as a height-mapped version of Figure 68 in Figures 69 and 70.

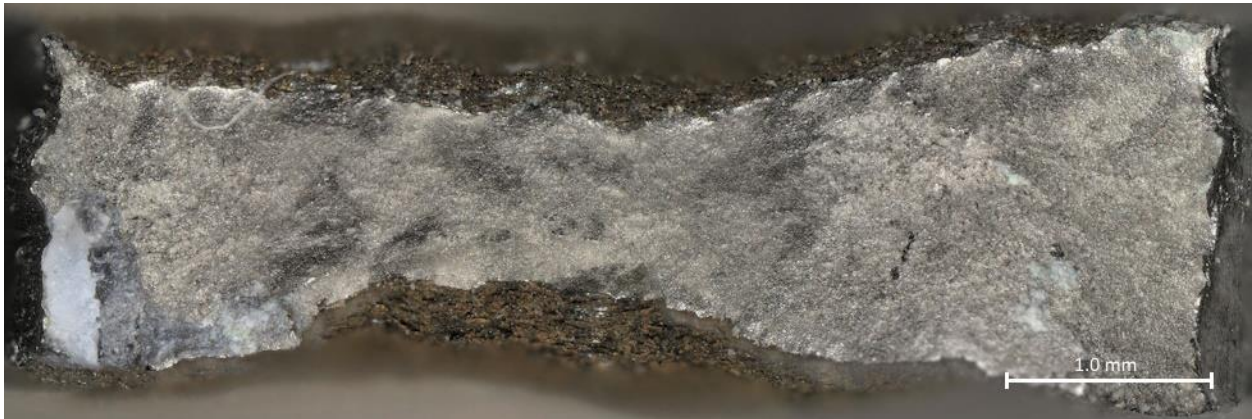
**Figure 72:** Top-Half Fracture of Control Sample 7D Taken at a Magnification of 100x

7D shows quite a bit of distortion at the fracture location. There is a crack visible within the section on the right-side of the image. There are no notable signs of corrosion present in the image. The fracture of 7D was ductile as per Figure 35.

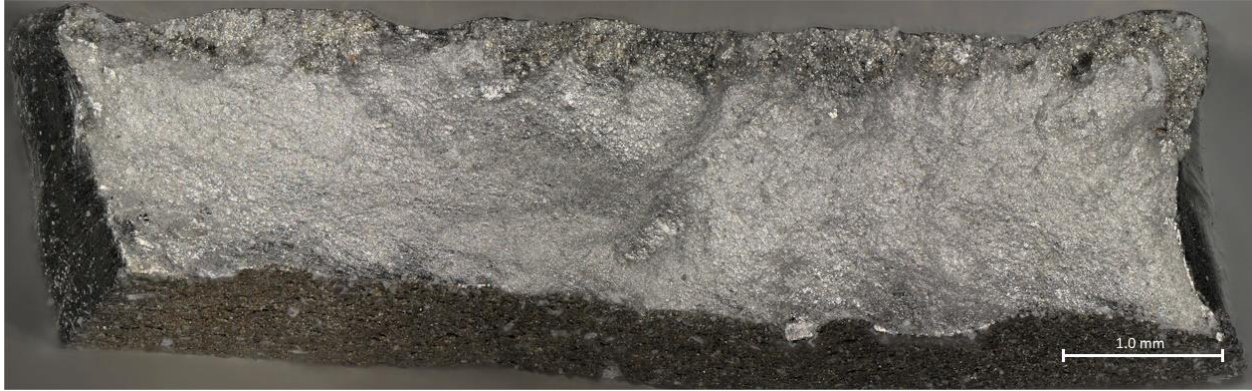
**Figure 73:** Top-Half Fracture of Control Sample 10D Taken at a Magnification of 100x

There are some signs of distortion in sample 10D. There are no visible cracks within the cross-section however one can see some evidence of corrosion towards the top-region of Figure 73. 10D experienced a ductile fracture as per Figure 36. As with Figure 68, corrosion is present as a darker grey region with black inclusions, specifically at the top of the sample, while no corrosion present is shown as bright, shiny metal.

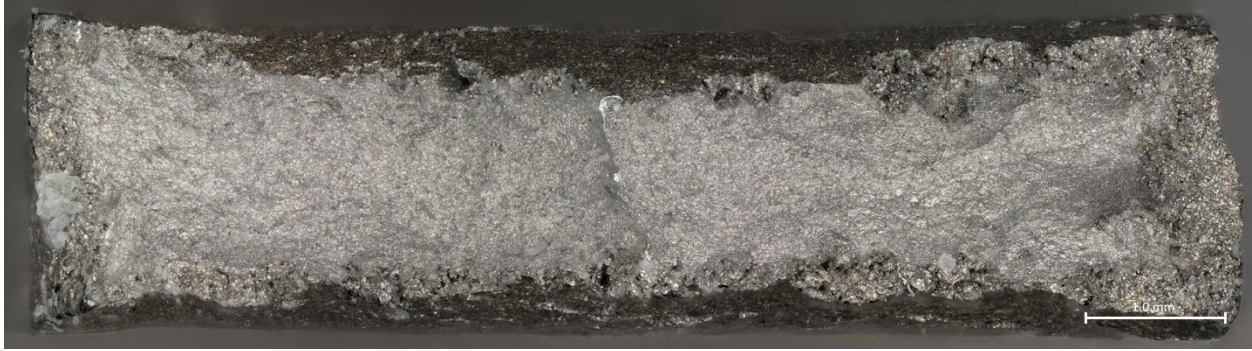
**Figure 75:** Top-Half Fracture of 21-Day Sample 4A Taken at a Magnification of 100x

4A shows some distortion across the cross-section. Pitting corrosion can be observed along the entire border of the sample, as indicated by very dark holes throughout the top and bottom edges. The fracture of 4A according to Figure 38 is mostly ductile; due to the slope of the fracture point, there were likely some small regions that broke in a brittle manner.

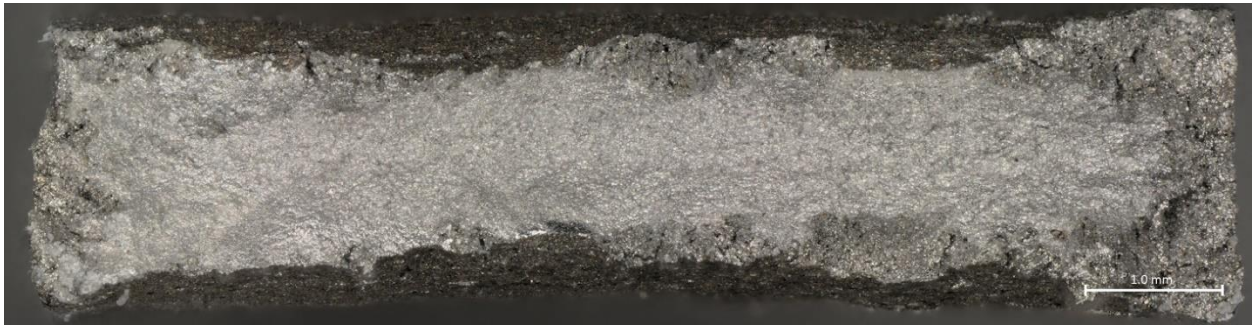
**Figure 76:** Top-Half Fracture of 21-Day Sample 9A Taken at a Magnification of 100x

9A shows minor amounts of distortion throughout the fracture. There are no notable cracks within the pristine area of the section, but evidence of corrosion is present around the borders of the section. 9A broke in a mostly ductile manner as per Figure 39, but some regions of the fracture-point suggest it was not far from being brittle.

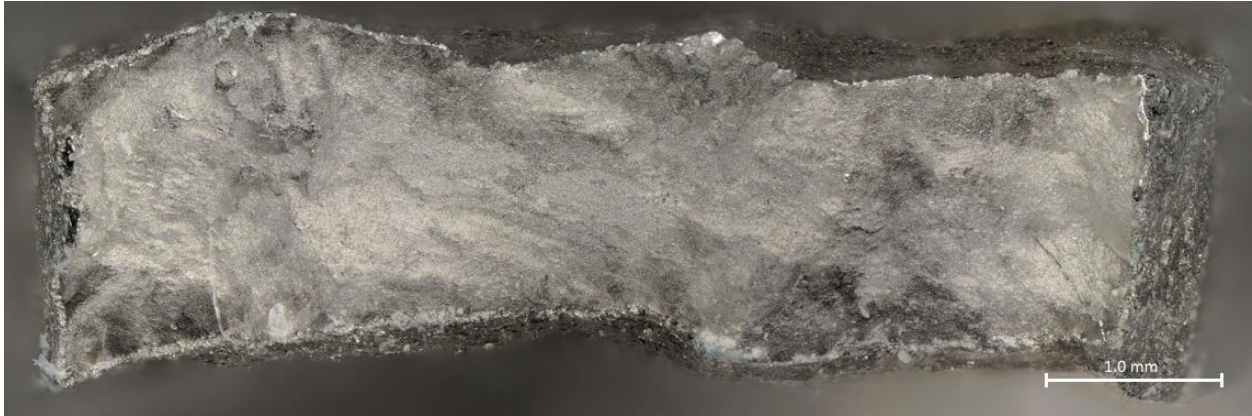
**Figure 77:** Top-Half Fracture of 21-Day Sample 3B Taken at a Magnification of 100x

3B shows a moderate amount of distortion throughout the fracture. There are some small internal cracks within the left and right portions of the image. Very minor amounts of pitting corrosion can be seen, most notably at the extreme left-side of Figure 77. 3B exhibited classic ductile fracturing as the border of the section obviously shows the “cup” feature raised to the viewer as well as Figure 40.

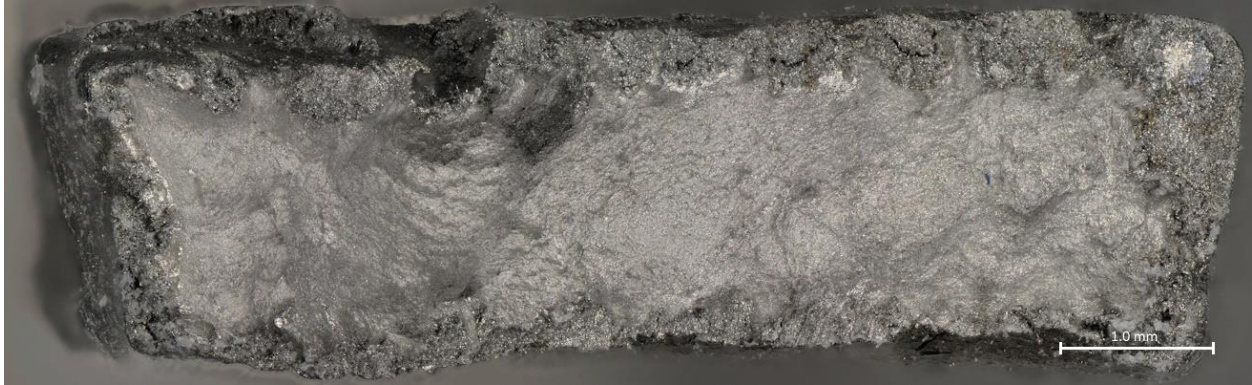
**Figure 79:** Top-Half Fracture of 21-Day Sample 3C Taken at a Magnification of 100x

3C shows moderate signs of distortion. There is very prevalent pitting corrosion occurring around the border of the sample. Figure 43.5 shows that the fracture of 3C is best described as ductile. Most notably, there is a surface defect on the back-side of the sample at the fracture location visible in the cross-section in the top-middle region of Figure 79. Figure 80 and Figure 81 depict both a surface view as well as a 3D scan of the pit.

Figure 81 to the left and Figure 80 depict the surface defect that became a point of stress where 3C ultimately fractured during tensile-testing. Regarding the scale shown in Figure 81, one can see that the pit is approximately 0.258 mm in depth. 3C's actual thickness measurement was recorded as 1.57 mm. The pit propagated 16.4% through the thickness of 21-Day Sample 3C which looks reasonable referring to Figure 79.

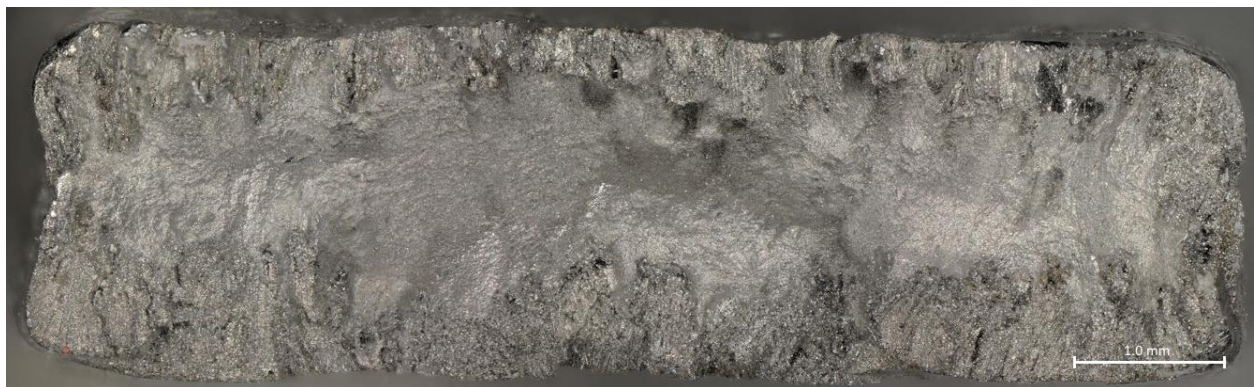
**Figure 82:** Top-Half Fracture of 21-Day Sample 5C Taken at a Magnification of 100x

5C shows mild amounts of distortion across the cross-section. It shows severe pitting corrosion around the border of the section, with large changes in the color of the metal on both the top and bottom of the figure. Figure 43 depicts a mostly ductile fracture based on the fracture-point.

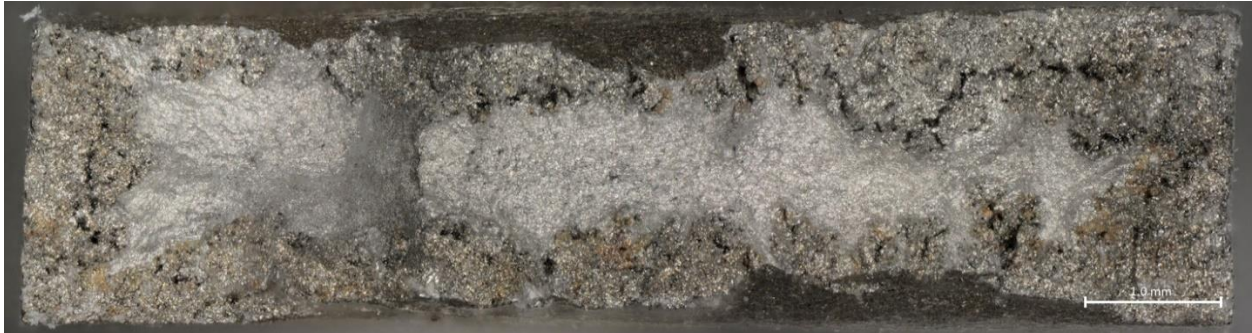
**Figure 83:** Top-Half Fracture of 21-Day Sample 2D Taken at a Magnification of 100x

2D shows some distortion across the cross-section. There is substantial evidence of pitting corrosion across the borders of the sample. When looking at this figure, the corrosion is identified as dark, dull gray, with some brownish spots indicating potential rust within the surface. It also appears to be more porous showing plenty of pits. It has the appearance that it is ready to crumble apart, although the sample held together all the way until it tensile-elongation tested. The fracture of 2D took place in steps, that is it was not ductile, rather brittle. Figure 84 below depicts a topographical map of 2D’s fracture.

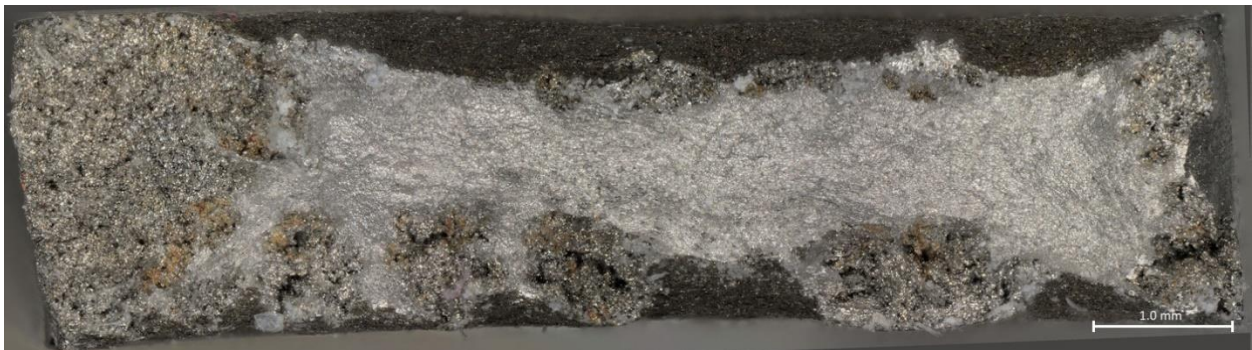
**Figure 86:** Top-Half Fracture of 21-Day Sample 9D Taken at a Magnification of 100x

9D shows moderate distortion across the cross-section. Substantial corrosion is present especially on the left-side of Figure 86, with the same crumbly appearance as Figures 84 and 85. The fracture was brittle as evidenced by Figure 46's fracture point.

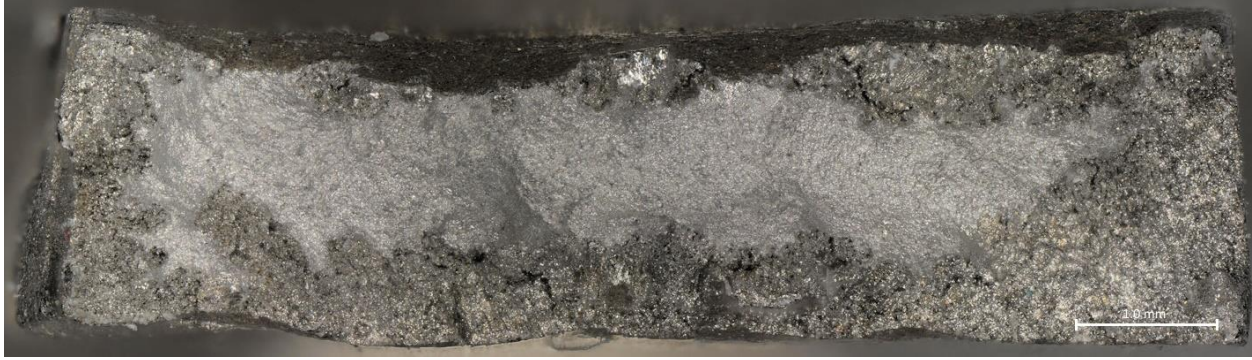
**Figure 87:** Top-Half Fracture of 43.5-Day Sample 2A Taken at a Magnification of 100x

2A shows little distortion across the cross-section. There is substantial evidence of pitting corrosion occurring along the border of the sample, with the dark, dull gray also beginning to penetrate into the lighter metal on the left side of the image. The fracture was brittle as evident by Figure 47's fracture point.

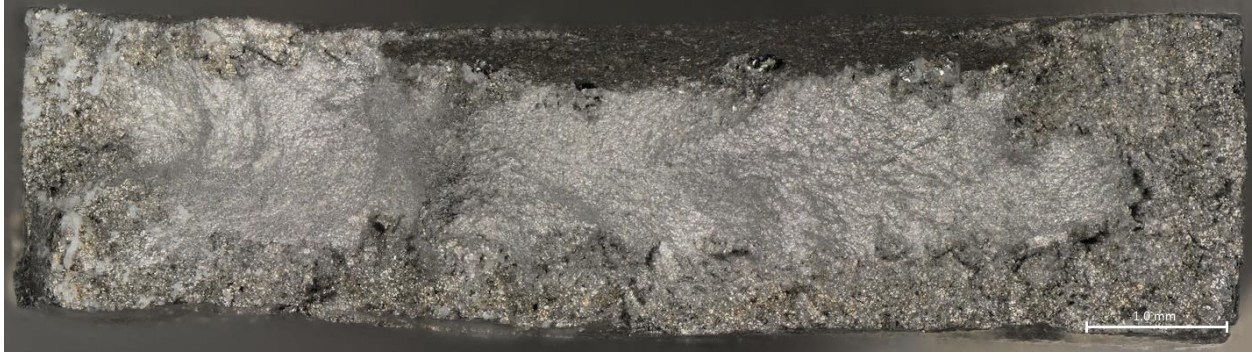
**Figure 88:** Top-Half Fracture of 43.5-Day Sample 5A Taken at a Magnification of 100x

5A shows very little distortion across the fracture location. There is a significant amount of pitting corrosion evident around the border of the cross-section. The fracture was brittle as supported by the fracture point depicted by Figure 48.

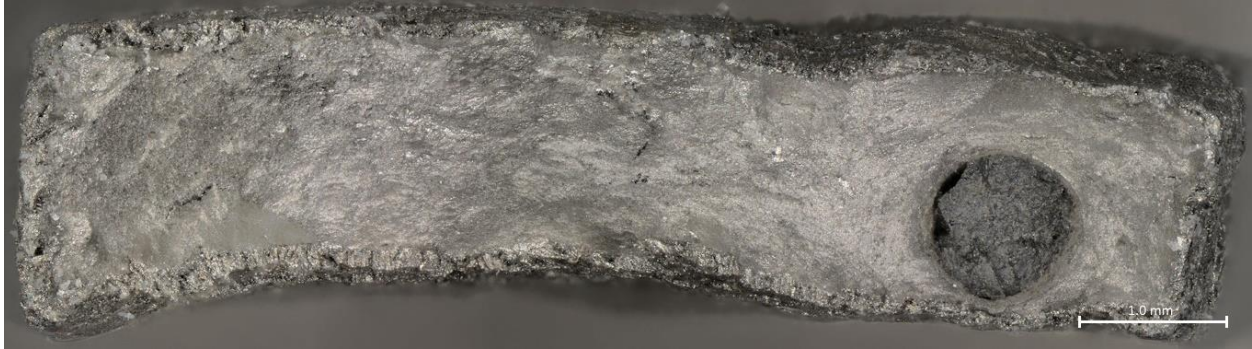
**Figure 90:** Top-Half Fracture of 43.5-Day Sample 4B Taken at a Magnification of 100x

Sample 4B shows a moderate amount of distortion across the cross-section. There is a very large defect present in 4B in the right-most portion of Figure 90. A mild amount of pitting corrosion can be seen around the borders of 4B. There are some small cracks present in the pristine area of the section. Unlike the rest of the 43.5-Day Samples, 4B demonstrates a ductile fracture as evident by Figure 50’s fracture point.

4B's fracture location was along the gauge-length towards the transition region approaching the labeled, thicker area of the tensile sample (i.e. the right side of Figure 91 where the neck became thinner with increasing corrosion duration). It can be seen that this region was not prevalent at the start of the experiment, but grew into a point of stress where the sample would ultimately fail under load.

4B's fracture is receiving additional notes due to its excellent tensile elongation properties as seen in Figure 50, in direct contrast to the rest of the 43.5-day samples which performed poorly. It was checked to ensure that the tensile data was not mismatched.

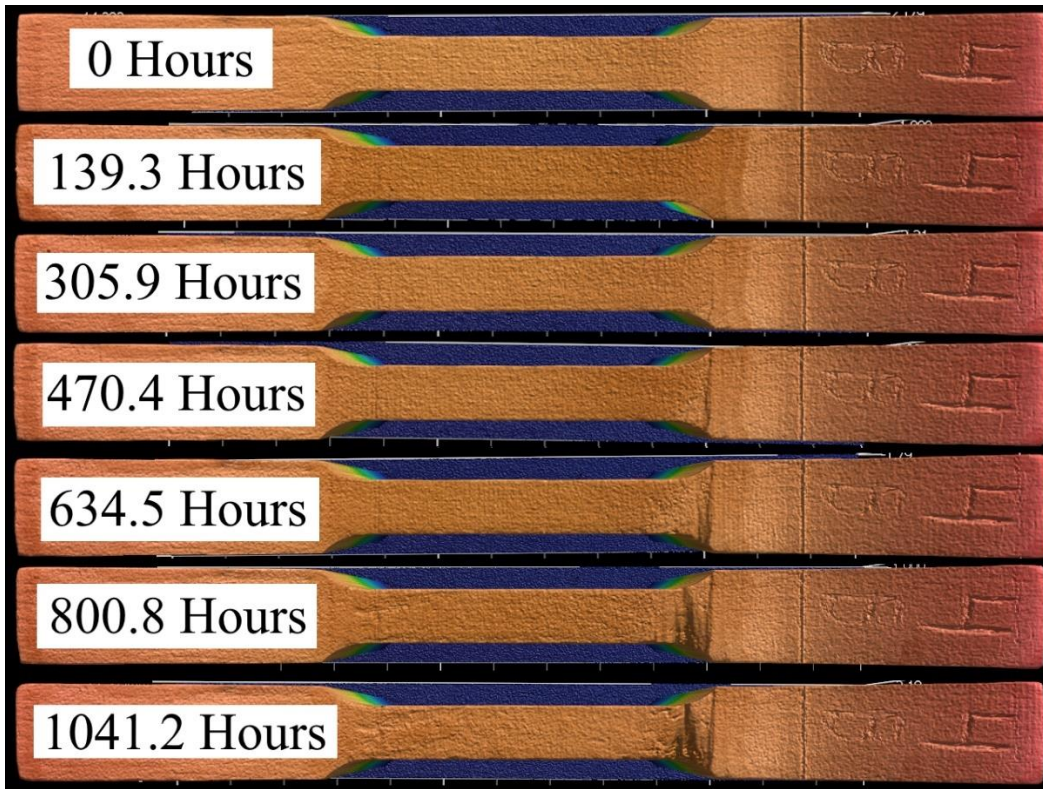
**Figure 91:** Chronological Progression of 4B's Corrosion Depicted by 3D Topographical Scans

4B's corrosion by time-stamp.

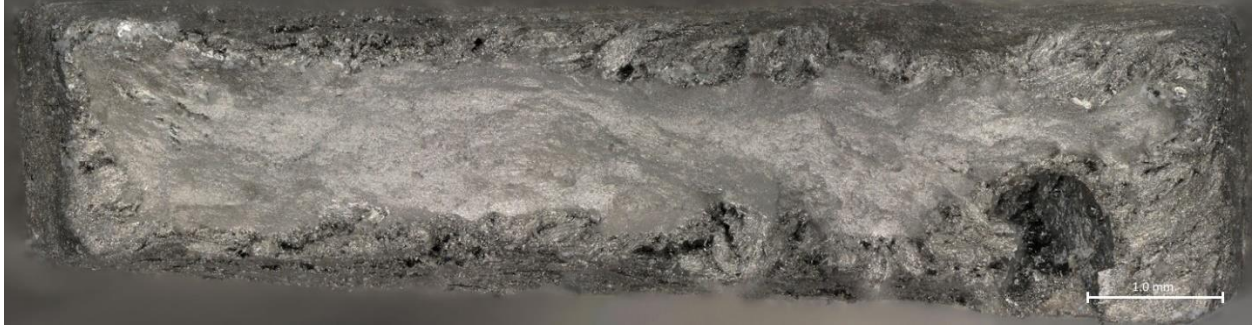
**Figure 92:** Top-Half Fracture of 43.5-Day Sample 9B Taken at a Magnification of 100x

9B showed almost no distortion across the cross-section. There is substantial pitting corrosion around the border of the sample. There is a very large defect in the bottom-right side of Figure 92 that also appears on the front-side of 9B’s surface scans. This pit served as a stress-point where failure eventually occurred in a brittle-manner under load according to Figure 51. Figure 93 shows an optical view of the front-side of sample 9B at the start and end of the corrosion experiment, with the defect where the sample failed also showing in the top-right side of the gauge length.

Figure 94 depicts the defect as being approximately 0.381 mm deep based on the color scale. This puts it at around a quarter of the overall depth of sample 9B. When referencing Figure 92, this estimate seems to be shallower than what one would expect; Figure 92 shows the defect reaching 50% of the sample's overall depth. This defect was created as a void during the printing of the sample

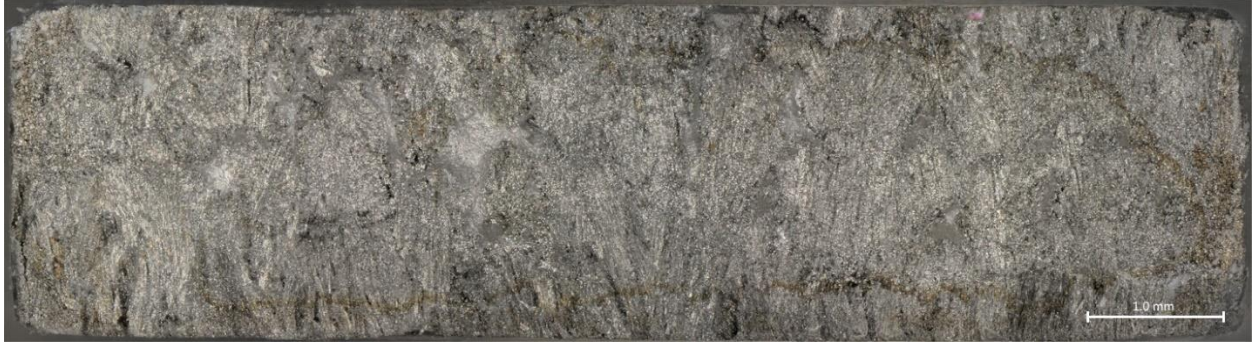
**Figure 95:** Top-Half Fracture of 43.5-Day Sample 4C Taken at a Magnification of 100x

Sample 4C shows almost the entirety of the fracture-surface that has been corroded by pitting. There is no distortion of the sample at all. The sample was completely brittle when broken as evidenced by Figure 52's fracture point. A contrast of 4C at 0 hours of corrosion versus at 800.8 hours of corrosion can be seen in Figure 96.

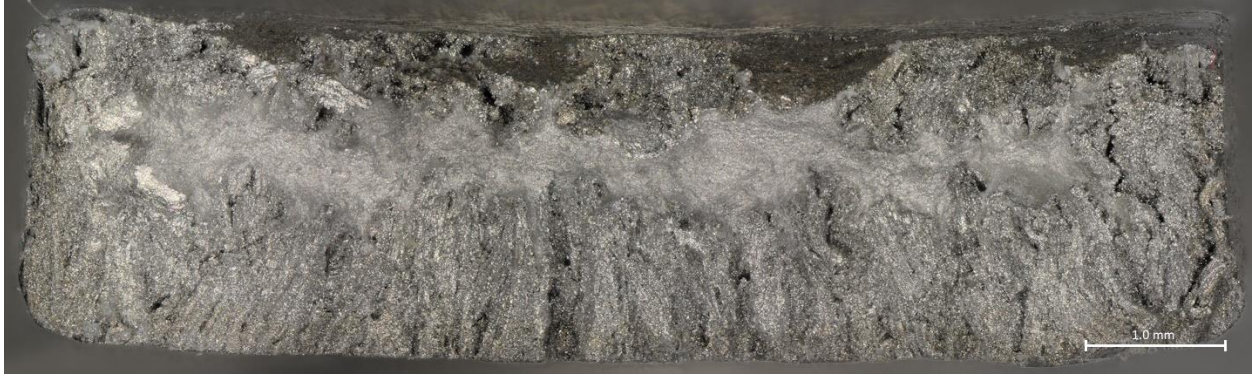
**Figure 97:** Top-Half Fracture of 43.5-Days Sample 8C Taken at a Magnification of 100x

8C shows very little distortion across the sample. Almost the entire cross-section has been affected by pitting-corrosion. A narrow region near the center of the fracture is still uncorroded metal. The fracture of 8C was brittle as seen by the fracture point of Figure 53.

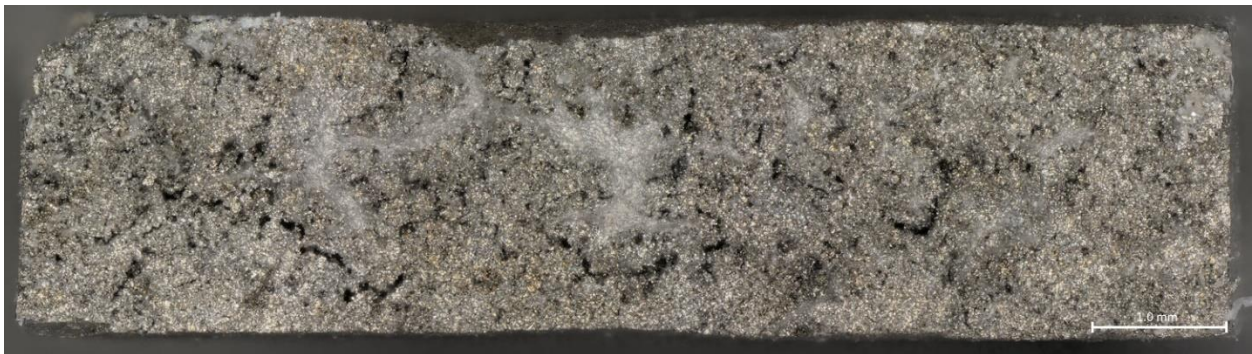
**Figure 98:** Top-Half Fracture of 43.5-Day Sample 3D Taken at a Magnification of 100x

3D shows essentially no distortion across the cross-section. There entire surface shows evidence of pitting corrosion with just a few very small regions, directly in the center of the sample, with the original metal appearance. The fracture was completely brittle as per Figure 54's fracture point.

Sample group D showed the smallest increase in the modulus of elasticity. This may be surprising at first considering how severe the propagation of pitting corrosion was in Figures 98, 99, and 100, but it is also useful to recall that sample group D was the only control group to demonstrate evidence of pitting corrosion with only 16.7 hours of exposure, as shown in Figures 68 and 73.

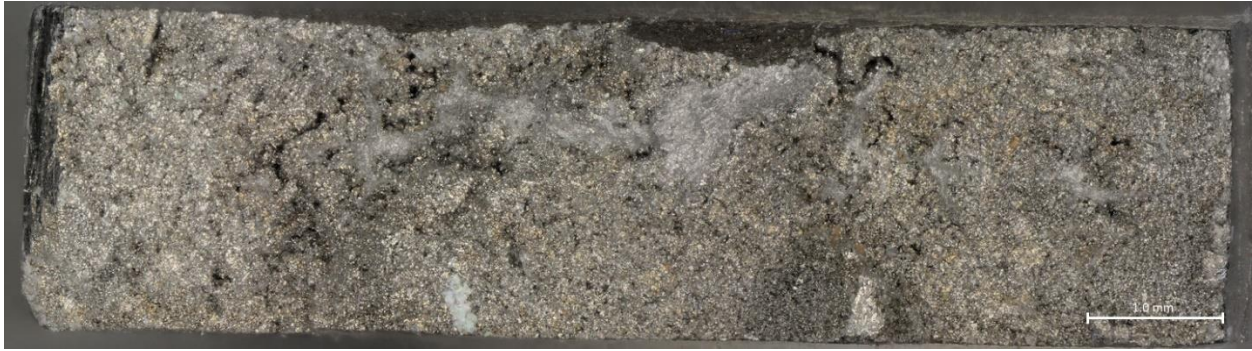
**Figure 99:** Top-Half Fracture of 43.5-Day Sample 6D Taken at a Magnification of 100x

6D as almost no distortion to it. The pitting corrosion has affected almost the entire cross-section of the sample, with only a tiny amount of the original metal in the center-top of the image. The fracture of 6D was brittle as shown by Figure 55's fracture point.

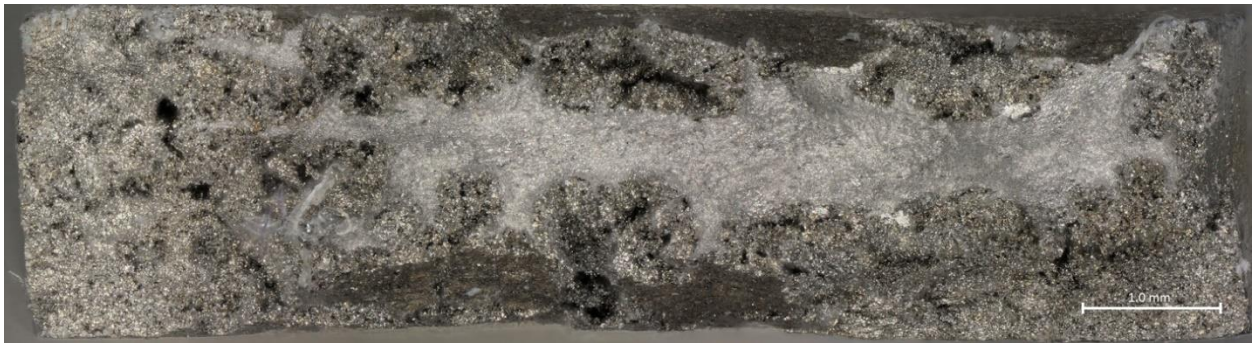
**Figure 100:** Top-Half Fracture of 43.5-Day Sample 8D Taken at a Magnification of 100x

8D has very little distortion across the fracture surface. Pitting corrosion can be seen across the vast-majority of the cross-section. A moderate patch of pristine steel exists from the middle to right-portion of Figure 100, while the left-side of the image has the standard crumbly appearance. The fracture point of Figure 56 shows that the break of 8D was brittle in nature.
