THE DIELECTRIC FAILURE MECHANISM OF A  
HIGH VOLTAGE FEEDTHROUGH

Submitted in Partial Fulfillment of the Requirements  
for the Degree of  
Master of Science  
in the  
Electrical Engineering  
Program

YOUNGSTOWN STATE UNIVERSITY

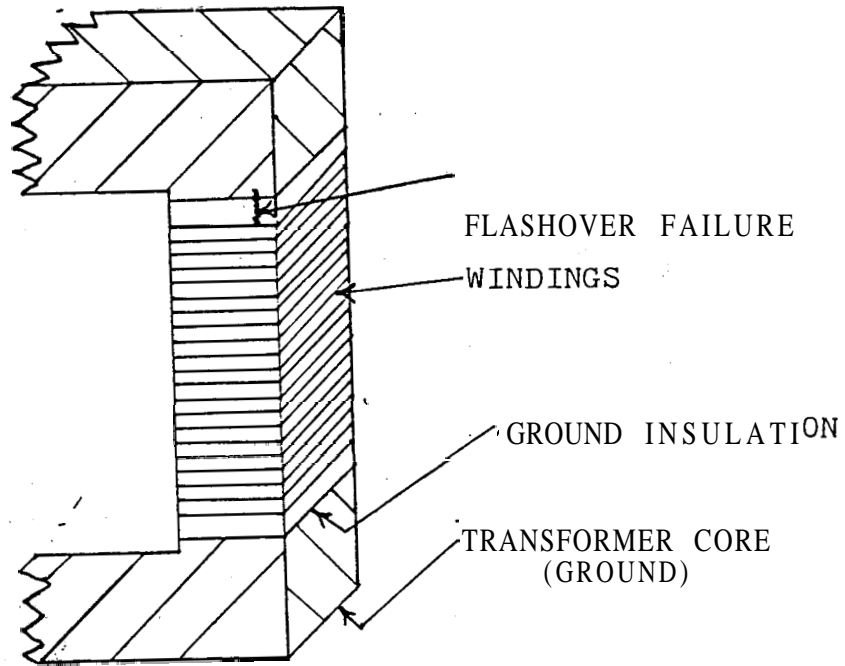
FIGURE 7. GROUND INSULATION FAILURE  
UNDER TRANSFORMER WINDINGS

Creepage distance is one good example. In power transformer design, for instance, a sheet of solid insulation is used from the end of layer of conductor winding to the grounded iron core. This solid insulation also serves as layer to layer insulation, but under failure conditions, failure will almost always occur as a flash-over along the surface from the winding to the grounded core. See Figure 7.

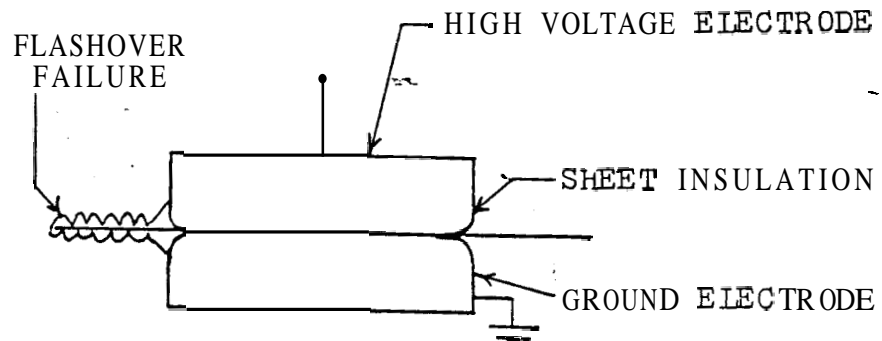
FIGURE 8. SURFACE FLASHOVER  
IN SHEET INSULATION TEST

Similarly, a common test for the dielectric strength of sheet insulation employs two, two inch diameter brass electrodes with the sheet of insulation under test sandwiched between the brass electrodes. The failure mode being tested for is one of puncture between the two electrodes. As the thickness of the insulation grows, the dielectric strength only increases until flashover becomes the failure mechanism. Increasing the insulation further

produces only a minimal increase in dielectric strength. This is illustrated in Figure 8.
