**A ROSGEN LEVEL III ANALYSIS OF TWO STREAM RESTORATION
PROJECTS NEAR YOUNGSTOWN, OHIO**

Rajesh Kumar Poudel

YOUNGSTOWN STATE UNIVERSITY

December, 2010

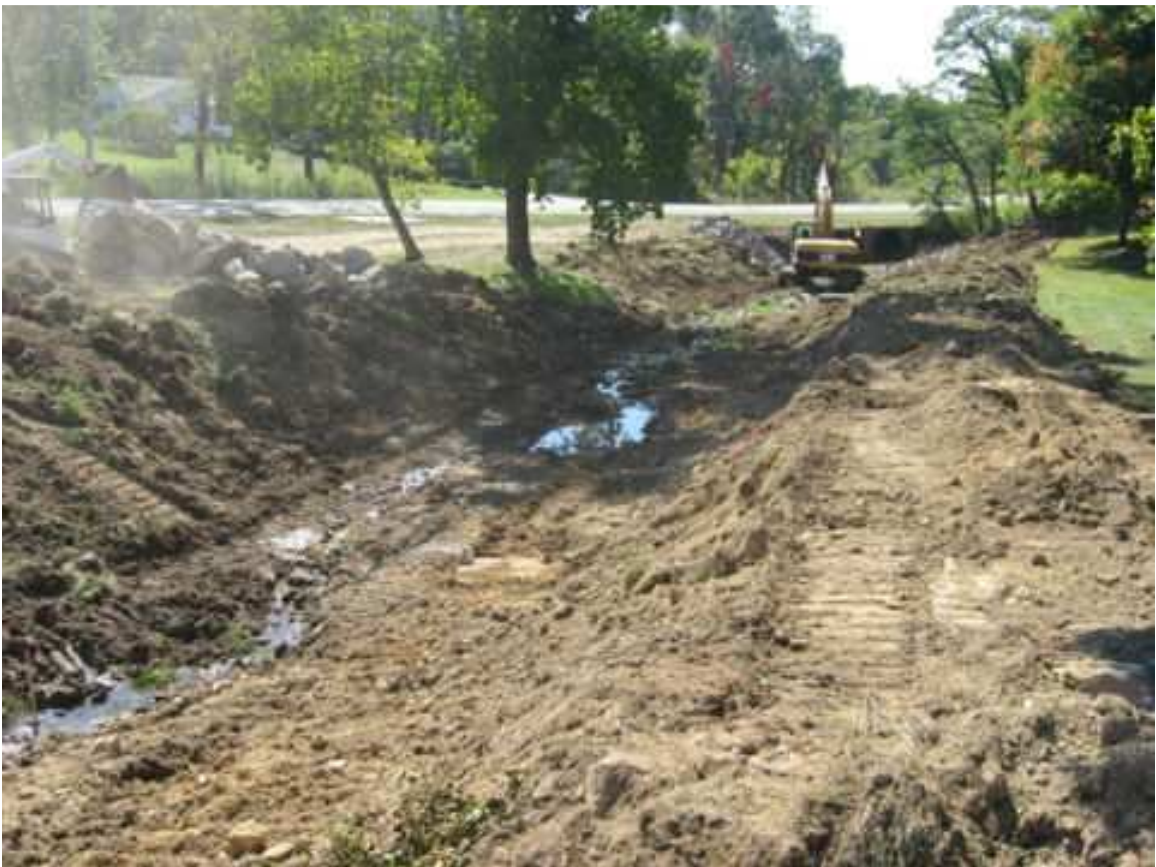
Figure 2.12 Widening of stream channel for Austintown Park restoration project (WPI 2008).

The stream enhancement consisted of the following activities: (1) removal of foreign materials (e.g. large concrete pieces); (2) stream bank excavation to create appropriate bankfull width for the stream and appropriate floodplain area; (3) installation of cross vane structures, (4) moderate re-alignment of the stream channel at its junction with the culvert, (5) planting of appropriate riparian seed mixes and shrubs, and (6) placement of armoring where necessary to reduce erosion and scouring. Excavation was done along the entire length of the project site on both banks of stream. The north bank of the stream was excavated to create a wider pooling area at the inlet of the culverts in order to increase the angle at which the stream approaches and enters the culvert. Stone armoring was placed at both the eastern and western ends of the headwall to further

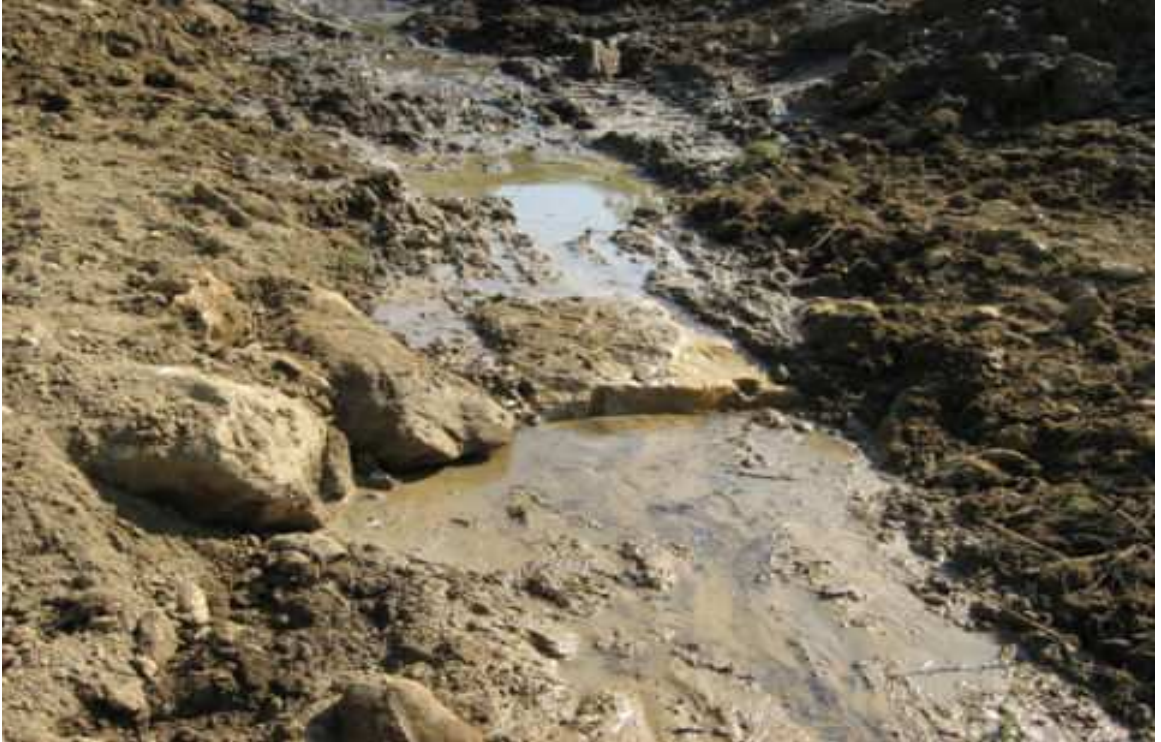
Figure 2.13 Finished cross vane structure for Austintown Park project (WPI 2008).

prevent erosion and scouring and subsequent structural damage to the culvert and headwall. Five (5) stone cross vane structures were placed throughout the length of the enhancement area. The riparian zones of the stream were stabilized through the planting of shrubs and a selected seed mix. The floodplain seed mix was applied within the newly created floodplain areas. Construction of the project was performed in September, 2007. Construction photos are shown in Figures 2.12, 2.13 and 2.14.

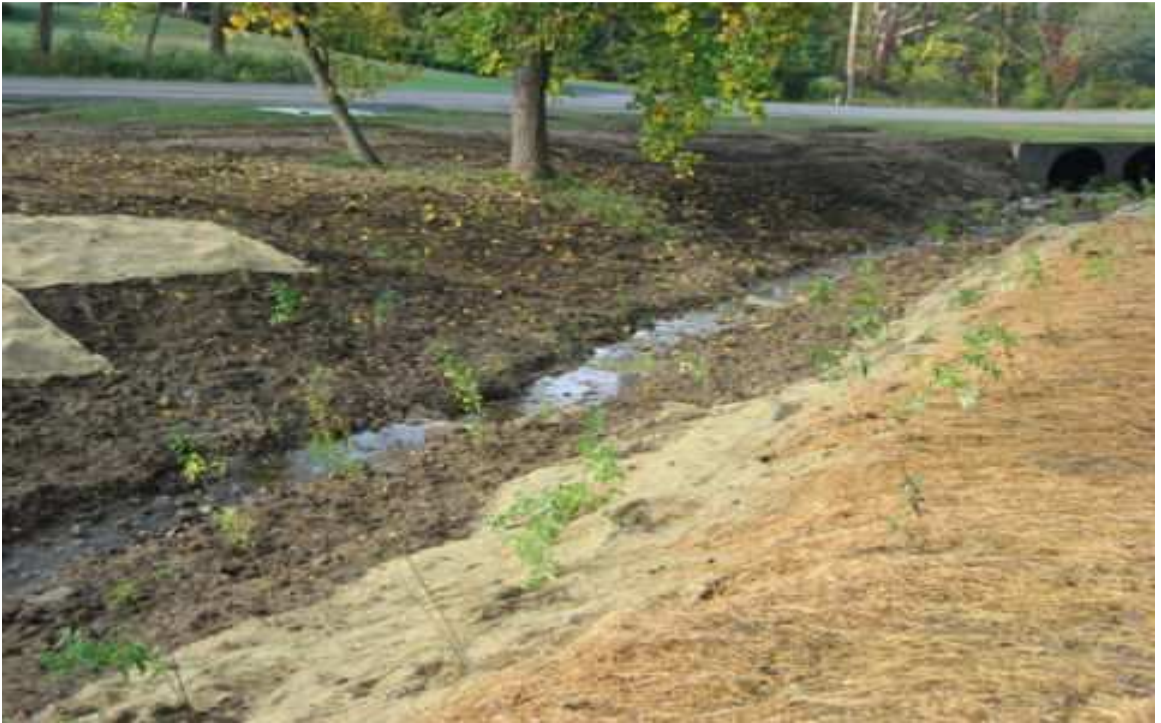
Figure 2.14 Planting riparian vegetation for Austintown Park project (WPI 2008).

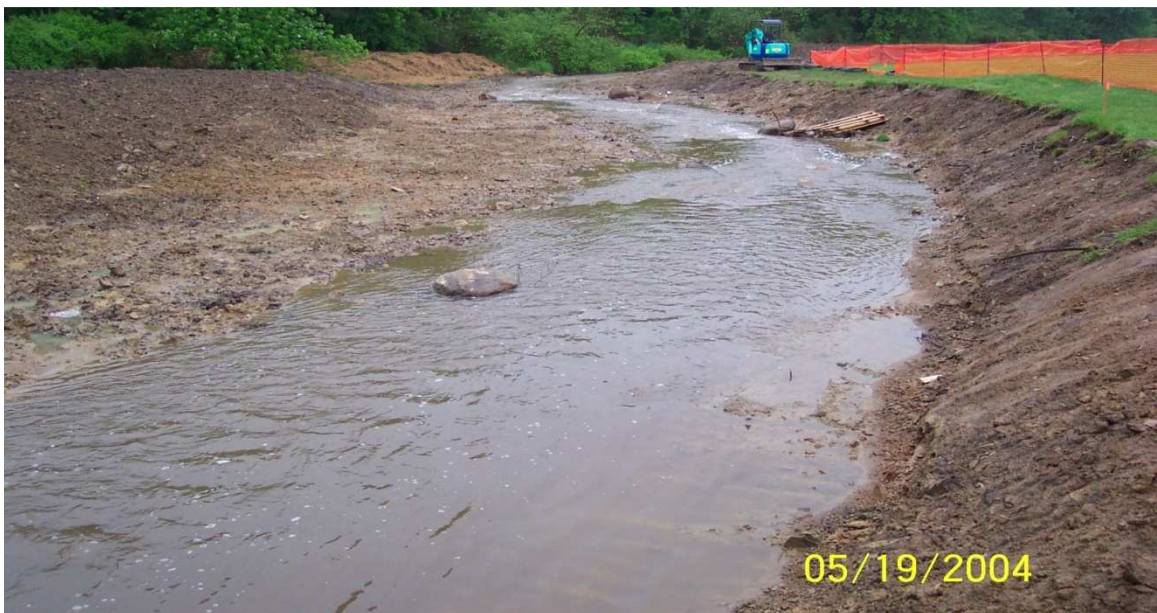
Figure 2.18 Widening of Indian Run stream channel (WPI 2004).

The restoration work included the stabilization of 1900 linear ft of degraded stream channel using natural channel design techniques, establishment of 0.23 miles of riparian buffer, installation of 20 aquatic habitat structures. This project also provided an educational outreach program that reached 2300 students and faculty, and involved one watershed group. Construction of the project was performed from May to July, 2004. Photos of the construction are shown in Figures 2.18 to 2.20.

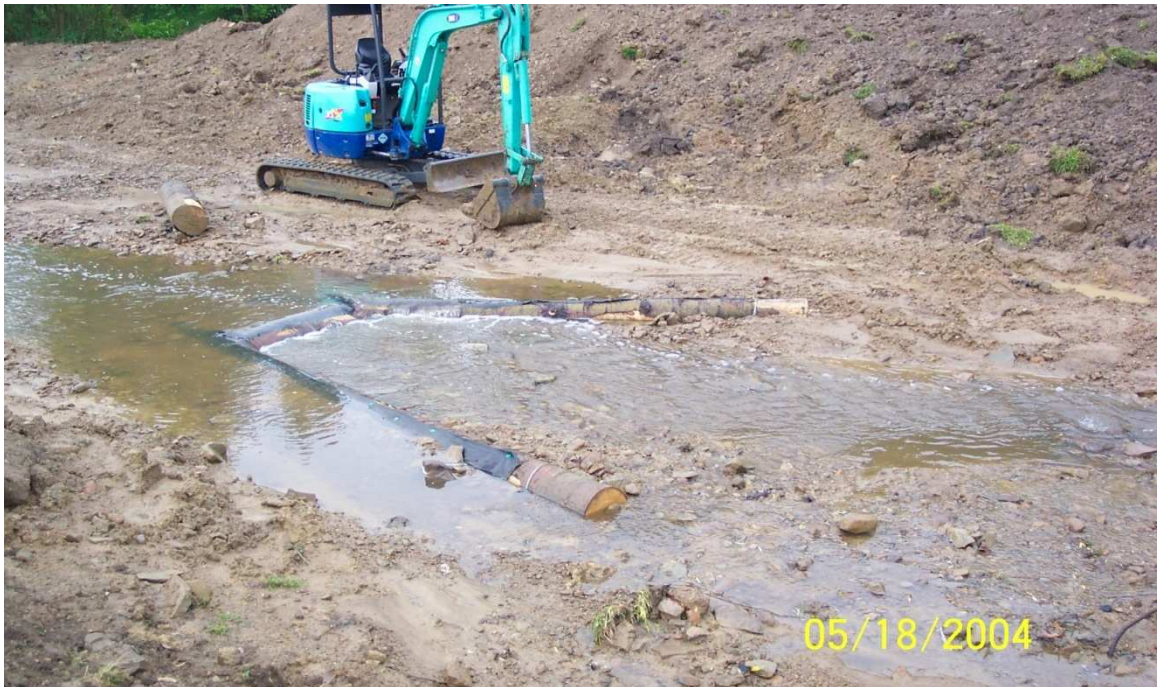
Figure 2.19 Finished log cross vane structure in Indian Run (WPI 2004).

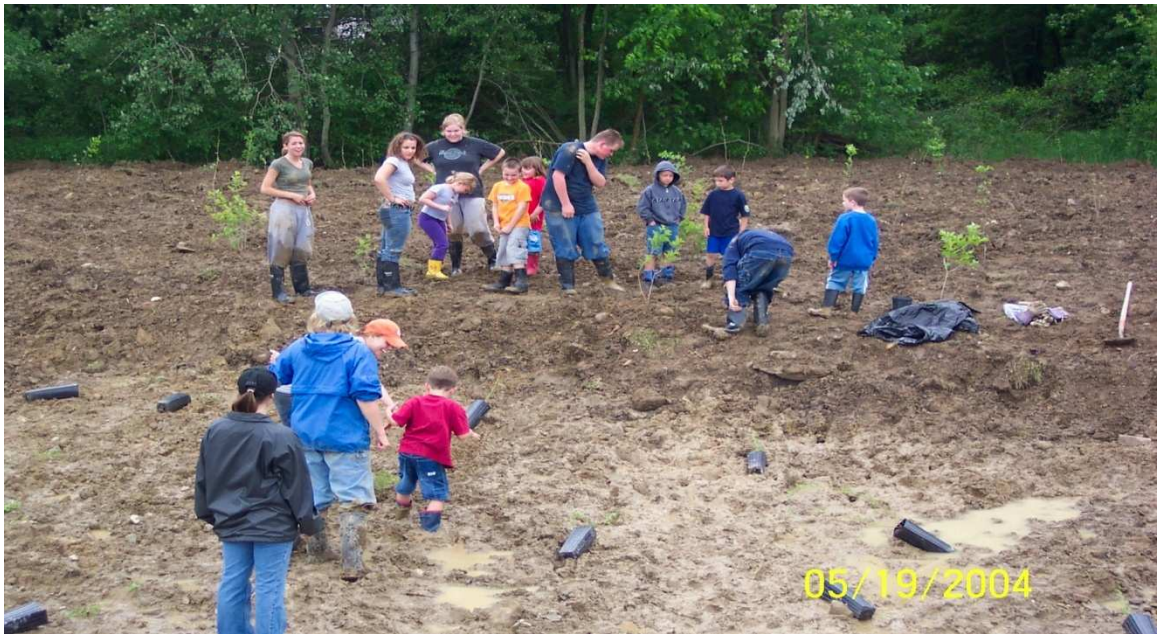
Figure 2.20 Planting riparian vegetation along Indian Run (WPI 2004).
